NATIONAL TRANSPORTATION SAFETY BOARD

# SAFER SEAS

# Digest

Lessons Learned from  
Marine Investigations

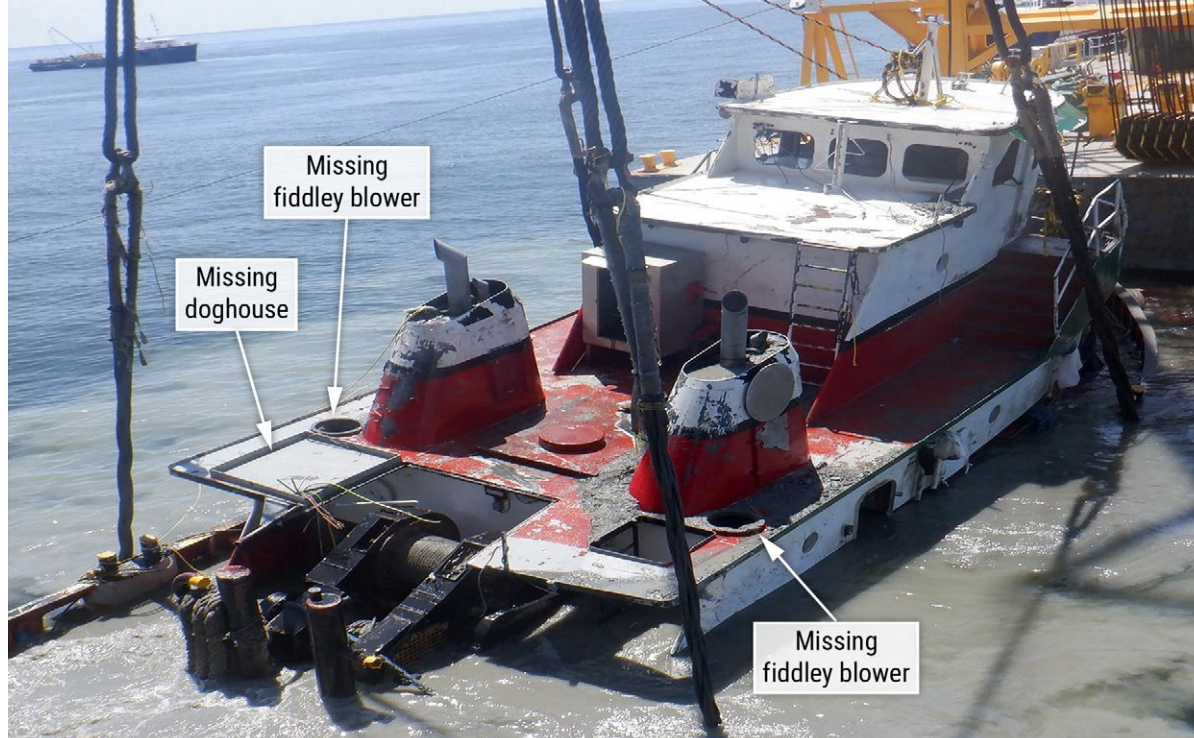
*Baylor J. Tregre* after salvage, showing the doghouse and fiddley blowers missing.

**THE PROBABLE CAUSE** of the capsizing and sinking of the towing vessel *Baylor J. Tregre* was the mate's inability to maneuver the tow into the wind due to the overwhelming towline force generated by the towed barge during the sudden onset of severe weather, resulting in unrecoverable heeling.

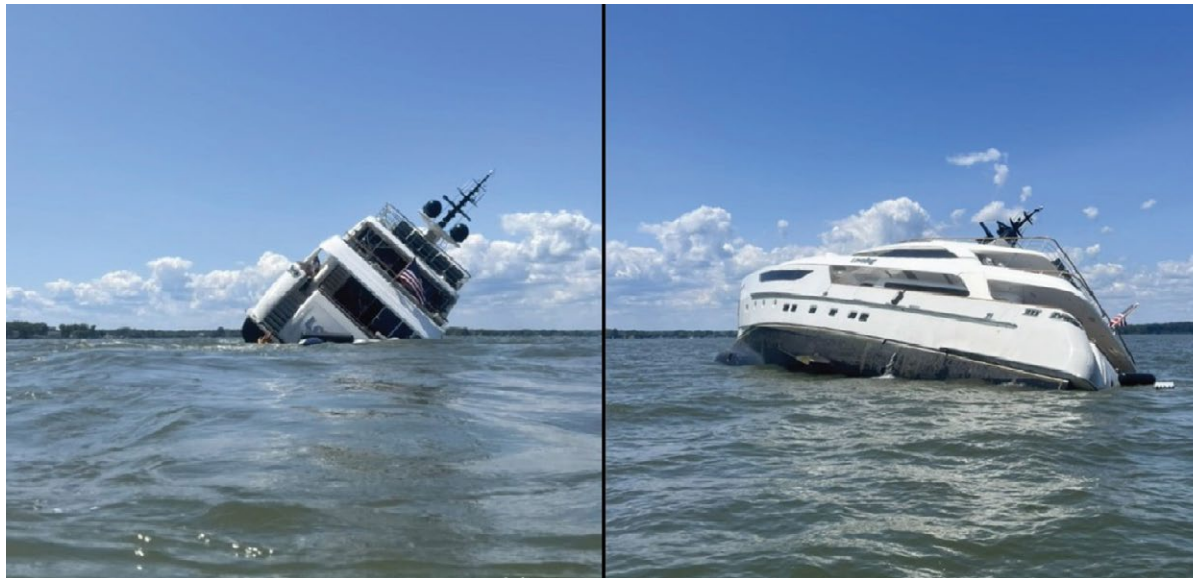
**THE PROBABLE CAUSE** of the listing and partial sinking of the yacht *Lovebug* was undetected flooding through an open watertight door, resulting in the vessel losing stability.

**The *Lovebug* on July 27, 2024, at 1238:48 and 1241:45, shortly after the owner and crew abandoned the vessel.**

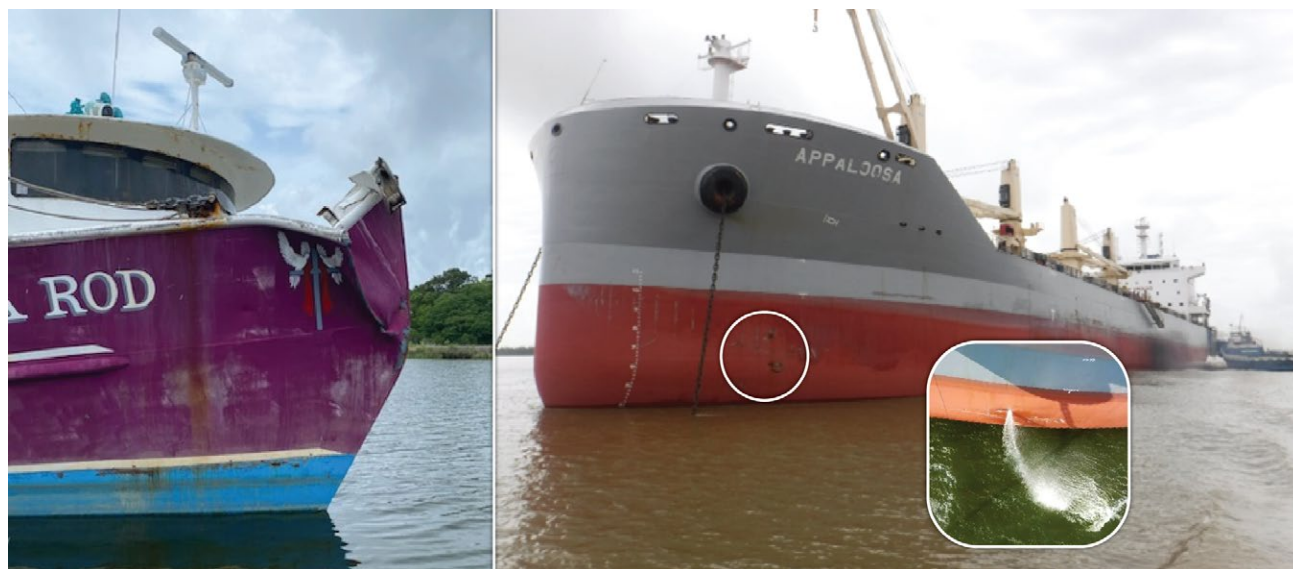
**Bow damage to the *Papa Rod* and *Appaloosa* hull breach (circled). Inset shows ballast water leaking from the breached hull. SOURCE: COAST GUARD.**

**THE PROBABLE CAUSE** of the collision between the fishing vessel *Papa Rod* and the anchored bulk carrier *Appaloosa* was the on-watch deckhand falling asleep while operating the *Papa Rod*. **POSSIBLY CONTRIBUTING** to his drowsiness were effects of his drug use or a related sleep debt.

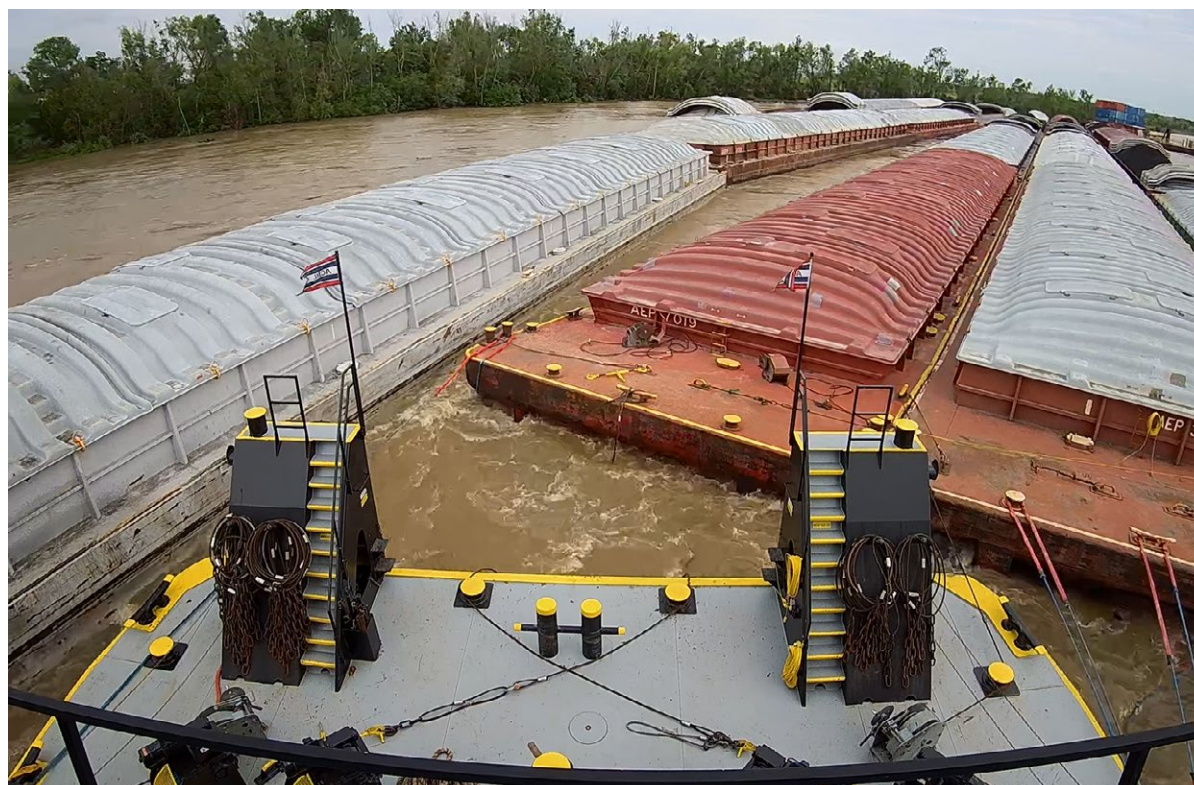
Screenshot from the onboard image recorder system at 1658 showing the **William B Klunk** tow beginning to break apart after the initial collision. SOURCE: AMERICAN COMMERCIAL BARGE LINE.

**THE PROBABLE CAUSE** of the collision of the towing vessel *William B Klunk* and tow with moored barges was the *William B Klunk* pilot becoming distracted due to cell phone use in the minutes leading up to the collision. **CONTRIBUTING** was the pilot's fatigue due to limited sleep the night before the casualty, which decreased his attentiveness and vigilance while operating the vessel.

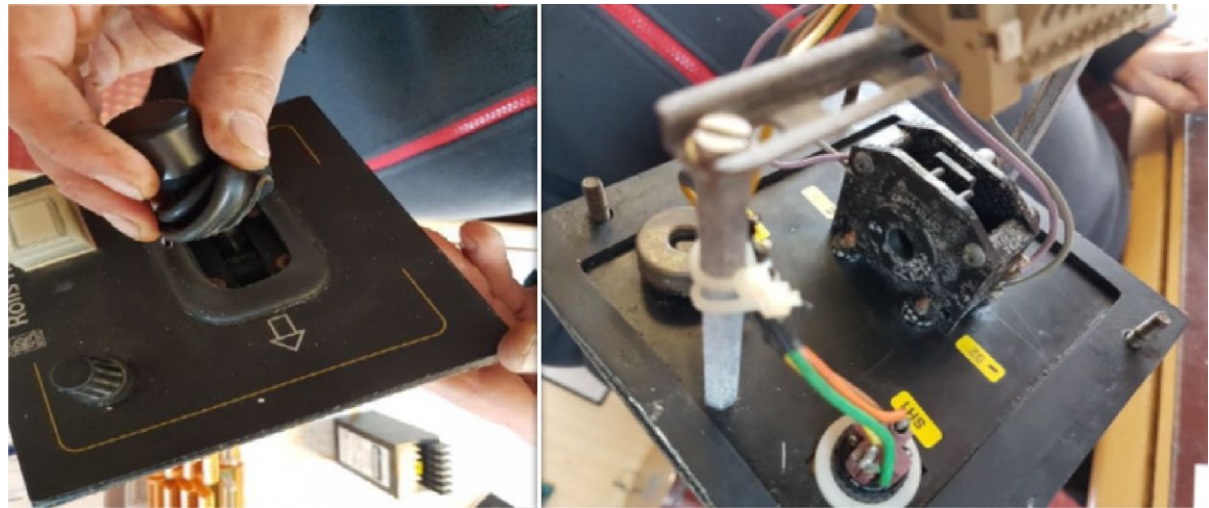
components on two other vessels with similar steering control systems). Additionally, after the collision, the steering gear manufacturer released a Safety Bulletin on switch failures in the bridge wing tillers. The bulletin specifically noted that micro switch failure could lead to unintended rudder movements. Therefore, based on the rudder's movements and the postcasualty testing and inspection, the steering control failure was likely due to the bridge wing tiller micro switch failing.

**THE PROBABLE CAUSE** of the collision of the multi-purpose carrier *BBC Africa* with the bulk carrier *Common Faith* was the *BBC Africa*'s loss of the primary steering control system due to a steering control system component failure. **CONTRIBUTING** to the collision was the delayed response from the ship's crew to implement the emergency steering procedure from the bridge.

***BBC Africa* non-follow up steering tiller of the port wing control station showing damaged rubber boot and corroded/defective micro switch.** SOURCE: KONGSBERG SERVICE REPORT.

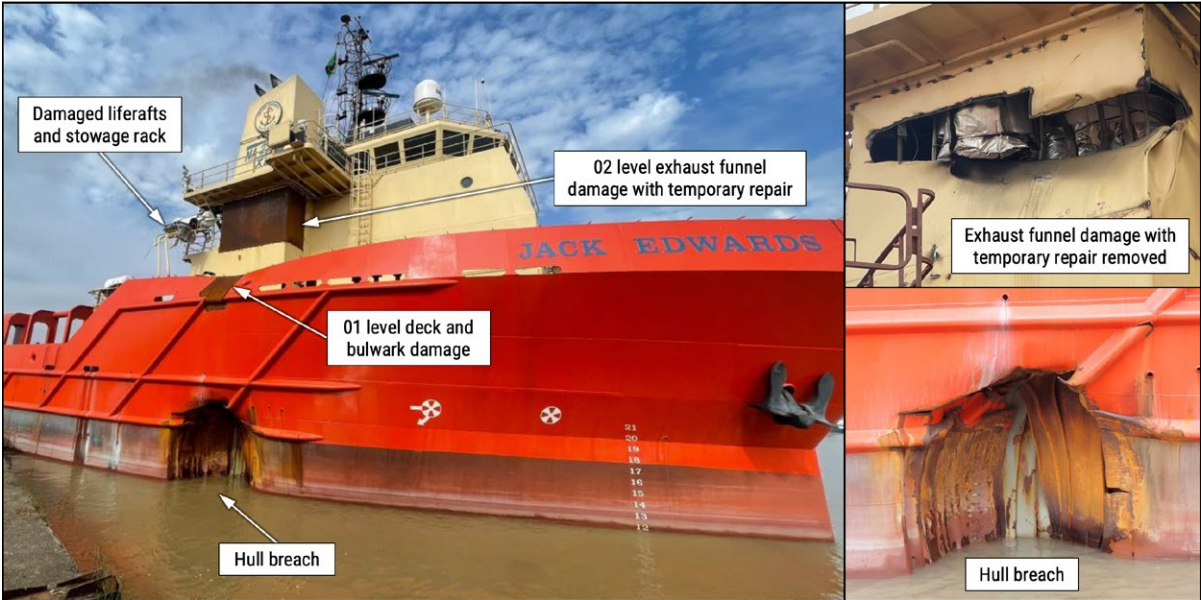
Jack Edwards external damage. SOURCE: EDISON CHQUEST OFFSHORE.

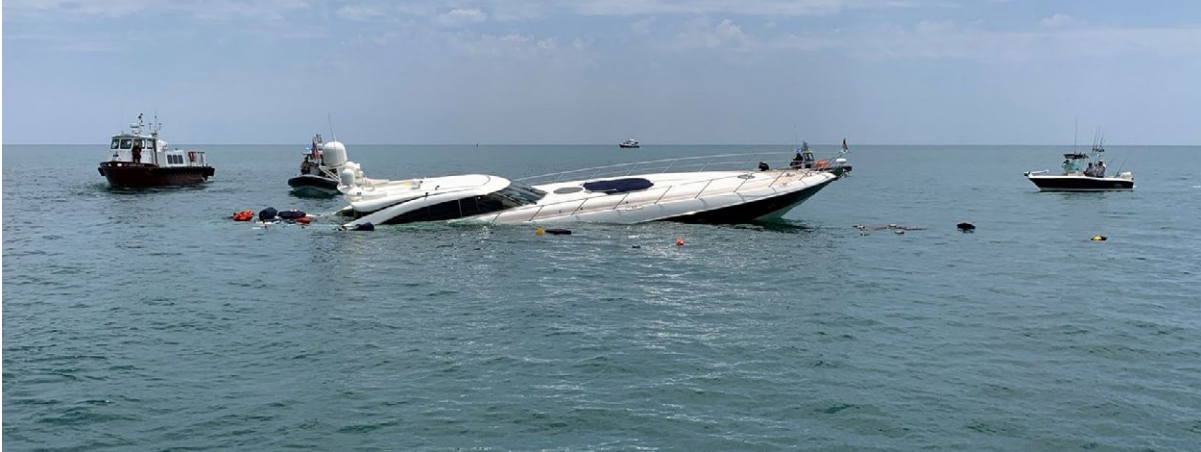
**Atlantis on May 25, 2024, following the contact.** SOURCE: FLORIDA FISH AND WILDLIFE CONSERVATION COMMISSION.

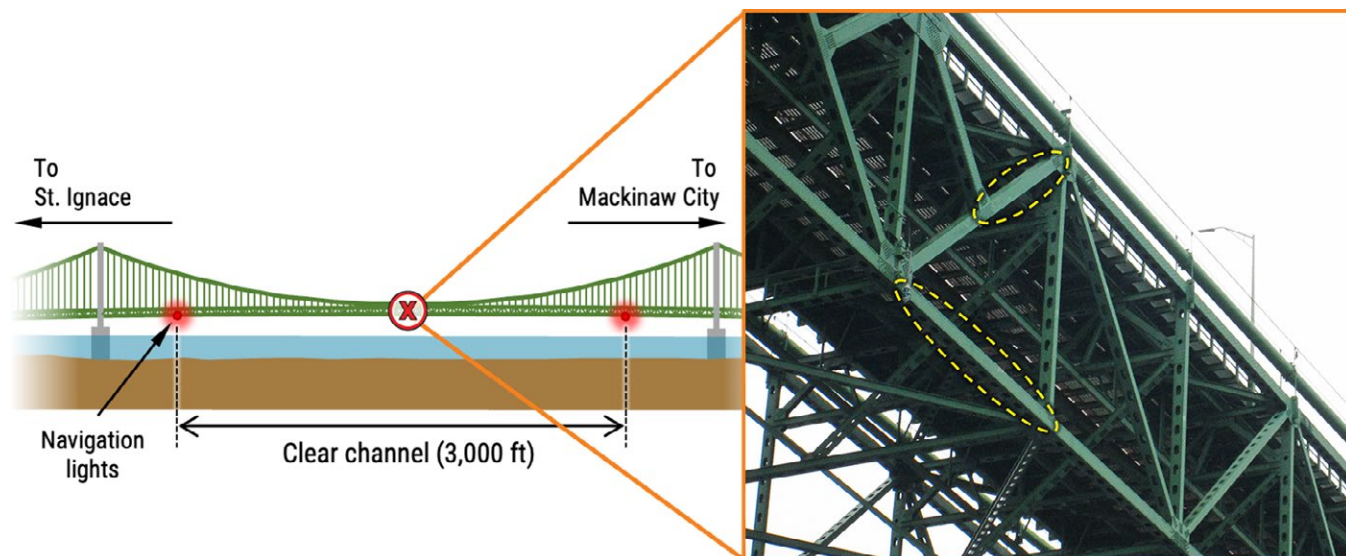
Area of west elevation of the Mackinac Bridge damaged by the contact with the crane boom aboard **BMI 209**, indicated by an X. Inset shows the location of the impacted stiffening truss bottom chord and upper diagonal truss (highlighted in yellow). INSET SOURCE: MACKINAC BRIDGE AUTHORITY.

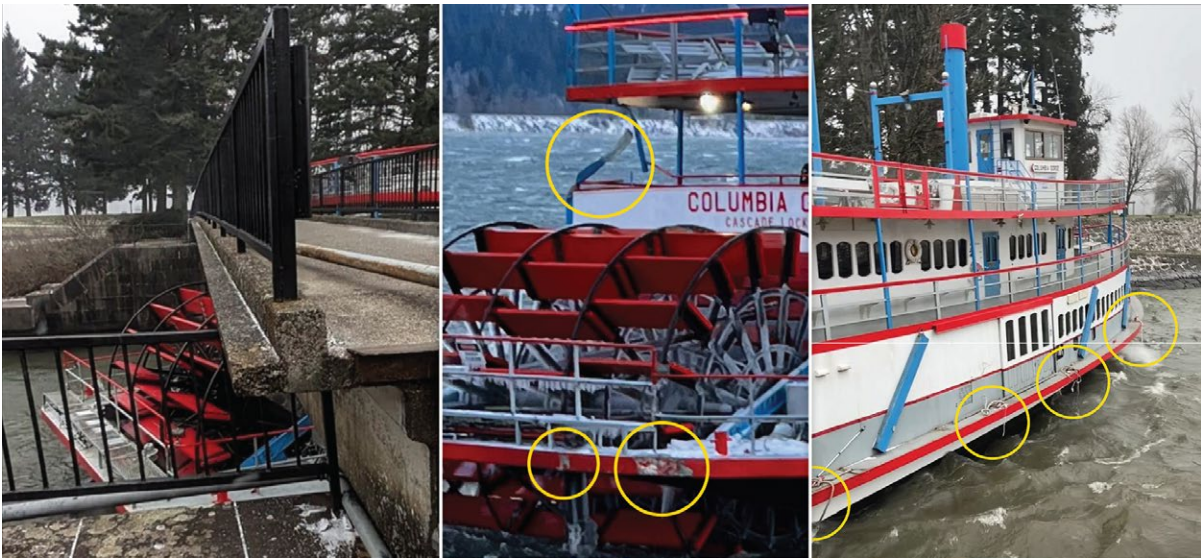
**Left to right:** The stern of the *Columbia Gorge* under the Thunder Island pedestrian bridge as seen from the mainland; damage to the stern and the support columns for the upper deck of the *Columbia Gorge* (circled); and the vessel in the lock with broken moorings visible (circled). BACKGROUND SOURCE: JETTYLIGHT LLC.

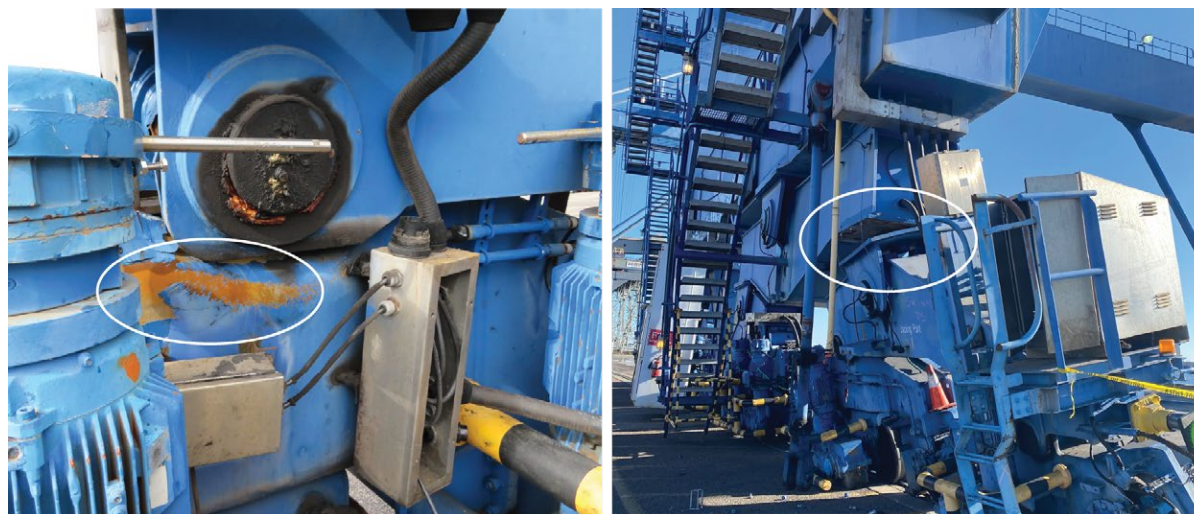
**Left to right: The damaged STS crane. Circled areas show (1) metal distress and (2) damage to one of four gantry assemblies.**

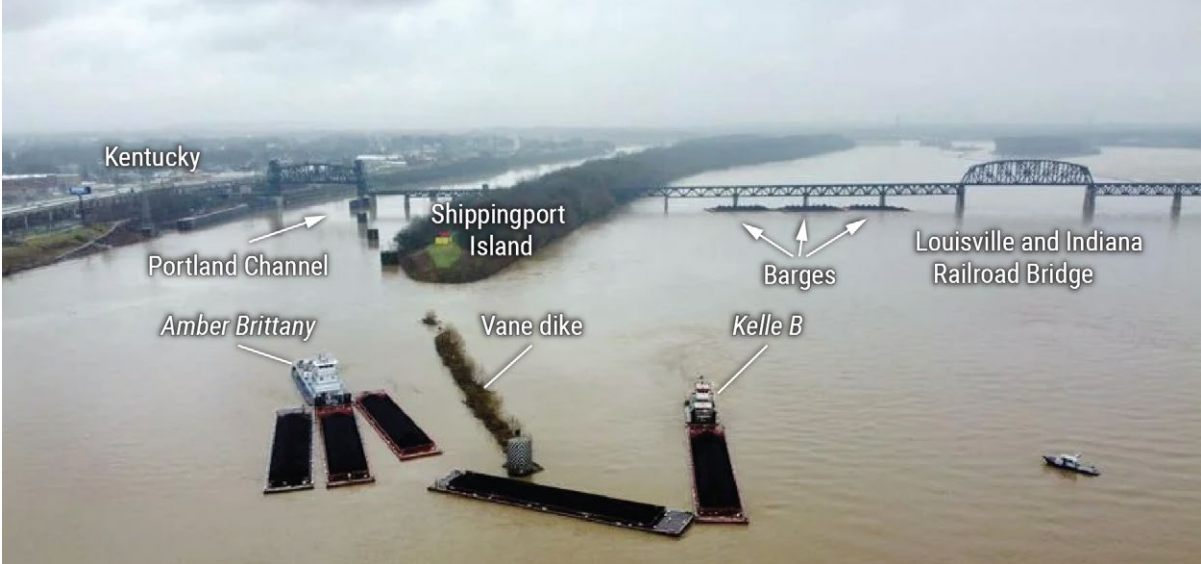
**The *Amber Brittany* with three barges, and tug *Kelle B* assisting, after the tow broke apart. Eight barges that broke free from the tow are lodged alongside the Louisville and Indiana Railroad Bridge pilings.**  
BACKGROUND SOURCE: RICH AMMON.

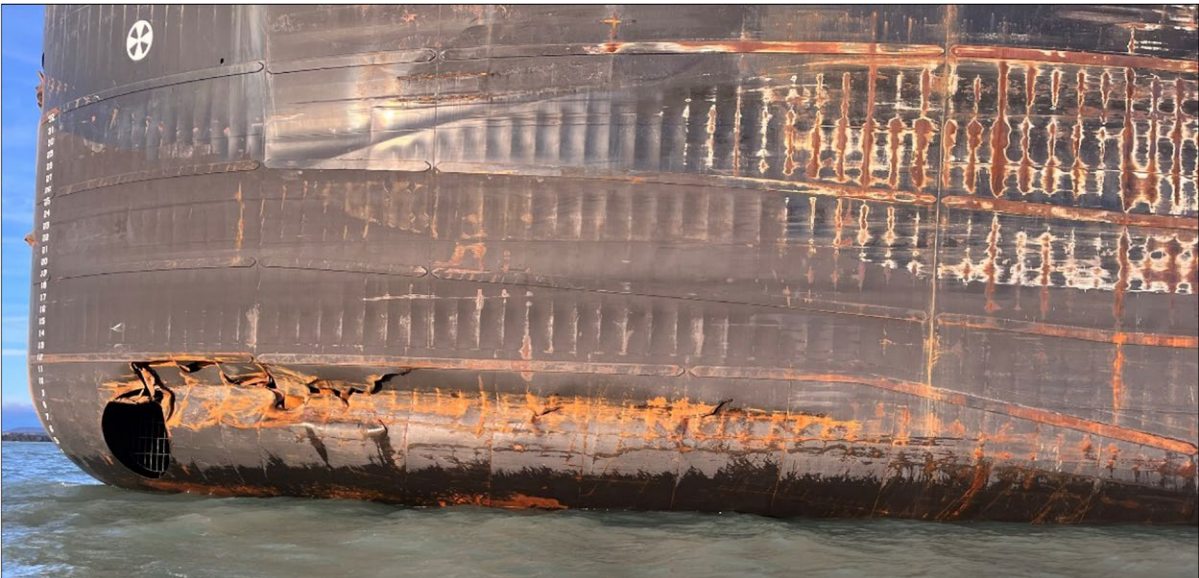
**Damage to the port side of the American Mariner** after striking the Munuscong Channel Junction Light.

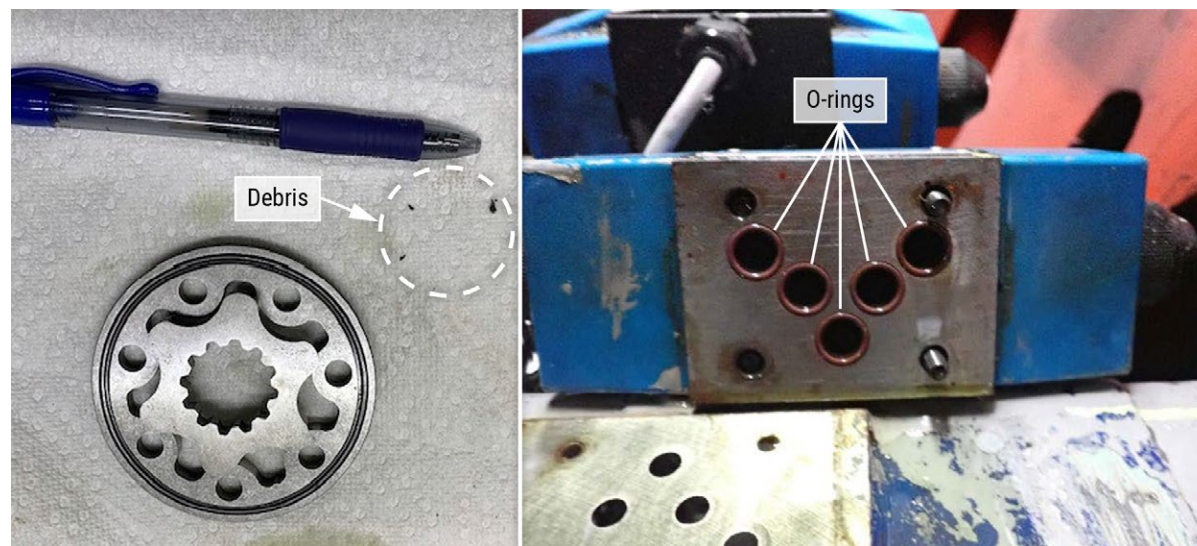
**Debris (circled) found in no. 1 steering gear control motor aboard the *American Mariner* and removed directional valve from *American Mariner* showing the O-rings replaced during winter layup.**

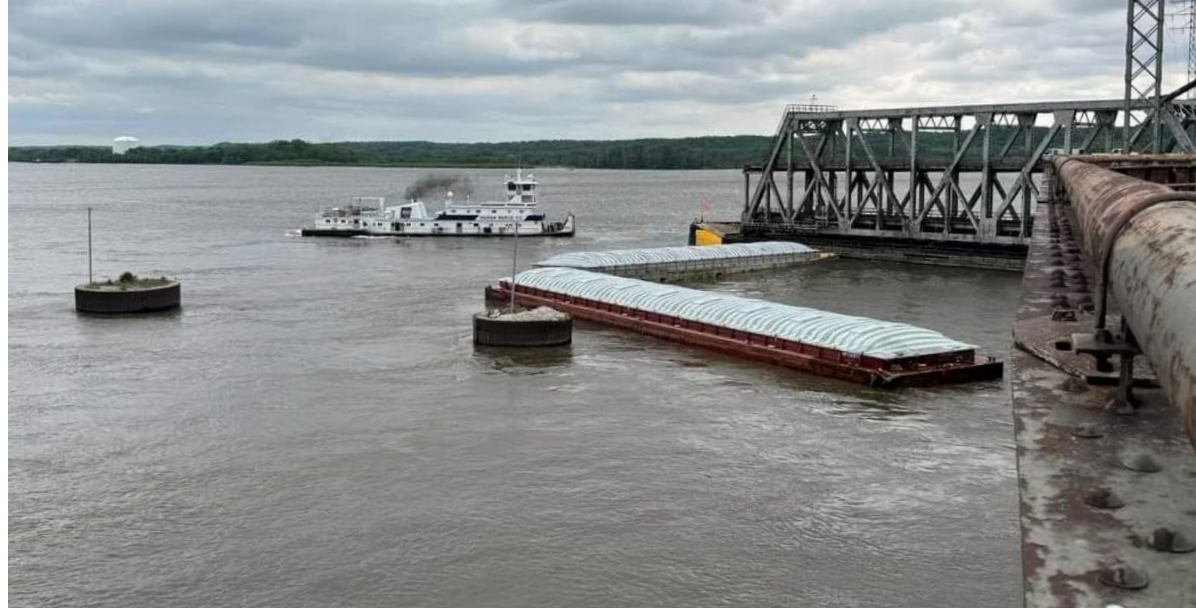
**Barges IN122011 and IN155499 immediately after impact blocking the primary channel. The IN155499 sinking next to the central wooden fendering. The Joe B. Wyatt is visible in the background.** SOURCE: COAST GUARD.

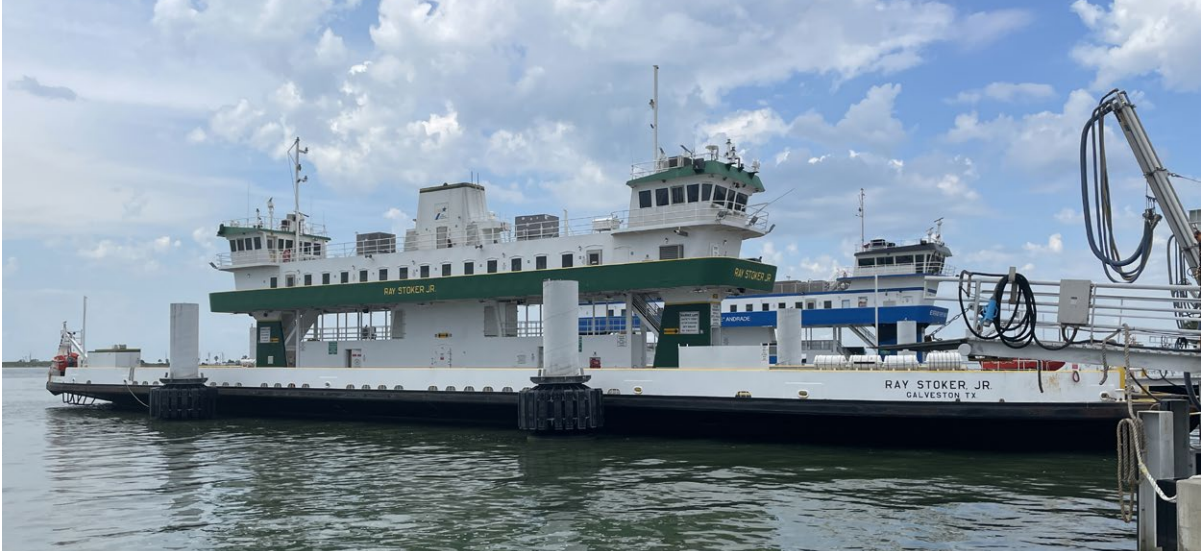
*Ray Stoker, Jr.* docked in Galveston, Texas, on September 25, 2024, after striking the floating dock at the Coast Guard Base Galveston.

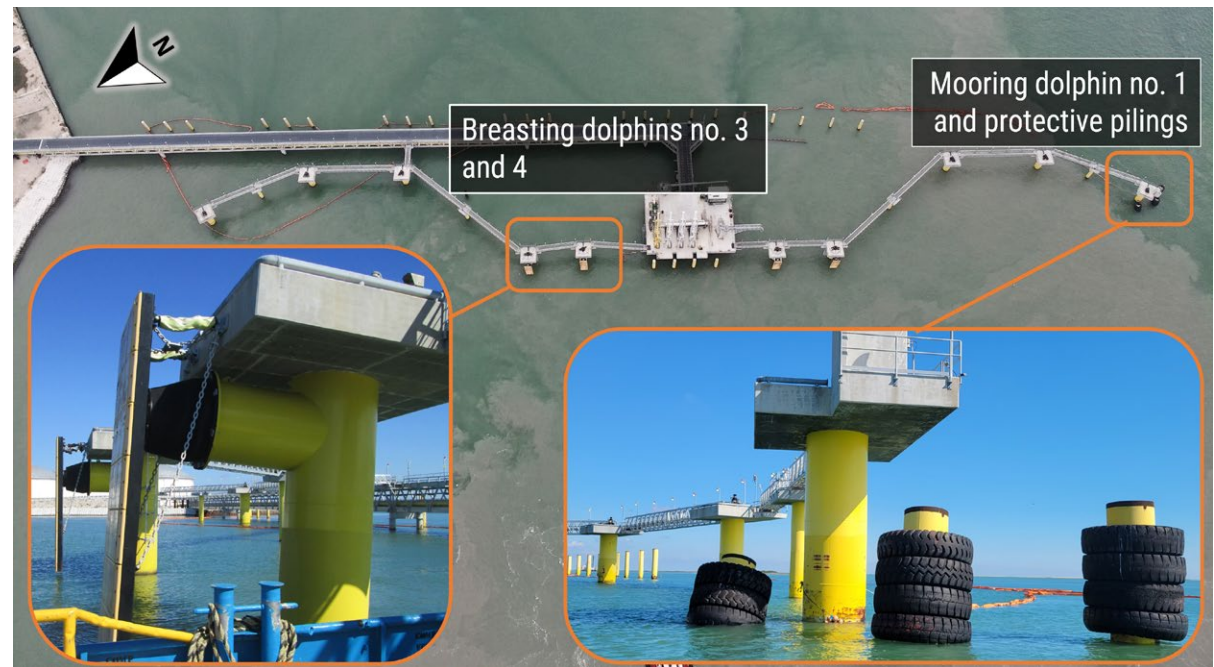
**Drone photo of the STGT east dock postcasualty, with the left inset showing damaged breasting dolphin no. 3, and the right inset showing the displaced westernmost and middle protective pilings.**

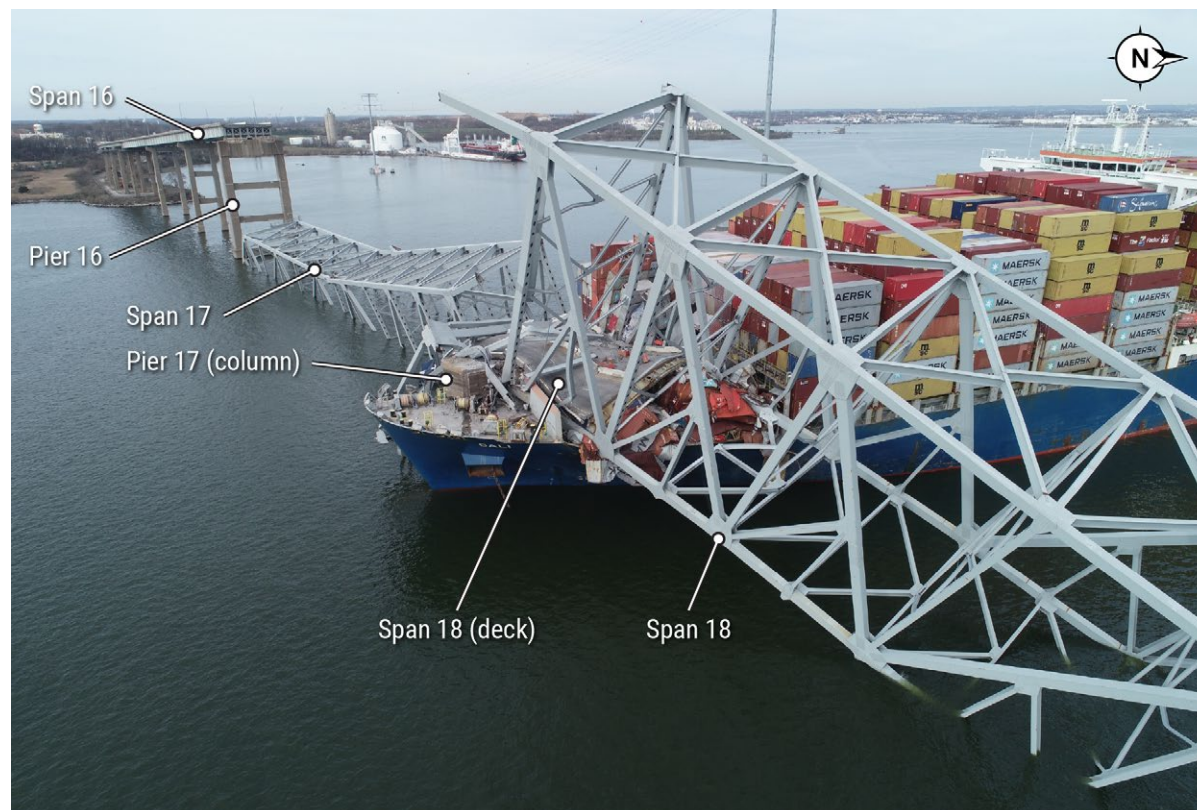
Damage to bridge Spans 16–18 and Pier 17, as seen looking toward the port side of the **Dali**.

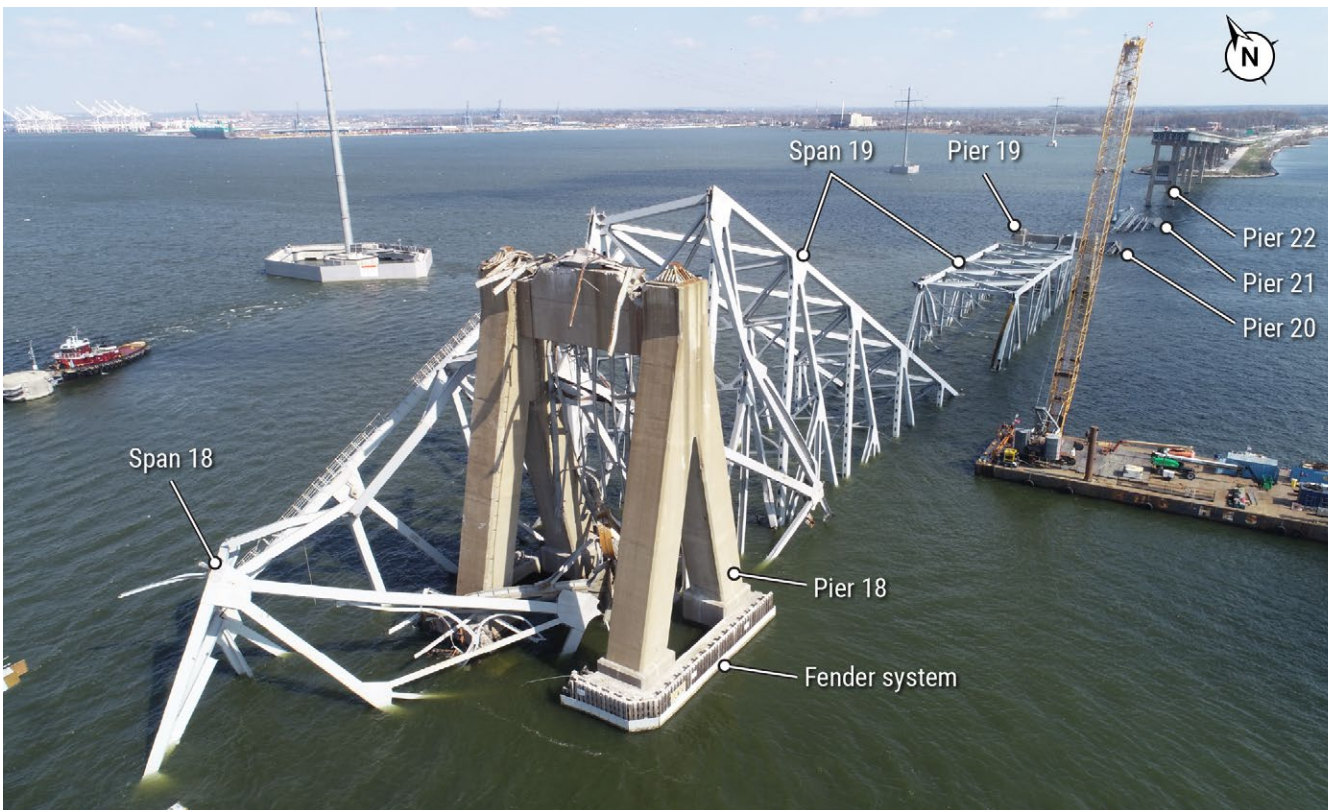
**Damage to Spans 18 and 19, and Piers 18–22.**

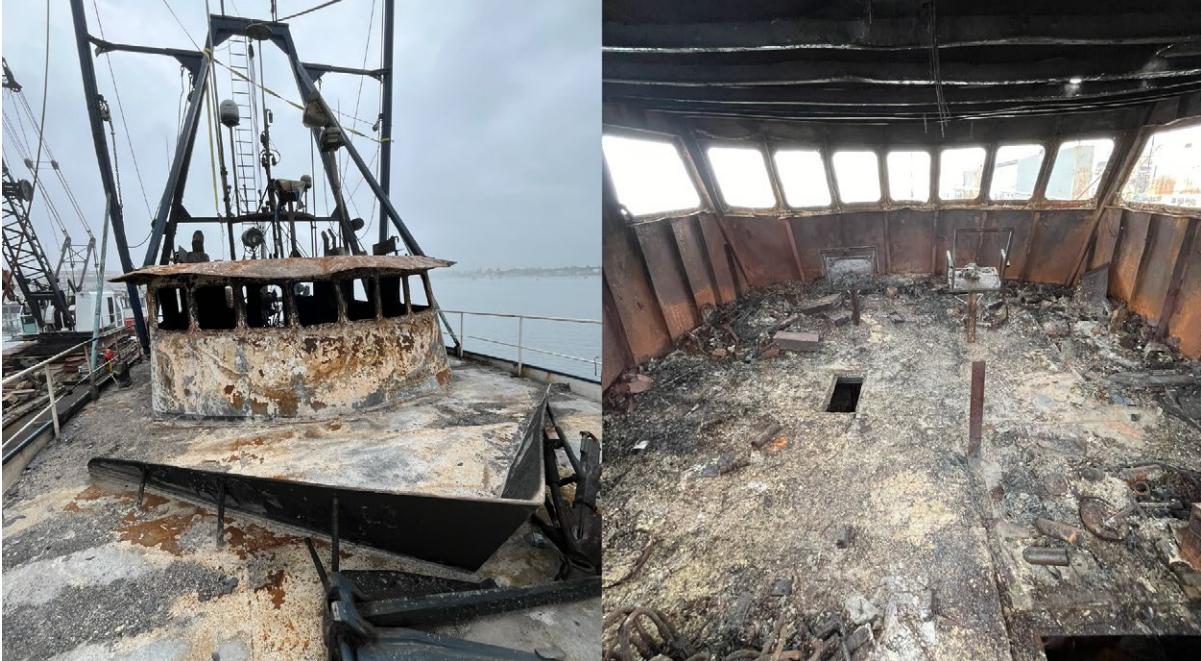
**Fire damage to the foredeck of the *Three Girls* and the interior of wheelhouse.**

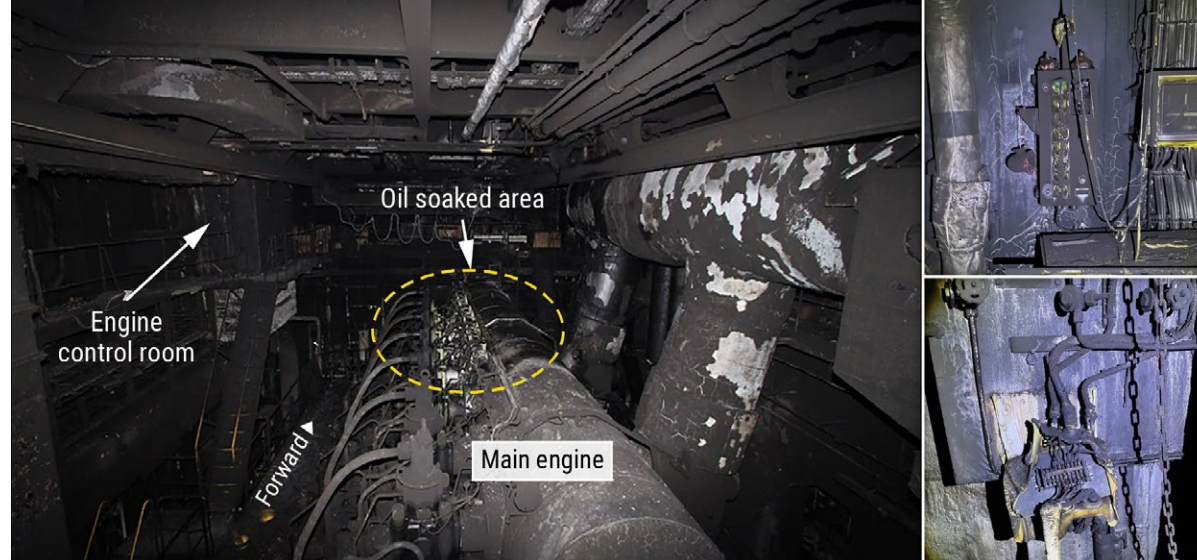
**View of the *Stride* engine room 3rd deck looking forward, after the fire, showing the main engine and surrounding areas covered in soot and an oil-soaked section of the main engine. Insets, from top: damaged light signal column in funnel casing and melted electrical component on boiler on D deck.**

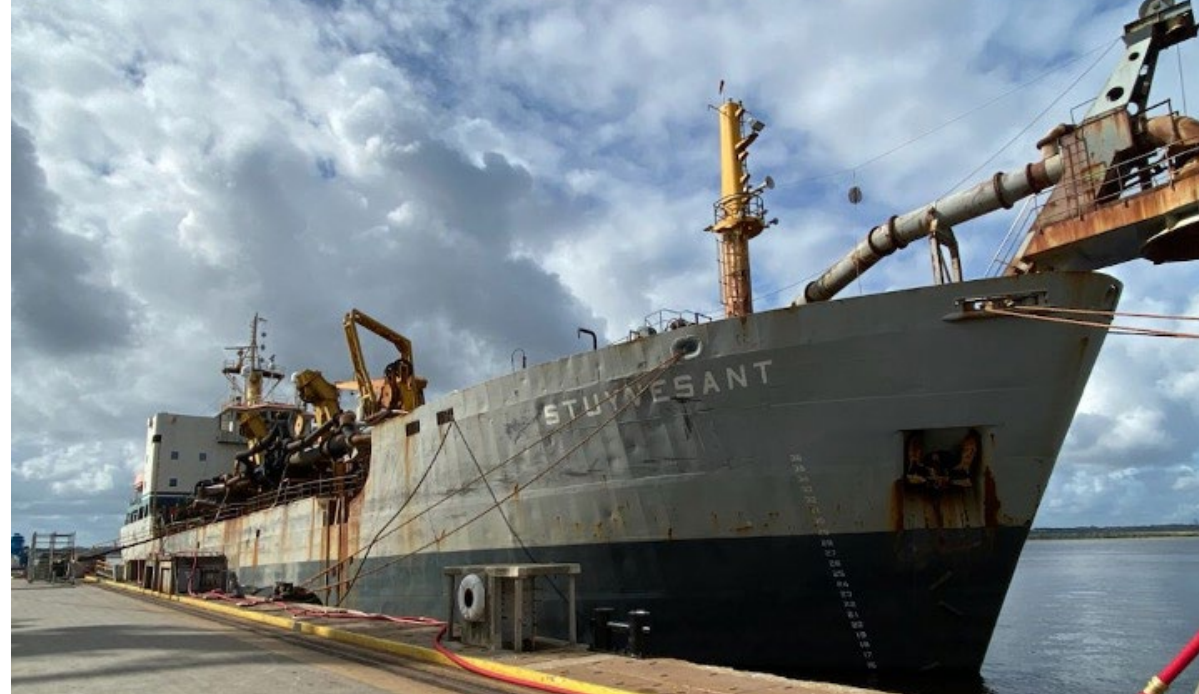
**The *Stuyvesant* after the fire.** SOURCE: COAST GUARD

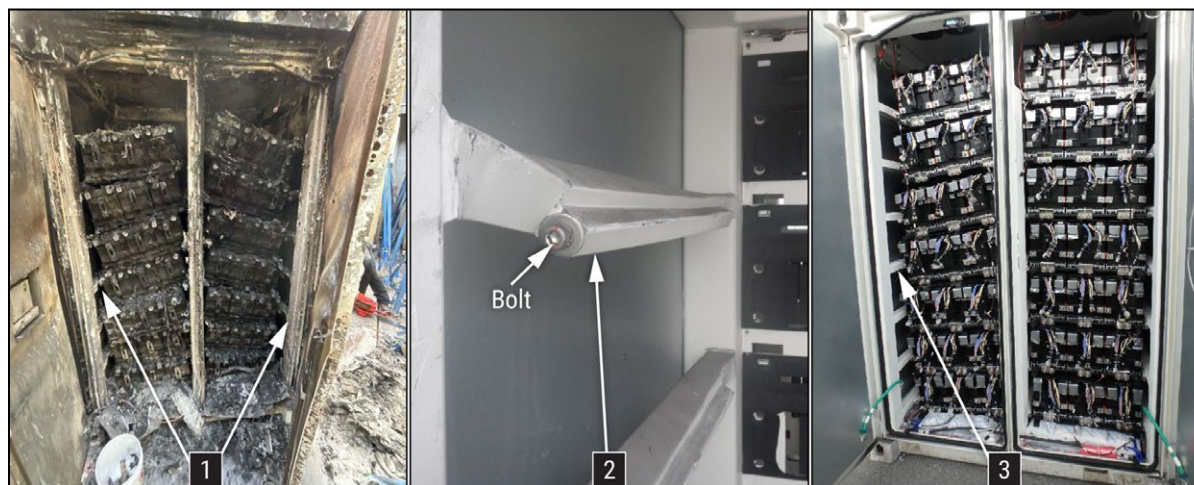
**Postcasualty examples of shelf rail deformation in BESS units, showing units that experienced (1) shelf rail deformation with collapse and thermal damage, (2) shelf rail deformation, and (3) shelf-rail deformation followed by a several shelf collapses with no fire. Note: the busbars were removed.** BACKGROUND SOURCE: ESA.

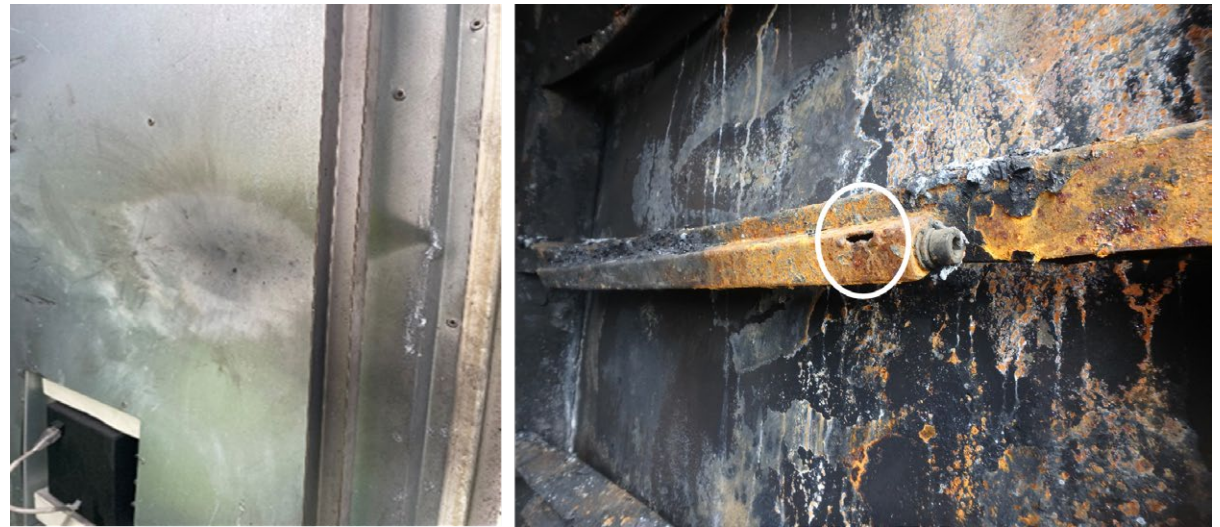
**Examples of internal damage due to indentation and scorching, and arcing (circled) found inside of the BESS units on the tween deck in cargo holds no. 1 and no. 2.** BACKGROUND SOURCE: ESA.

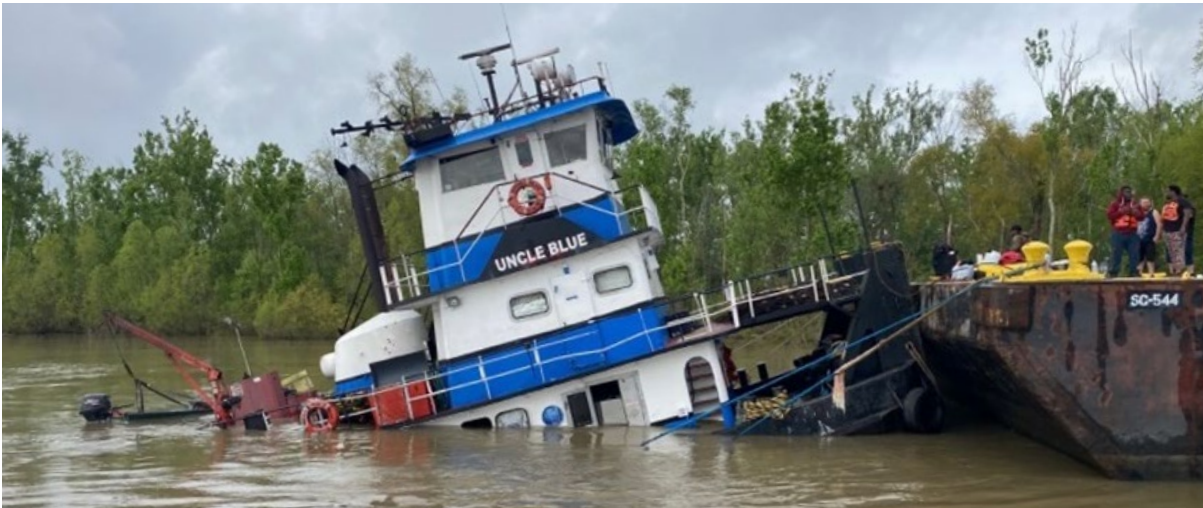
*Uncle Blue* partially sunken. SOURCE: COAST GUARD.

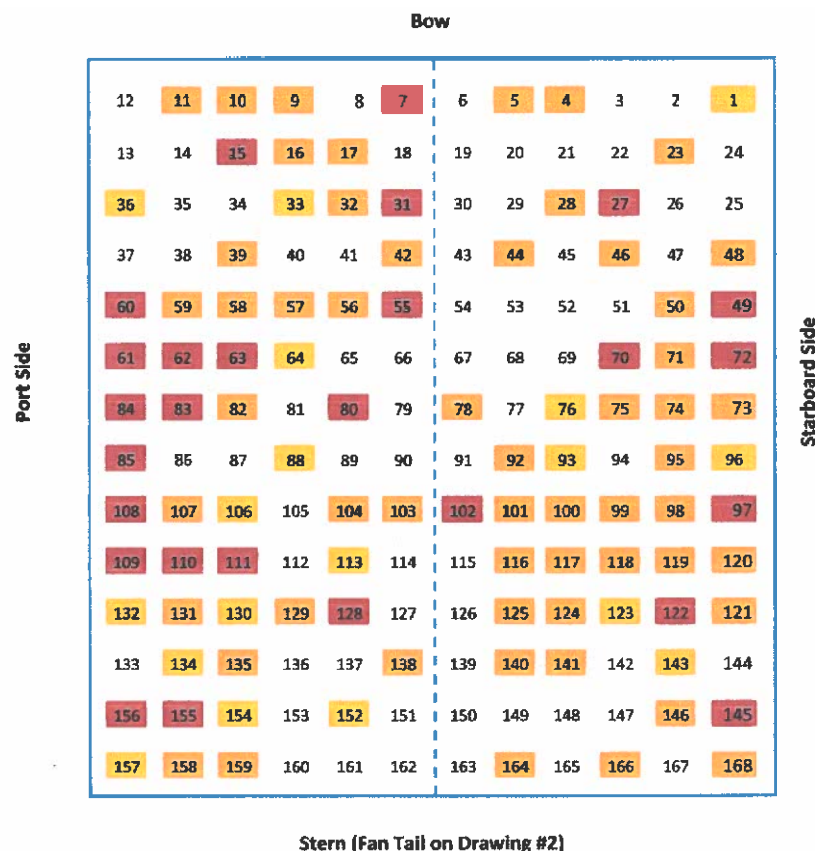
**Results of the 2022 audio gauge hull testing on the bottom plating of the *Cape Douglas* (numbers shown are survey audio gauge locations). Hull wastage between 15–18% is shown in yellow, 18–25% wastage is shown in orange, and wastage exceeding 25% is shown in red.** SOURCE: ALASKA MARINE SURVEYORS, INC.

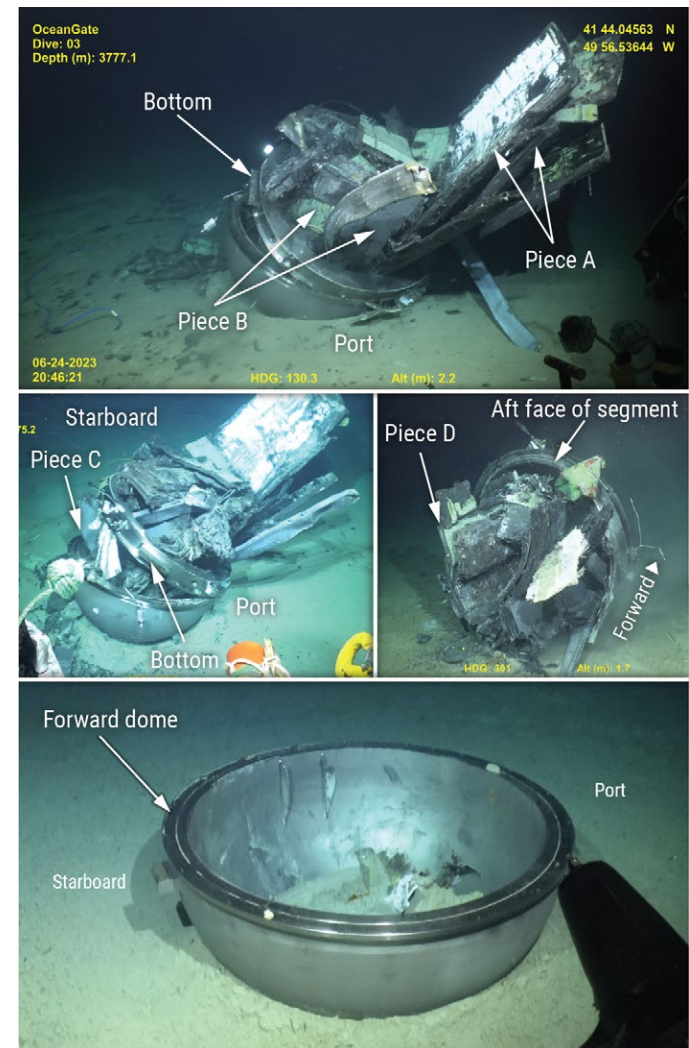
**Titan wreckage showing pressure vessel pieces A, B, C, and D, and forward dome.**

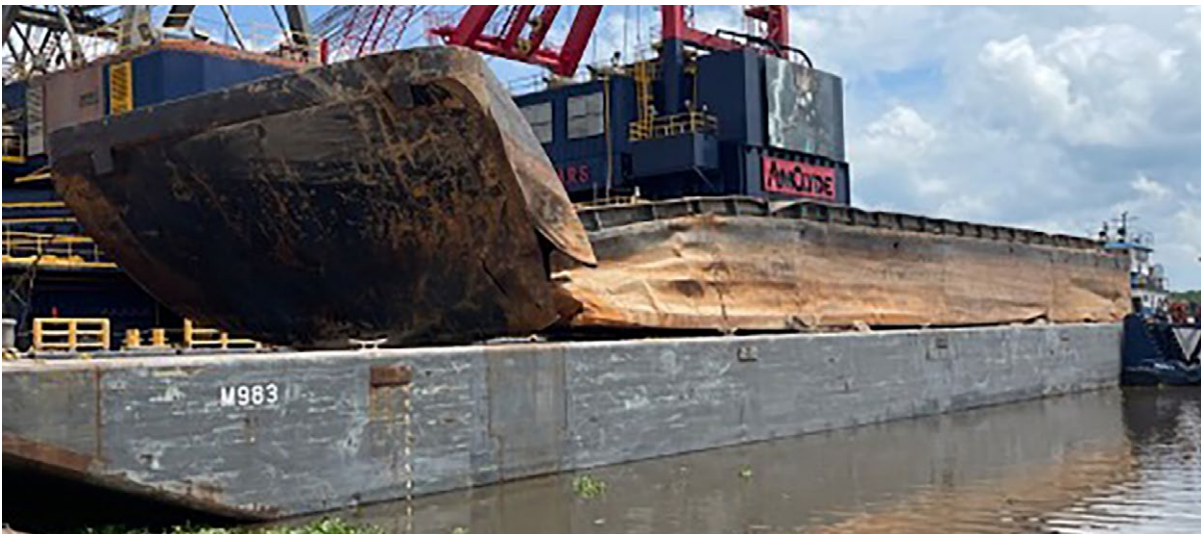
Barge **PTC 706** after arriving at the recycling yard in Houma, Louisiana, on April 22, 2024, with damaged rake.  
SOURCE: MODERN AMERICAN RECYCLING SERVICES, INC.

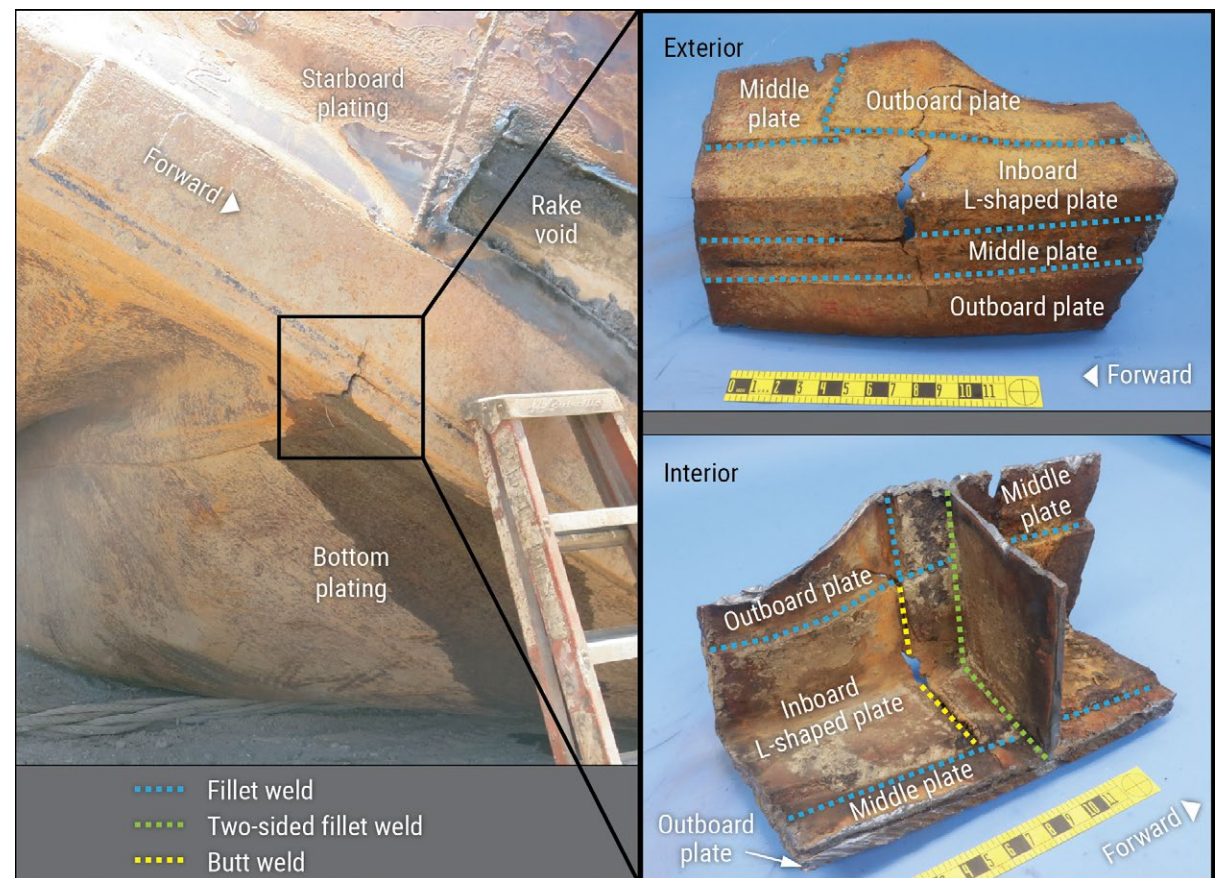
**PTC 706 starboard-side bilge knuckle before section was cut away on April 22, 2024. Inset: Bilge knuckle section cutaway examined by the NTSB, with plate segments and types of welding joints labeled.**
