NATIONAL TRANSPORTATION SAFETY BOARD

# SAFER SEAS

# Digest

Lessons Learned from  
Marine Investigations

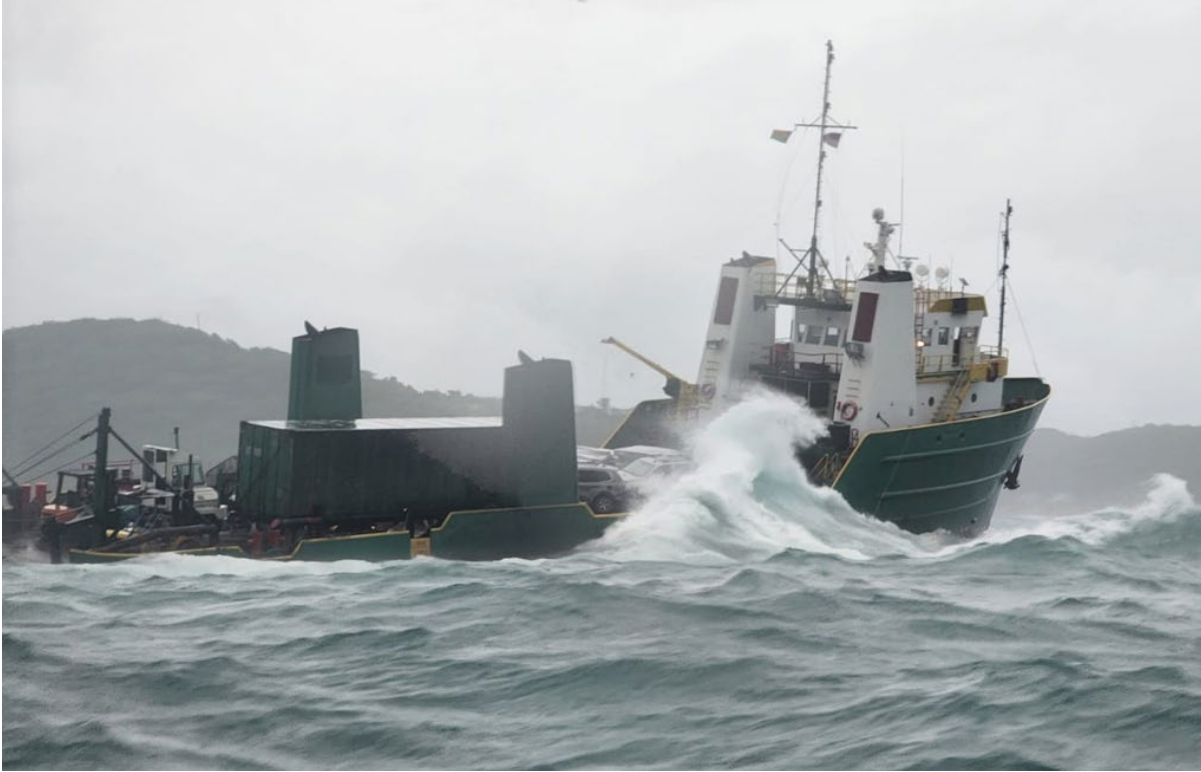
*Bonnie G* stranded on the rocks following the grounding. SOURCE: COAST GUARD.

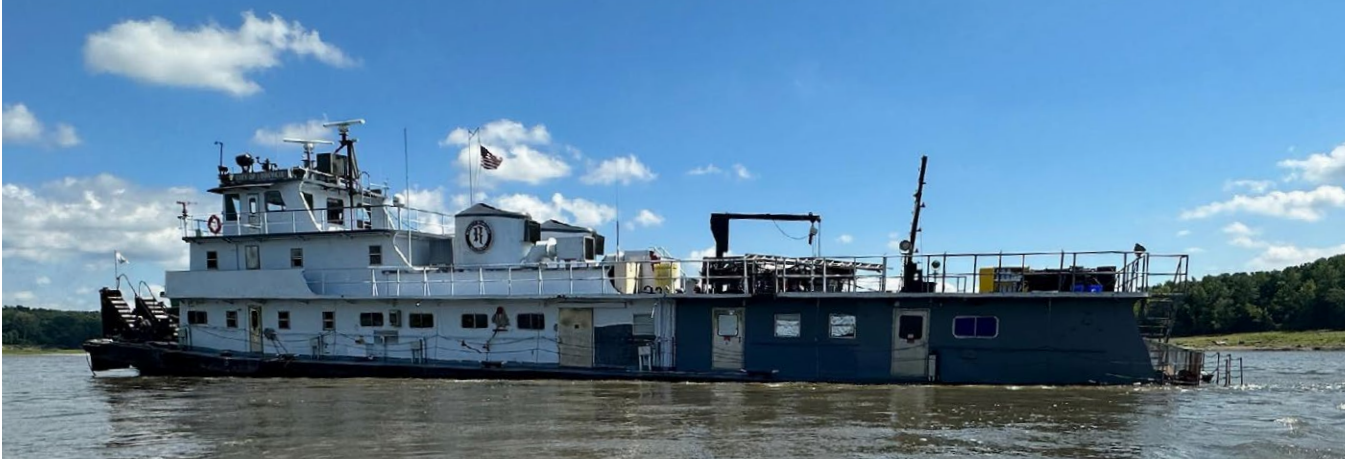
**The City of Louisville aground.** SOURCE: COAST GUARD.

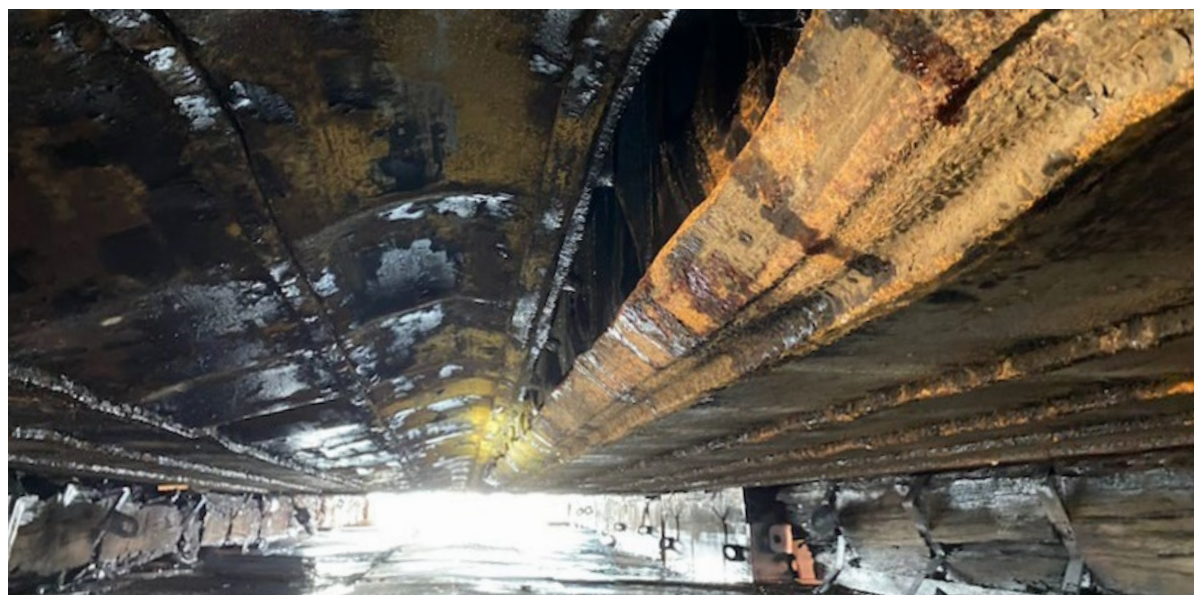
**The aft portside (looking forward) bottom shell plating damage of the *City of Louisville*, shown in dry dock.**

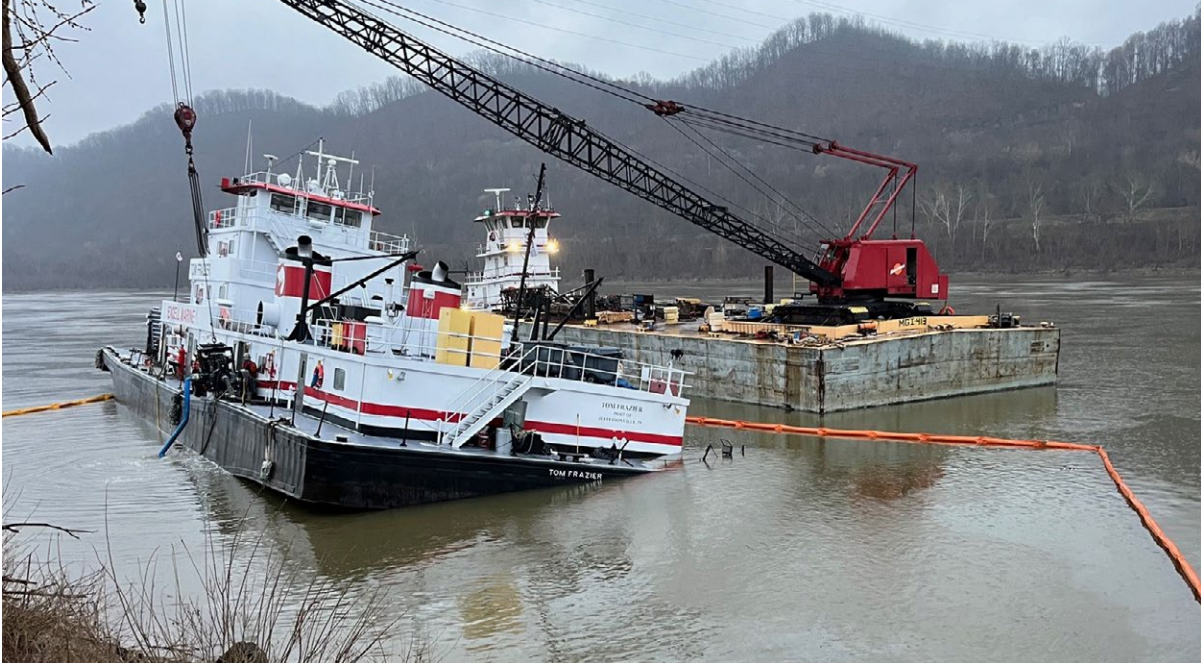
The *Tom Frazier* aground. SOURCE: COAST GUARD.

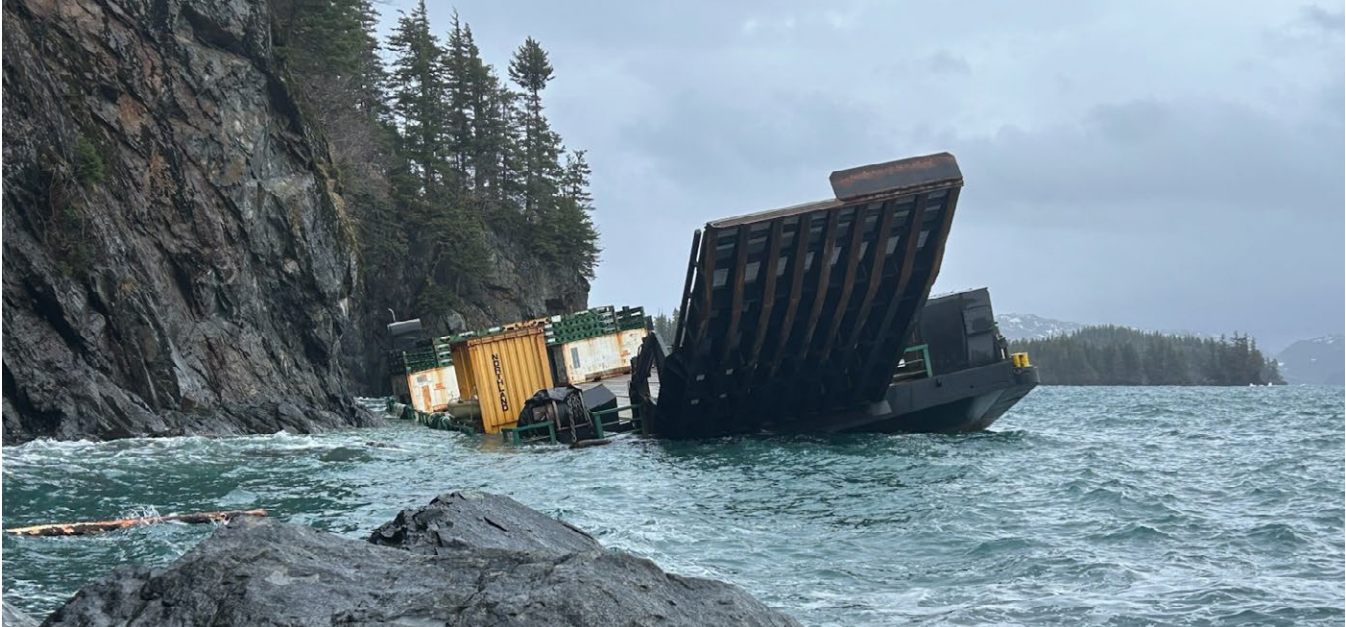
The *Cordova Provider* aground on the rocks at Axel Lind Island on January 14, 2025. SOURCE: CORDOVA PROVIDER LLC.

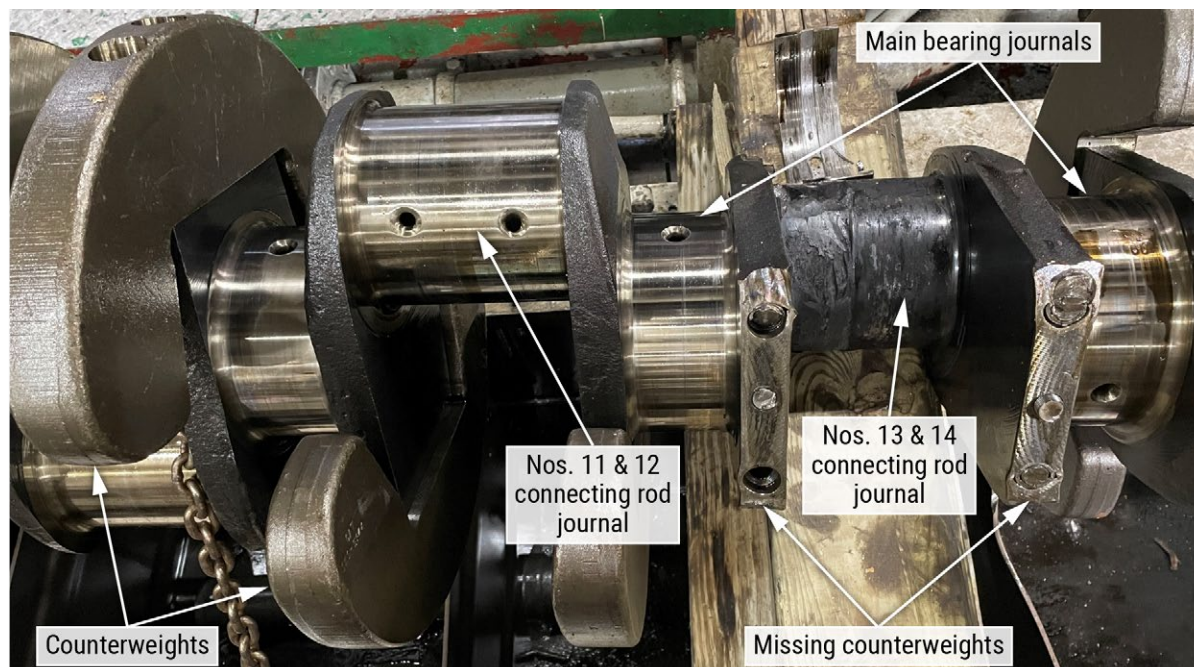
Removed crankshaft from damaged no. 2 auxiliary generator on board *Ocean Navigator* after the engine failure.

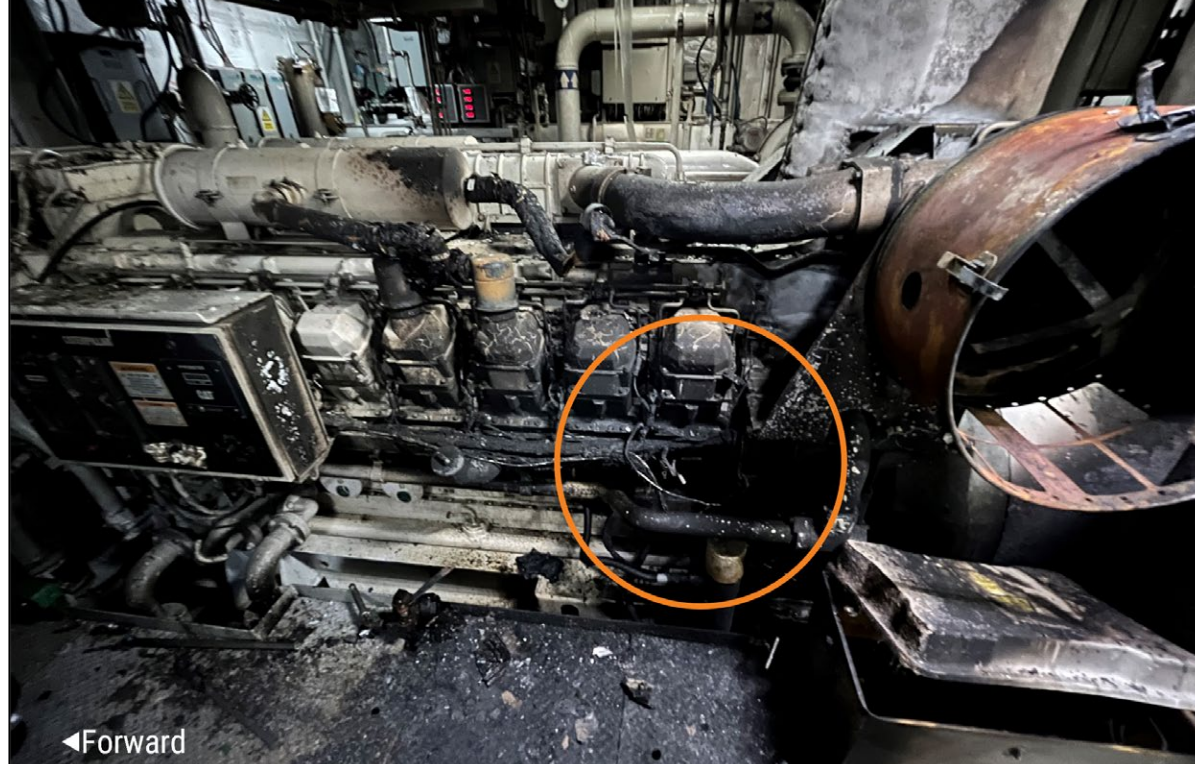
**Damaged no. 2 auxiliary generator aboard *Ocean Navigator* after the engine failure. The circled area identifies the location of the engine block damage.**

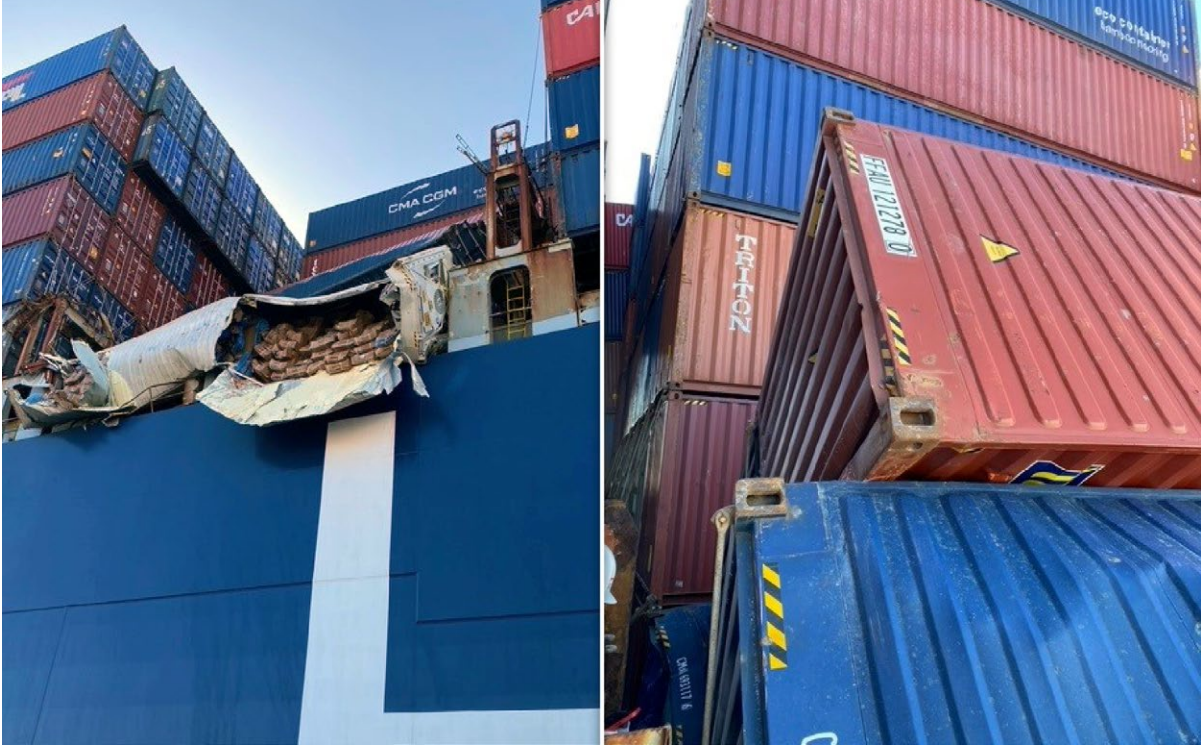
Area of the container collapse in bay 42 on the port side of the *President Eisenhower* and closer view of the collapsed containers. SOURCE: COAST GUARD.

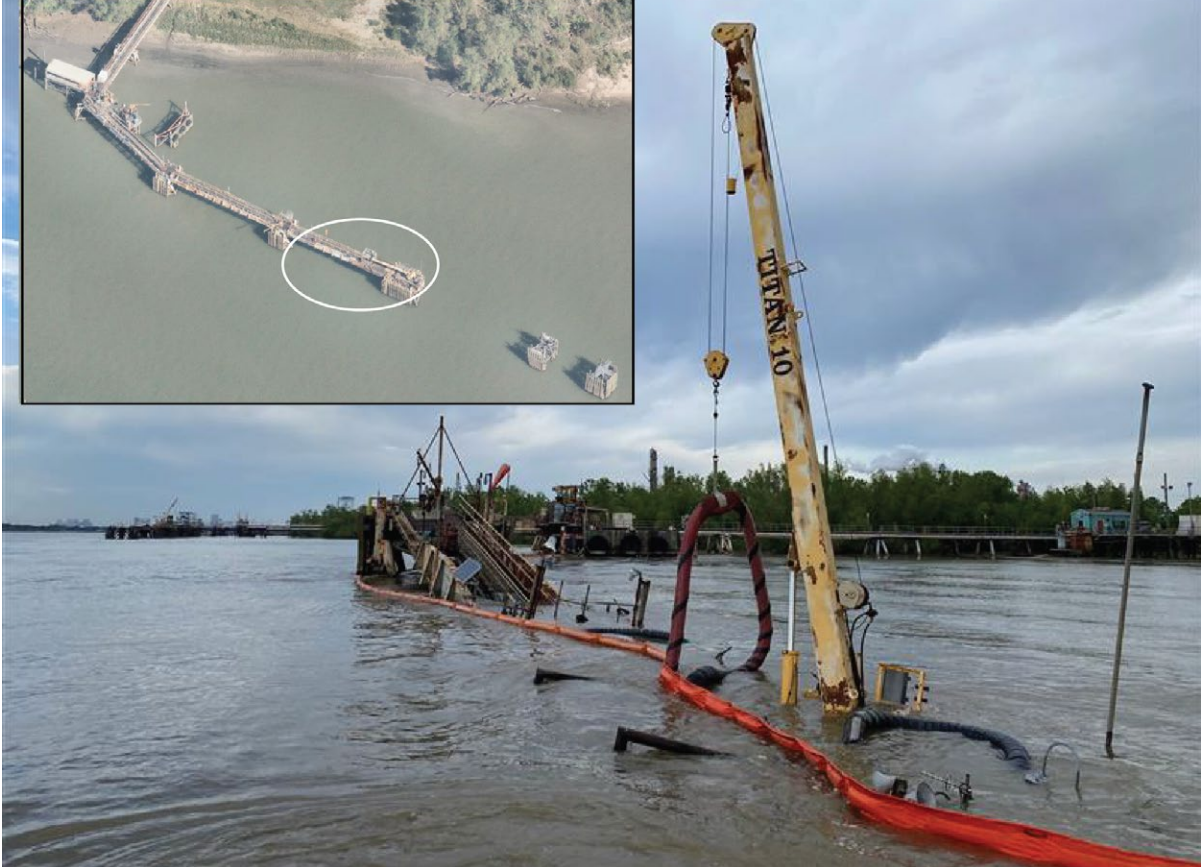
The collapsed crude oil dock, looking upriver. Inset shows the area of the dock that collapsed (circled).  
SOURCES: COAST GUARD, NEARMAP.

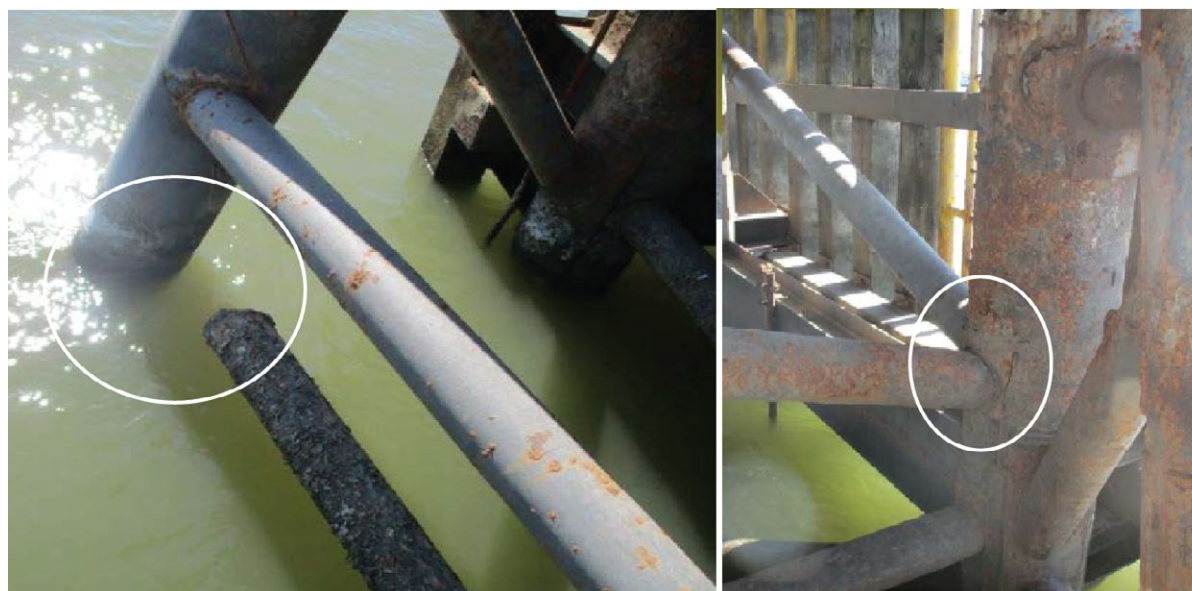
**Visual inspection photos from 2021 showing a lower header joint not connected to the other column and a joint starting to disconnect on the dolphin no. 3 transfer platform at the Chalmette Refinery crude oil dock.**
