Railroad Investigation Report: RIR-25-09

CSX Transportation Conductor Trainee Fatality

Baltimore, Maryland

June 26, 2023

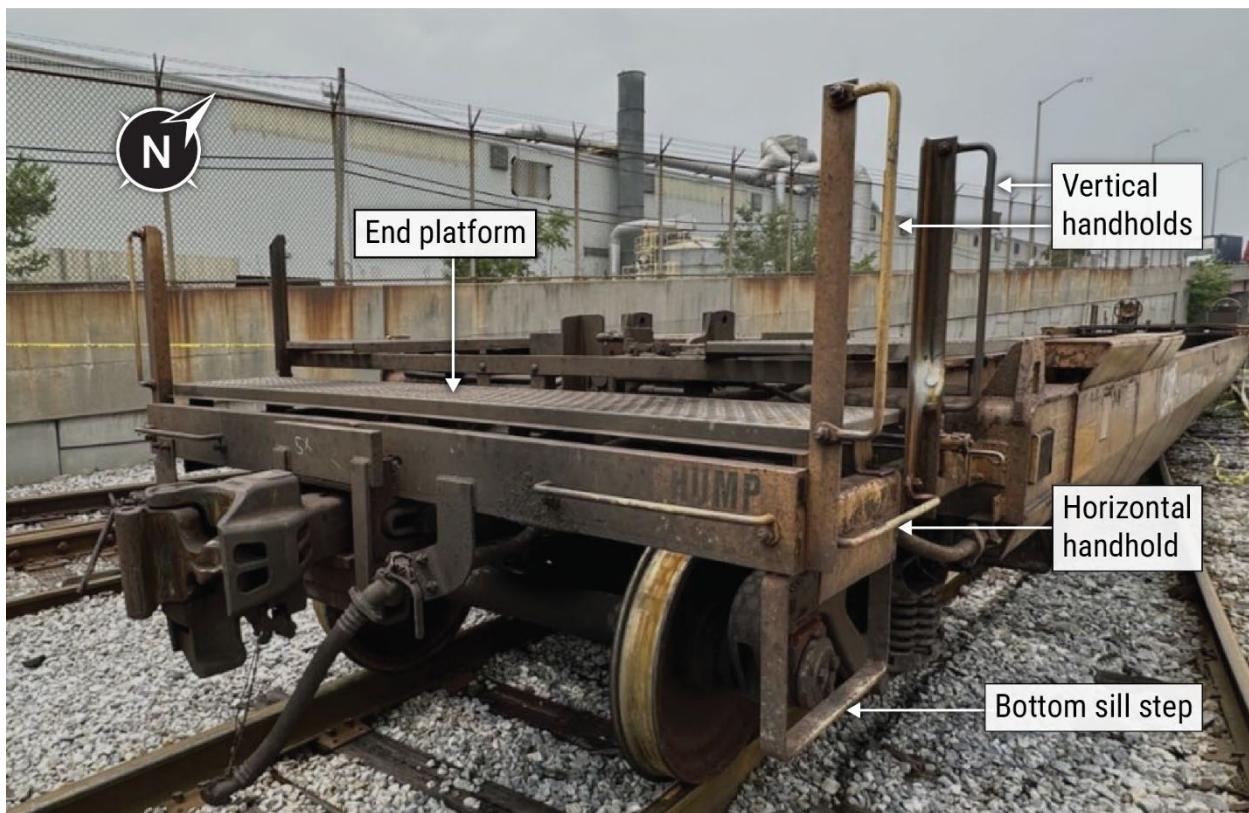
Figure 2 shows the accident intermodal railcar, highlighting several of its railcar safety appliances and their locations.⁷ Figure 3 shows investigators reenacting the conductor trainer and the conductor trainee's riding stances on the accident railcar. (See section 1.4 for more on the reenactment.)

Figure 2. Photograph of the accident intermodal railcar and several of its railcar safety appliances. (Courtesy of the Brotherhood of Locomotive Engineers and Trainmen.)

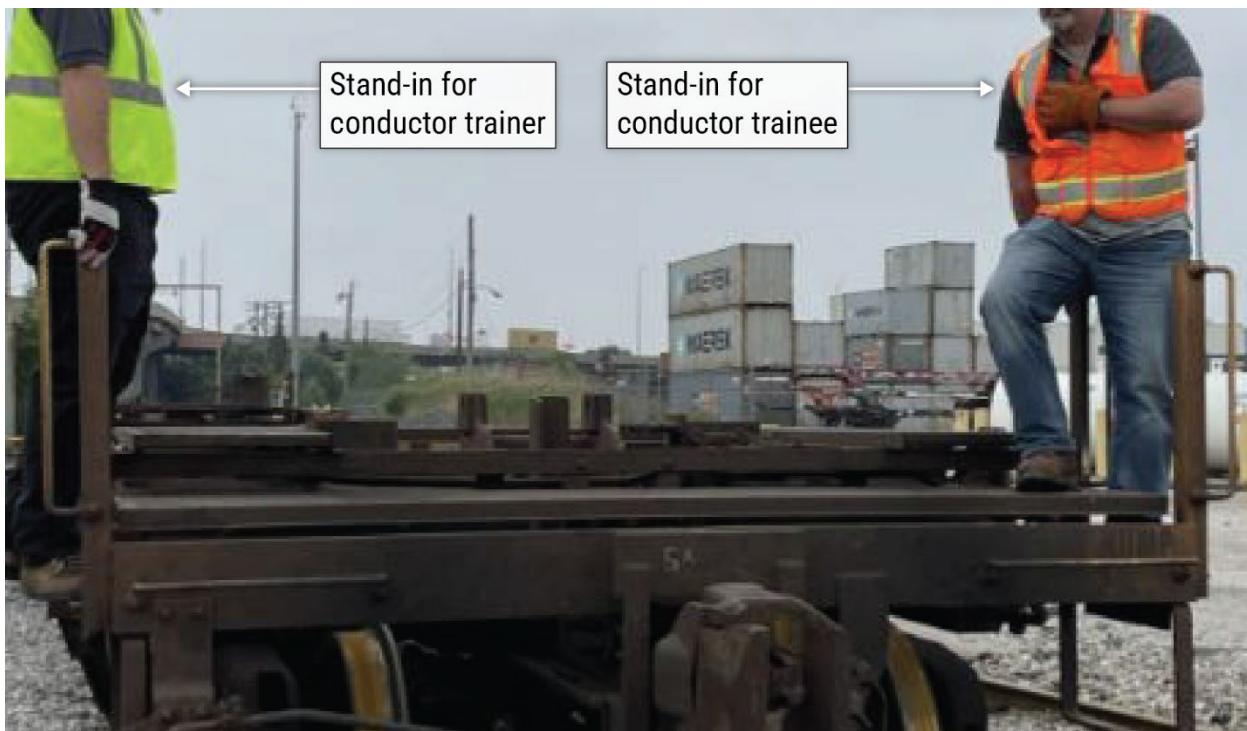
Surveillance video showed that moments before the accident, the conductor trainer was riding with his feet on the railcar's horizontal handhold and his hands on the railcar's vertical handholds while his body faced the railcar, and he looked in the direction of travel.⁶ The surveillance video also showed the conductor trainee was riding with his left foot on the horizontal handhold, his right foot on the end platform, his right hand on a vertical handhold, and his left hand on the lapel microphone attached on the right of his shoulder vest while his body (and head) faced the direction of travel.

Figure 3. Photograph shows investigators reenacting the crewmembers' riding stances.

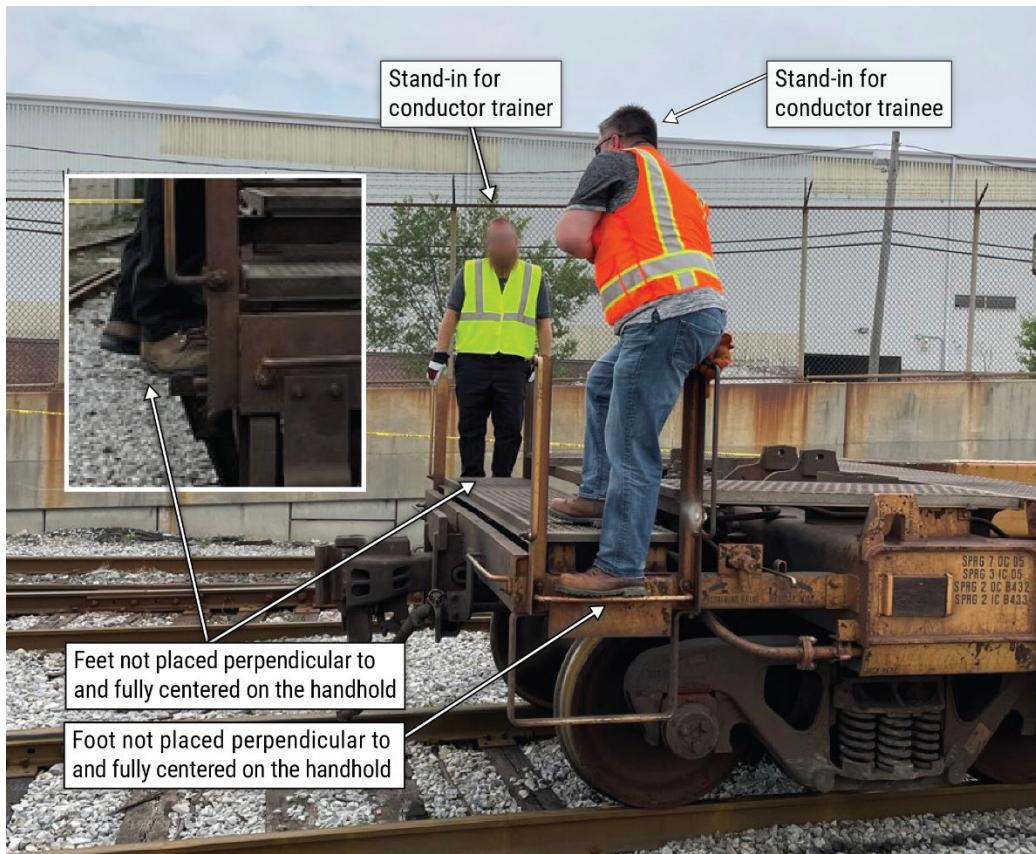
Figure 5. Reenactment photograph shows the crewmembers' restricted foot placement.

The NTSB reenactment noted that the conductor trainer and the conductor trainee were unable to place their feet perpendicular to and fully centered on the

ladder rung and therefore had restricted foot placement. A 2014 study found that ladder climbers with restricted foot placement were six times more likely to experience a slip than climbers with unrestricted foot placement (Pliner, Kyureghyan, and Beschorner 2014). During the NTSB foot placement study at the CN Homewood training facility, the demonstrator slipped from the simulator (which replicated railcar movement during slack action) when his foot placement was restricted, similar to the accident crewmembers. The demonstrator did not slip when his foot placement was unrestricted, similar to the findings in Pliner, Kyureghyan, and Beschorner's 2014 study. Thus, restricted foot placement reduced the stability of the accident crewmembers' riding stances.

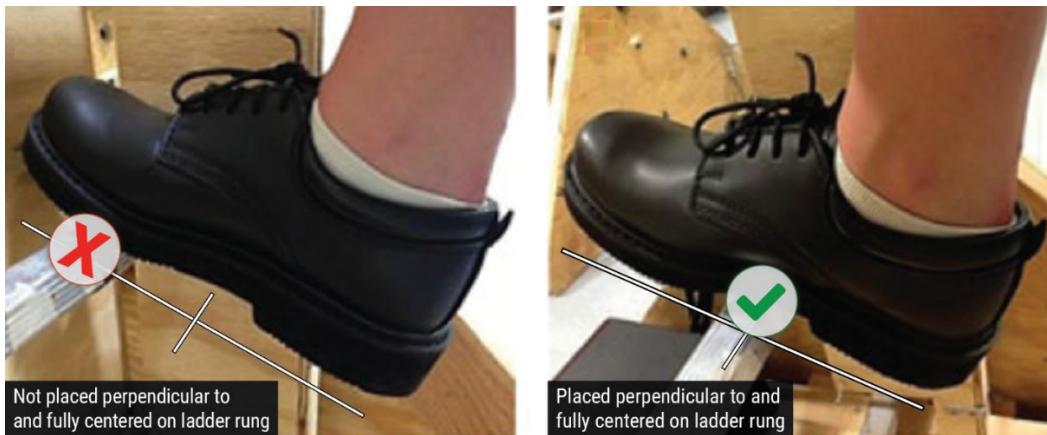
Figure 6. Photographs of restricted foot placement (left) and unrestricted foot placement (right). (Courtesy of *Ergonomics with NTSB* annotations.)

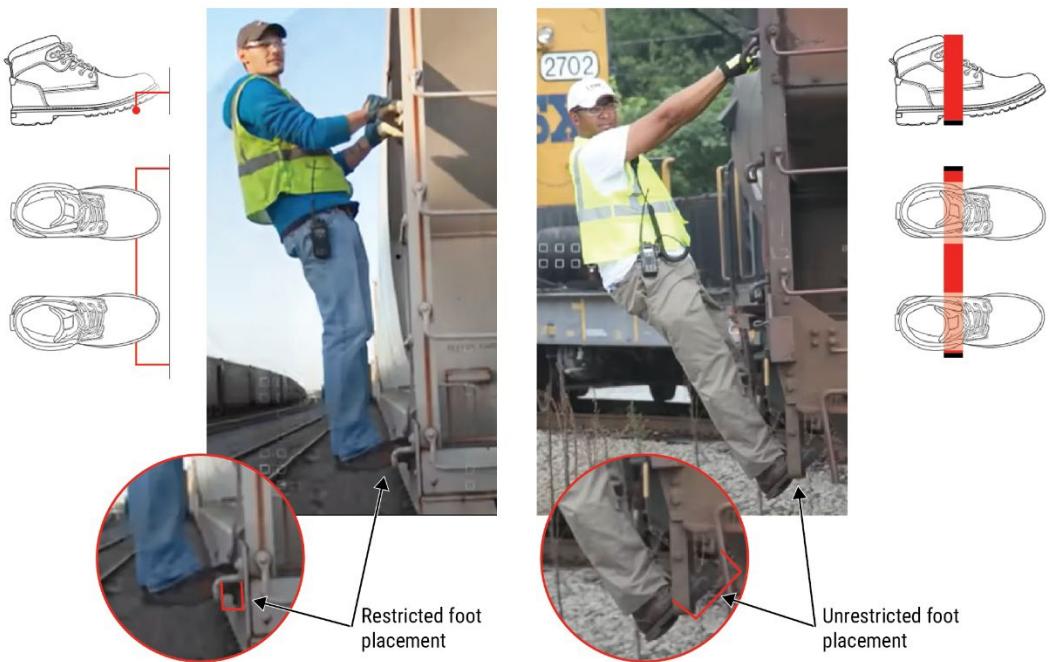
Figure 7. Photographs show CSX employees displaying restricted foot placement (left) and unrestricted foot placement (right). (Courtesy of CSX with NTSB annotations.)

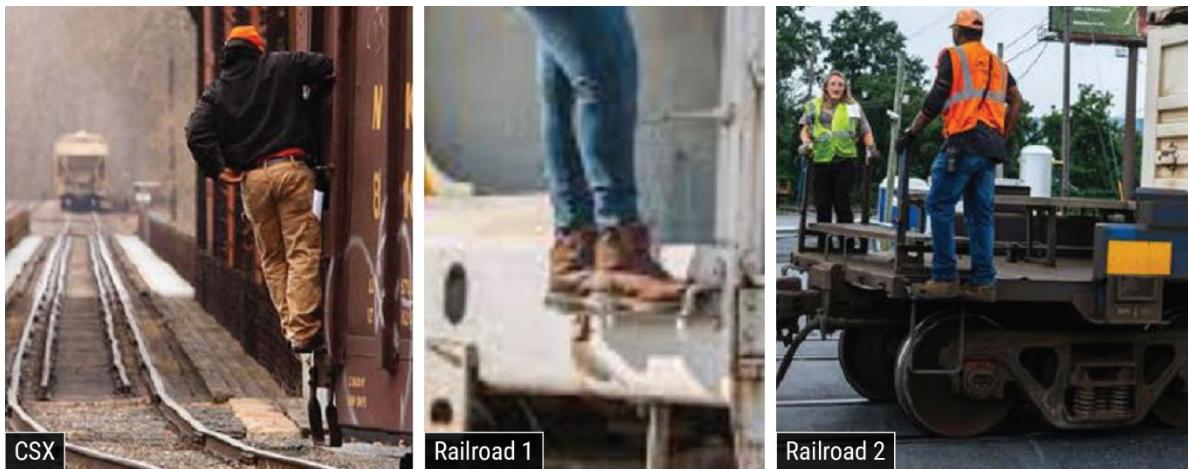
Figure 8. Photographs show CSX and other Class I railroad employees angling their feet to stand on various railcar safety appliances. (Courtesy of *Trains*, Union Pacific Railroad, and *The Patriot-News*.)

Class I railroad employees often use horizontal handholds as steps (or footholds), which the FRA does not prohibit. The FRA requires horizontal handholds to be placed at least 2 inches from the railcar body. This clearance requirement is about 1 inch less than the federal ladder clearance requirement for miners, which Pliner, Kyureghyan, and Beschorner's study found restricted foot placement (Pliner, Kyureghyan, and Beschorner 2014). Publicly available photographs of Class I railroad employees show them standing on horizontal handholds and other railcar safety appliances that do not allow them to place their feet perpendicular to and fully centered on the appliance rung, displaying restricted foot placement. (The photographs show that there is not enough clearance between the appliance and the railcar body to allow the foot to be placed perpendicular to the appliance, to allow the foot to advance and center on the appliance, or both.) Restricted foot placement

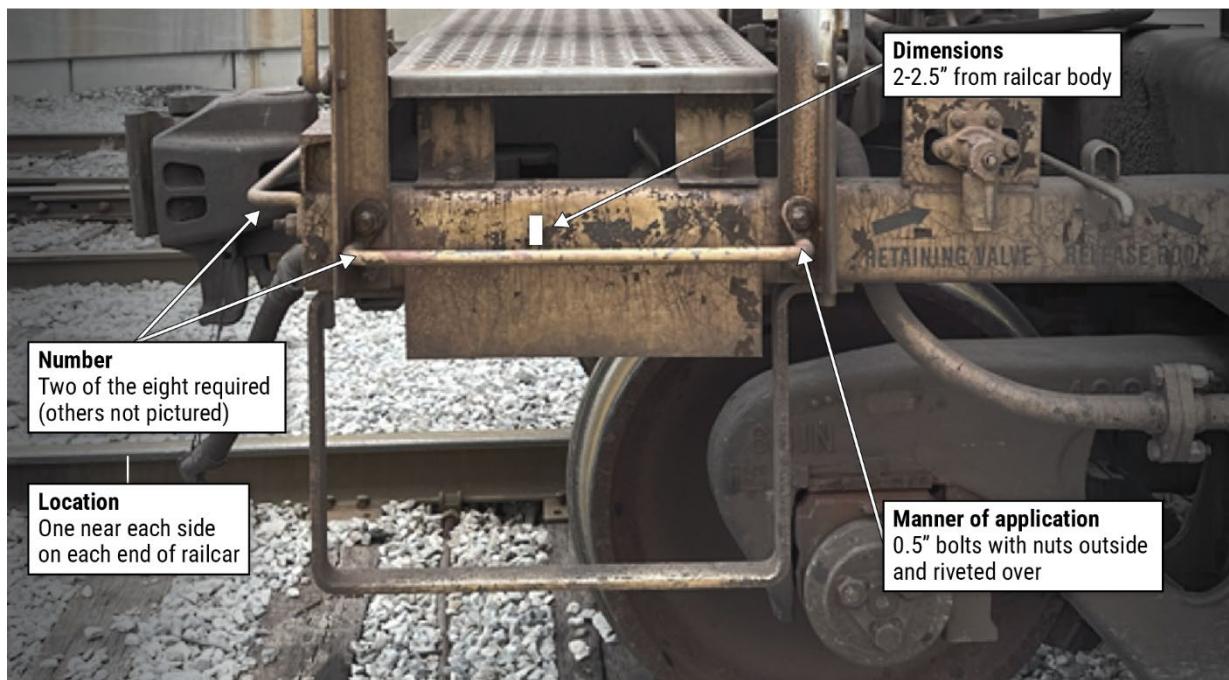
Figure 9 shows the accident intermodal railcar's horizontal handholds.

Figure 9. Photograph of the accident intermodal railcar's horizontal handholds as described in the regulation. (Courtesy of the Brotherhood of Locomotive Engineers and Trainmen.)

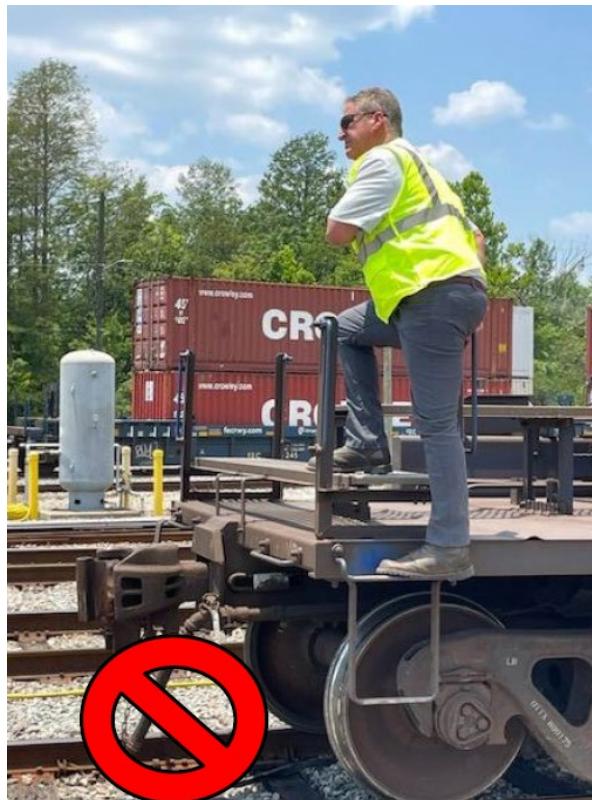
Figure 11. Photograph from the CSX safety alert of an employee modeling a noncompliant method for riding an intermodal railcar. (Courtesy of CSX.)

In response to the accident, on June 27, 2023, CSX issued a safety alert to its employees that reminded them of operating rules 104.5, 2102.1, 2102.2, and 2102.3, which apply to employee trainer responsibilities and riding equipment. The alert provided photographs of employees riding several kinds of railcars (although not an intermodal railcar) in compliance with CSX operating rules and a photograph of a noncompliant method for riding an intermodal railcar. (See figure 10 and figure 11.)
