HIGHWAY ACCIDENT REPORT

INTERSTATE BUS--AUTOMOBILE COLLISION

INTERSTATE ROUTE 15

Baker, California

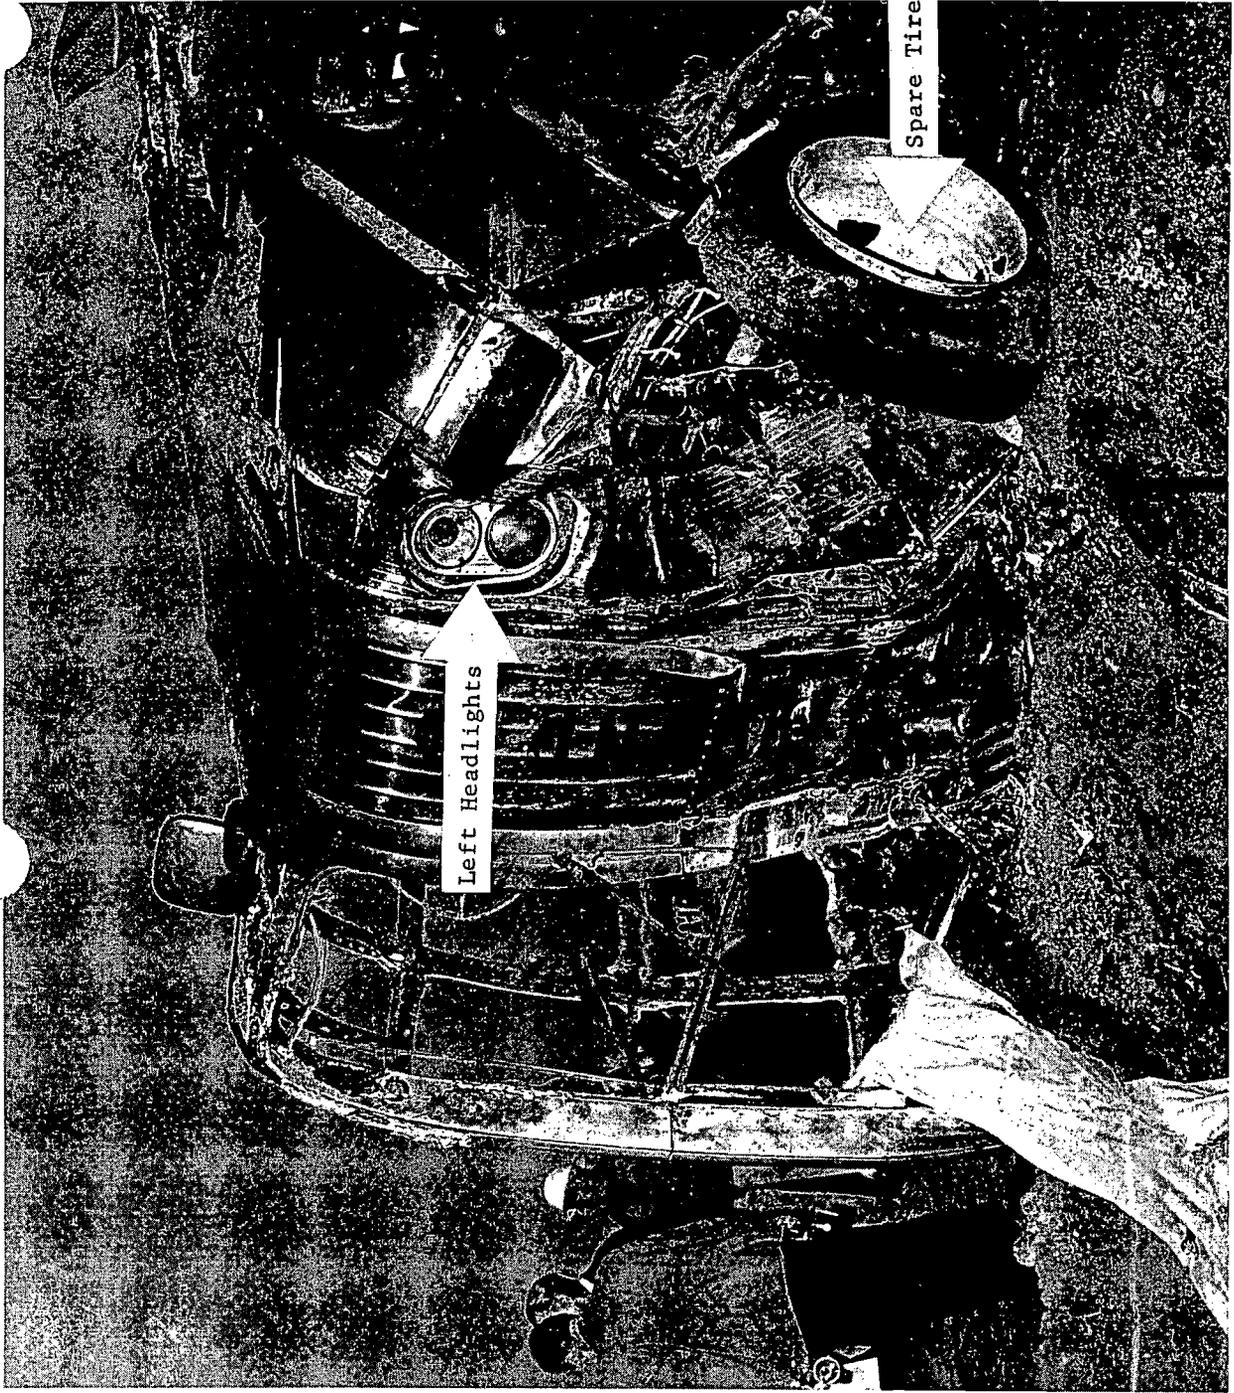
ILLUSTRATION 1

The bus and automobile collided head-on as indicated by damage to the front of the bus from its left headlights through the right front corner (Illustration 1), and to the frontal area of the automobile.

The front of the bus was severely damaged by the impact in increasing severity from the left through its right front corner, primarily in the area below its windshield. The right front wheel assembly, including suspension members, was pushed rearward through a bulkhead, penetrating and compressing the fuel tank (located immediately to the rear of the right front wheel well), and contributing to damage and distortion of the plywood floor of the passenger compartment. The fuel tank contained approximately 115 gallons of diesel fuel. The battery compartment, which was located immediately to the rear of the fuel tank, was also partially crushed and displaced. Both sections of the windshield were ejected from their mountings upon impact. The overturning motion of the bus did not contribute materially to further mechanical damage to the bus. The seats were not dislodged from their floor anchorages as a result of the collision.

Damage to front of bus from left headlights through right front corner.

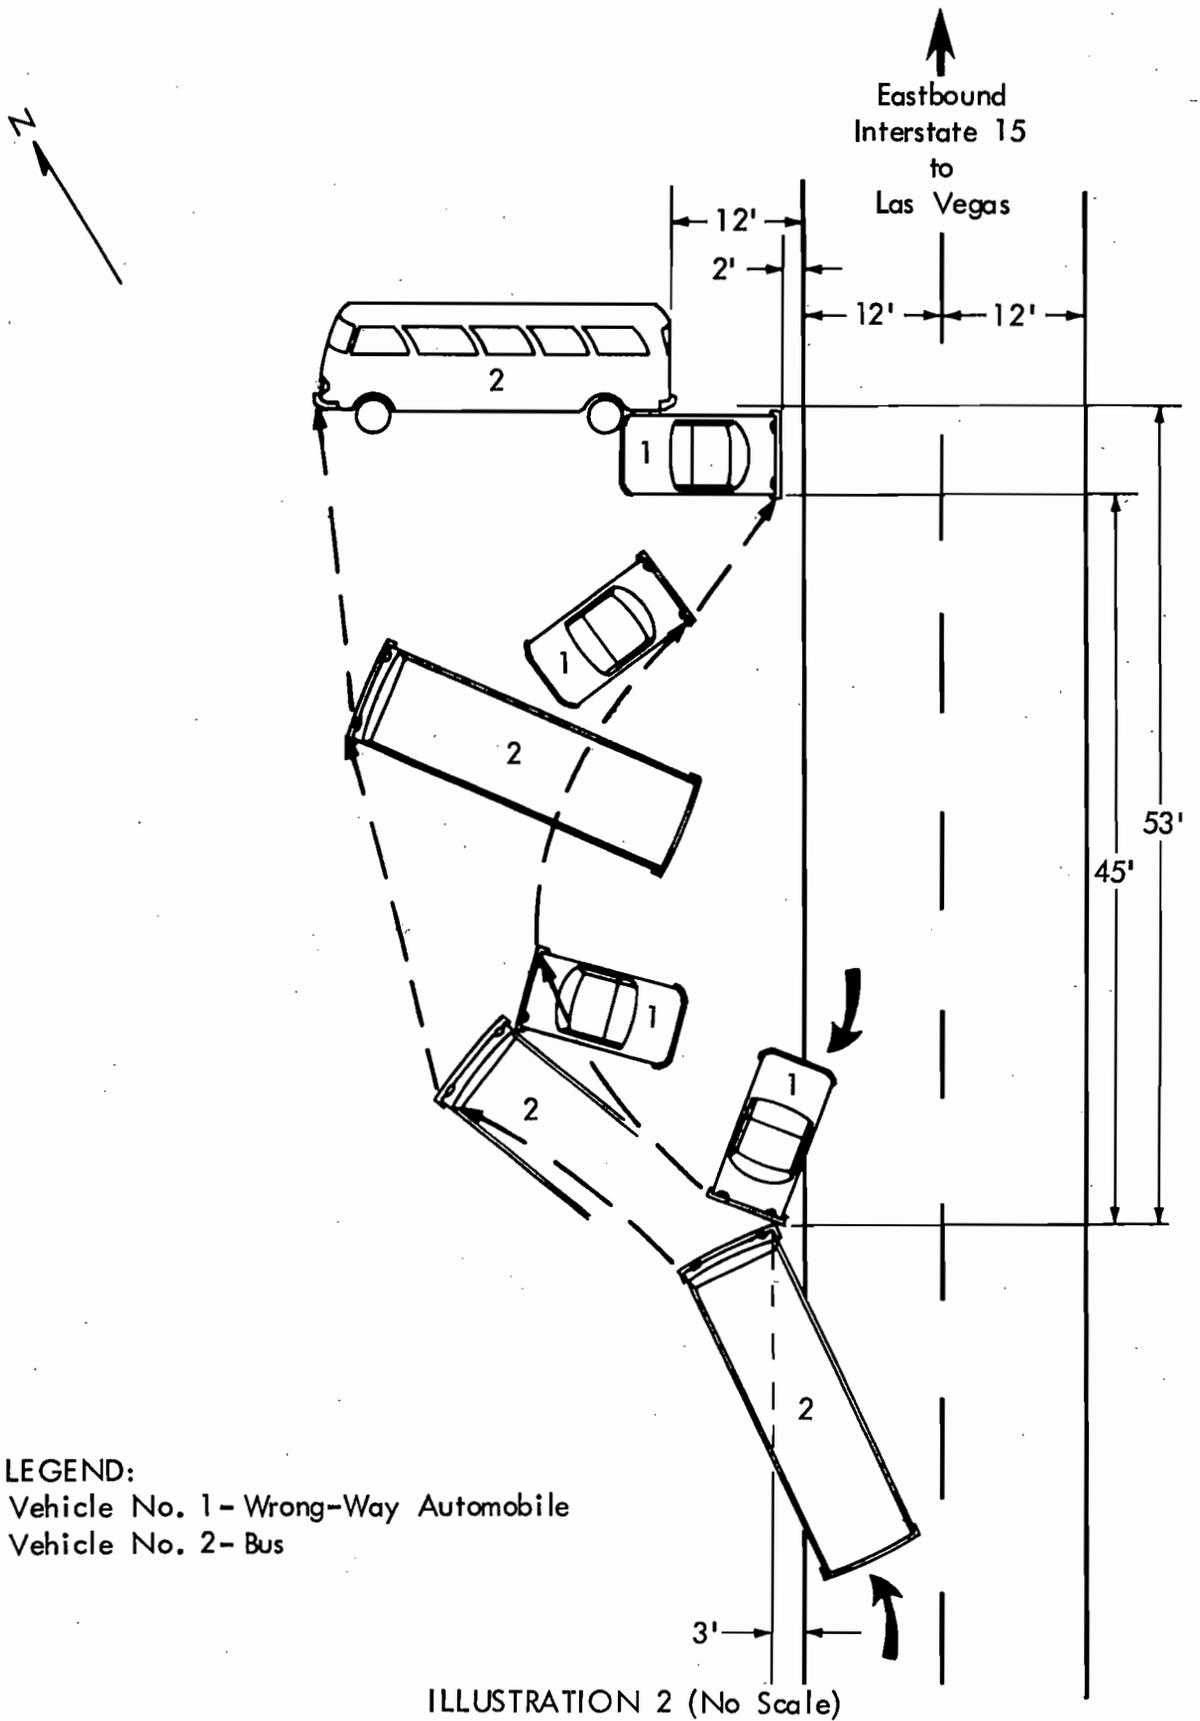
Accident diagram showing relative vehicle position during collision and post-collision phases of accident.

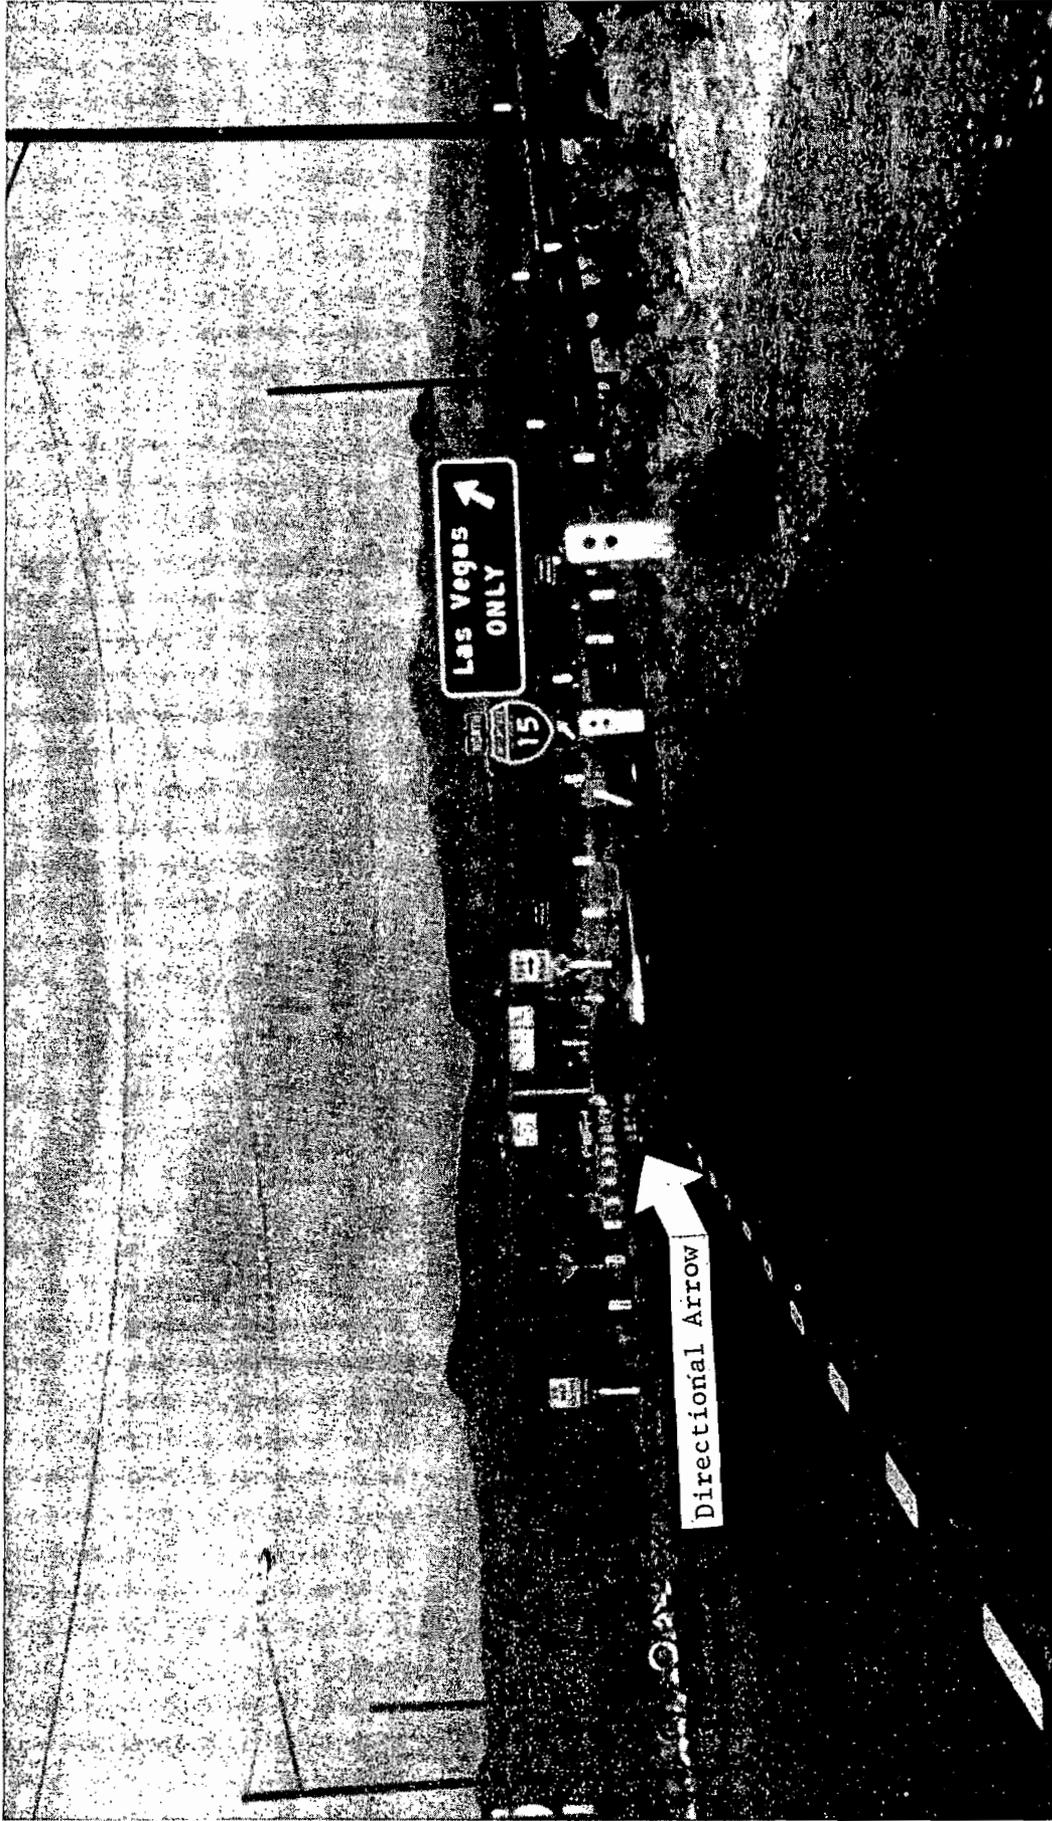
ILLUSTRATION 7

Baker interchange. Entrance to eastbound Interstate 15 (Las Vegas) is on right. Exit from westbound Interstate 15 to Baker is on left. Note Keep Right, Wrong-Way and Do Not Enter signs and centerline pavement markings. A white directional arrow is in place on the roadway pavement.
