# National Transportation Safety Board

## Aircraft Accident Brief

Accident Number:	DCA01MA034
Operator:	Avjet Corporation
Aircraft and Registration:	Gulfstream III, N303GA
Location:	Aspen, Colorado
Date:	March 29, 2001

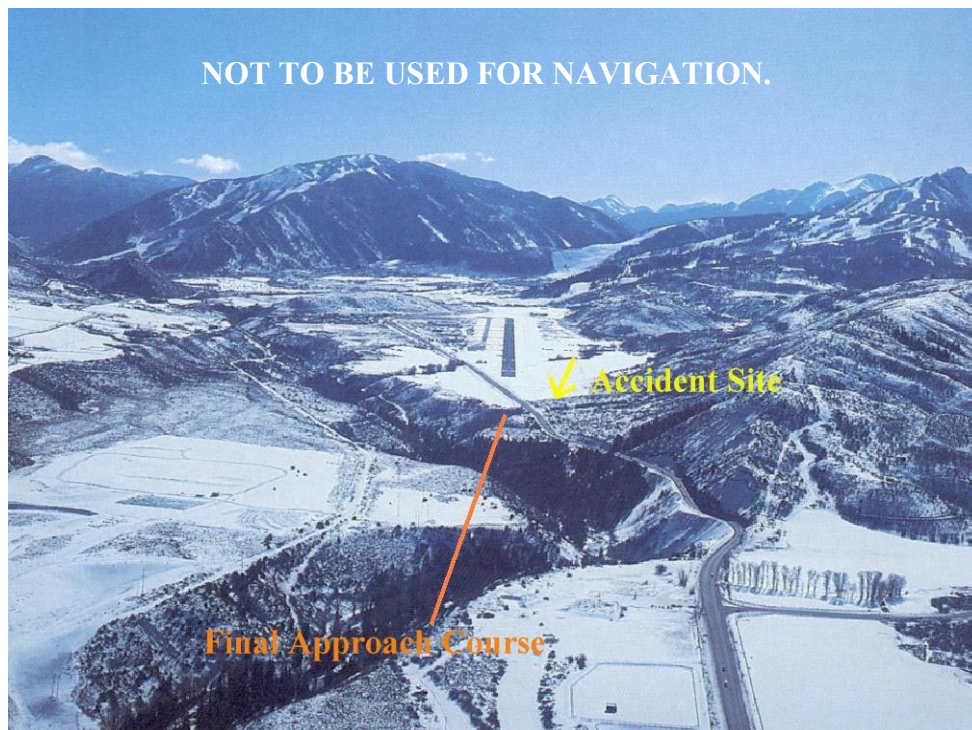
**Figure 2.** Airborne view of runway 15.

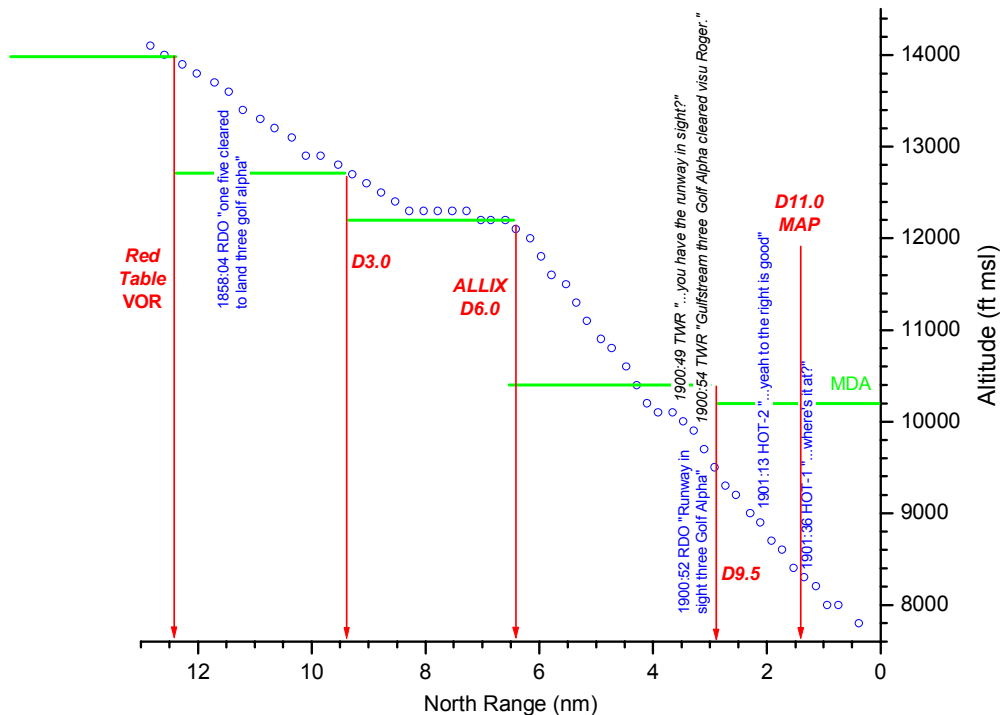
**Figure 3.** Profile view of N303GA's approach to ASE.

RDO, radio communication transmitted to and from N303GA; TWR, radio transmission from ASE local controller; HOT-2, first officer's audio panel information; MAP, missed approach point; HOT-1, captain's audio panel information; MDA, minimum descent altitude.

The airplane passed the step-down fix located 9.5 DME south of the Red Table VOR about 1901:00 at an altitude of 9,500 feet, 900 feet below the specified minimum altitude (see figure 3). Because the airplane was still in instrument meteorological conditions, the first officer should have announced this altitude deviation to the captain, but the CVR did not record any such callout.
