National Transportation Safety Board

Aircraft Accident Brief

Accident Number: IAD05FA023
Aircraft and Registration: CASA C-212-CC, N960BW
Location: Bamiyan, Afghanistan
Date: November 27, 2004
Adopted On: November 8, 2006

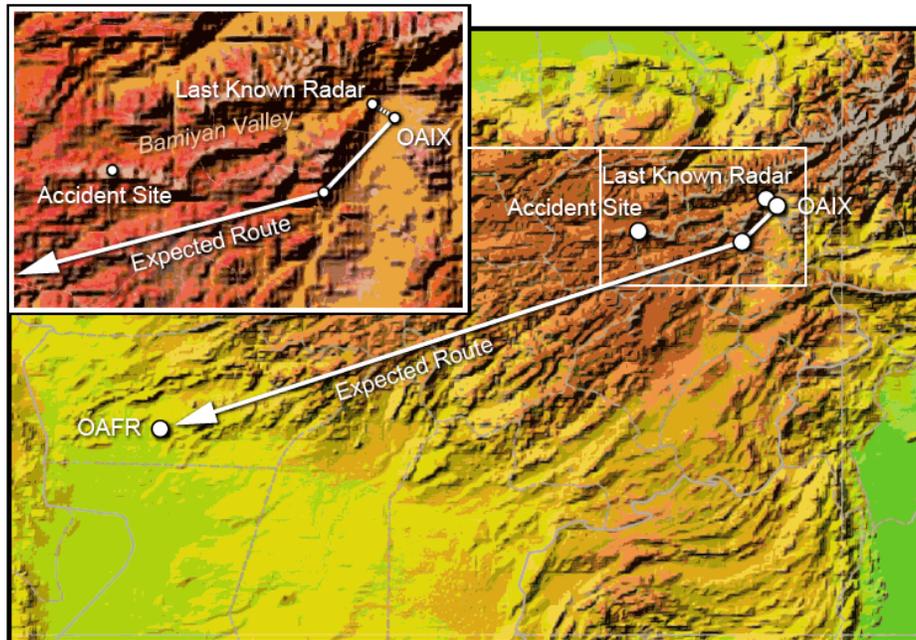
A review of ground-based radar data revealed the airplane did not depart on the southerly heading but, instead, departed to the northwest. Radar contact was lost approximately 9.5 nm northwest of OAIX, consistent with the normal expected limit of radar coverage for the area. The last recorded radar position showed the flight on a westerly heading at an approximate altitude of 10,000 feet msl; the position and heading were consistent with the flight entering the Bamiyan Valley (see figure 1).

Figure 1. Map of the expected route, the last known radar position of the flight, and the accident site.

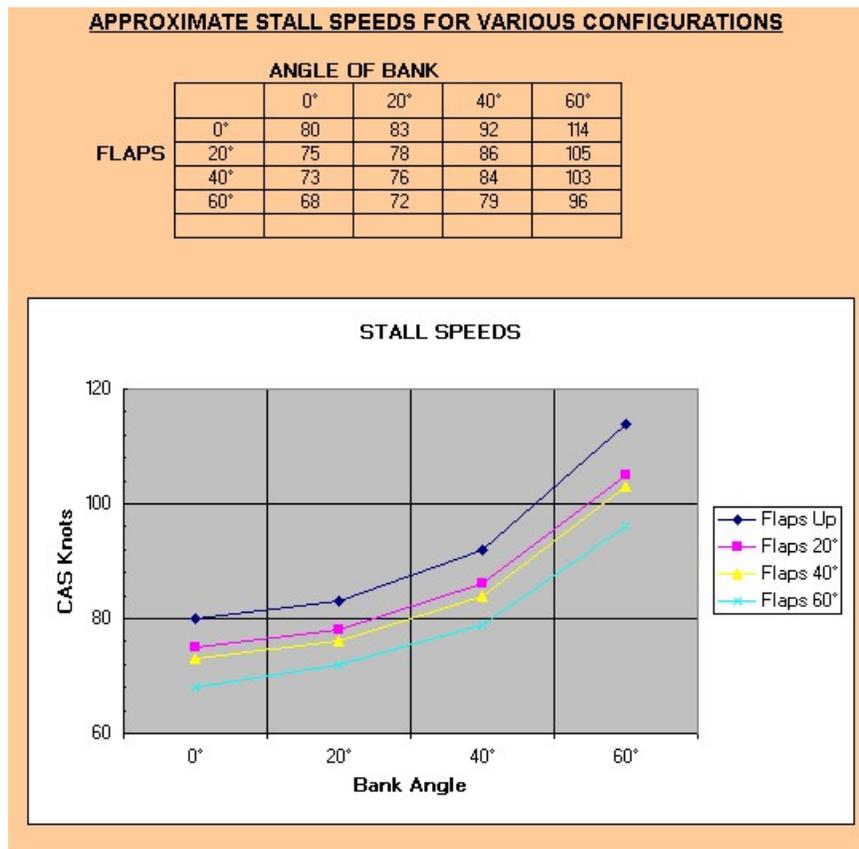
The stall speed of the airplane is affected by flap configuration and wing bank angle. As the airplane's flap angle increases (that is, as flaps are lowered), stall speed decreases. As the airplane's wing bank angle increases (to turn in level flight), stall speed increases. Based on AFM performance charts, the approximate stall speeds for the airplane, in knots (kts) of calibrated airspeed in various bank angle and flap configurations, are shown in figure 2.

Figure 2. Approximate stall speeds for various bank angles and flap settings.
