Crash of Skydive Quantum Leap  
de Havilland DHC-6-100, N203E  
Sullivan, Missouri  
July 29, 2006

AIRCRAFT ACCIDENT SUMMARY REPORT

NTSB/AAR-08/03/SUM  
PB2008-910403

**National  
Transportation  
Safety Board**

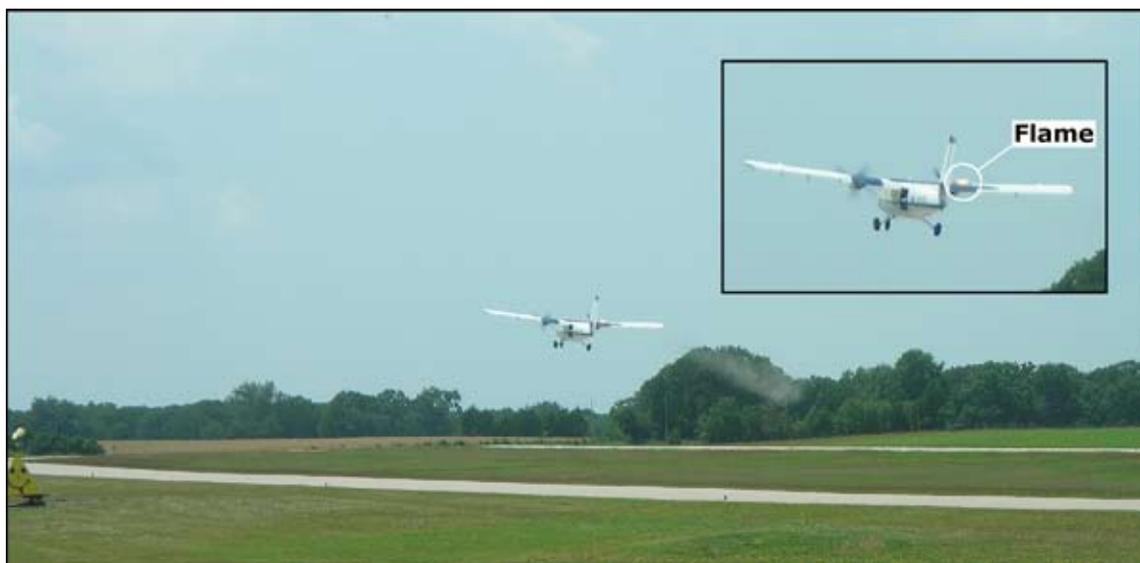
According to photographic evidence provided by a witness, the pilot taxied the airplane onto runway 24 from the intersecting taxiway, which is about 1,700 feet from the runway's west end, and began a takeoff roll to the west from that location, rather than using the runway's entire 4,500-foot length. Photographic evidence depicting the airport windsock shows that the airplane departed into a moderate headwind. Witnesses at the airport reported seeing the airplane take off and climb to about treetop height.<sup>2</sup> Several witnesses reported hearing a "poof" or "bang" noise and seeing flames and smoke coming from the right engine. One witness reported that, after the noise and the emergence of flames, the right propeller was "just barely turning." Photographic evidence shows that, at one point after the flames occurred, the airplane was about one wingspan (about 65 feet) above the runway. (See figure 1.) One witness estimated that the airplane climbed to about 150 feet.

**Figure 1.** Witness' photograph showing accident airplane above the end of runway 24 with smoke and flames visible from right engine. (Inset shows an enlarged view.)

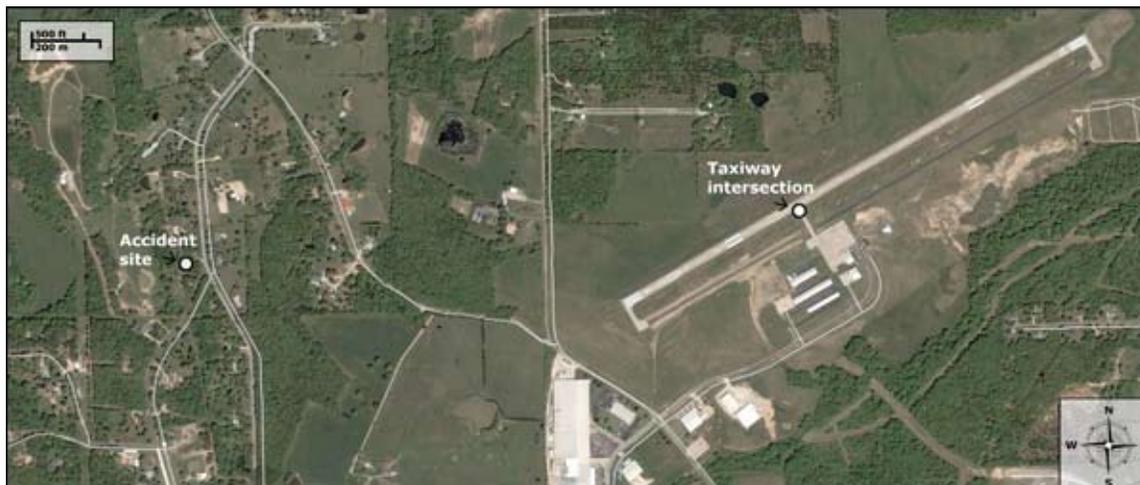
Witnesses reported that the airplane lost some altitude, regained it, and then continued to fly low above the treetops before turning to the right and disappearing from their view behind the treeline. Another witness in the backyard of a residence northwest of the airport reported that she saw the airplane flying straight and level but very low over the trees before it dived nose first to the ground. She and her father called 911, and she said that local emergency medical service personnel arrived within minutes. The airplane impacted trees and terrain and came to rest vertically, nose down against a tree behind a residence about 1/2 mile northwest of the end of runway 24. (An aerial map of the runway and accident site is shown in figure 2.)

**Figure 2.** Aerial map of UUV showing runway 24, the intersecting taxiway, and the accident site.

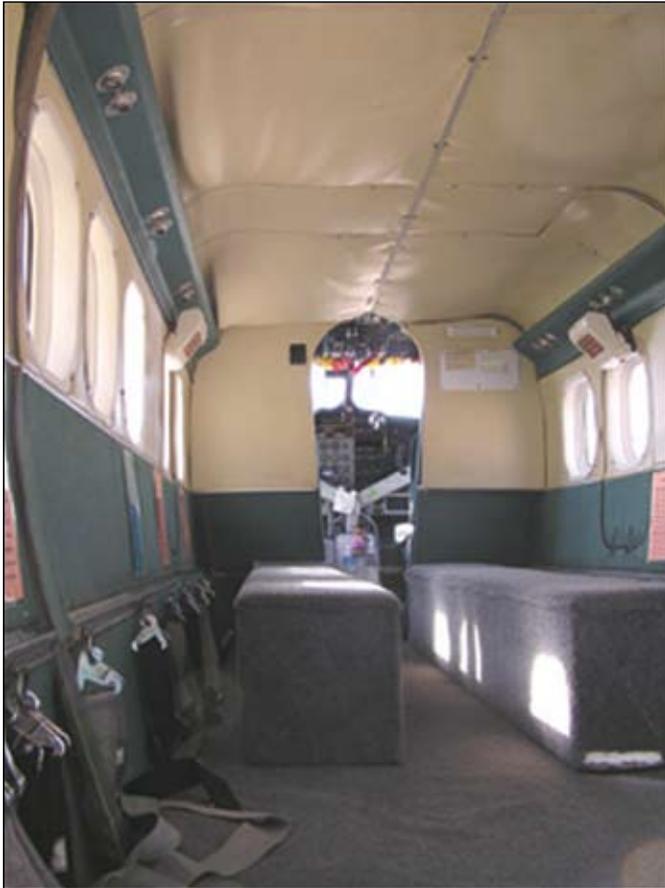
**Figure 3.** Pre-accident photograph of accident airplane interior showing both foam block benches and some left-side restraints (view from left-side cargo door, looking forward); photograph provided by a relative of the pilot.

wreckage; instead, two solid foam blocks, each measuring about 5 to 6 feet long and 15 to 18 inches tall and wide, were in the airplane. Each solid foam block served as a seating bench that extended aft from the forward cabin, parallel to each exterior cabin wall. The position of the two foam block benches allowed space for a center aisle and space between each bench and sidewall. (See figure 3 above.)

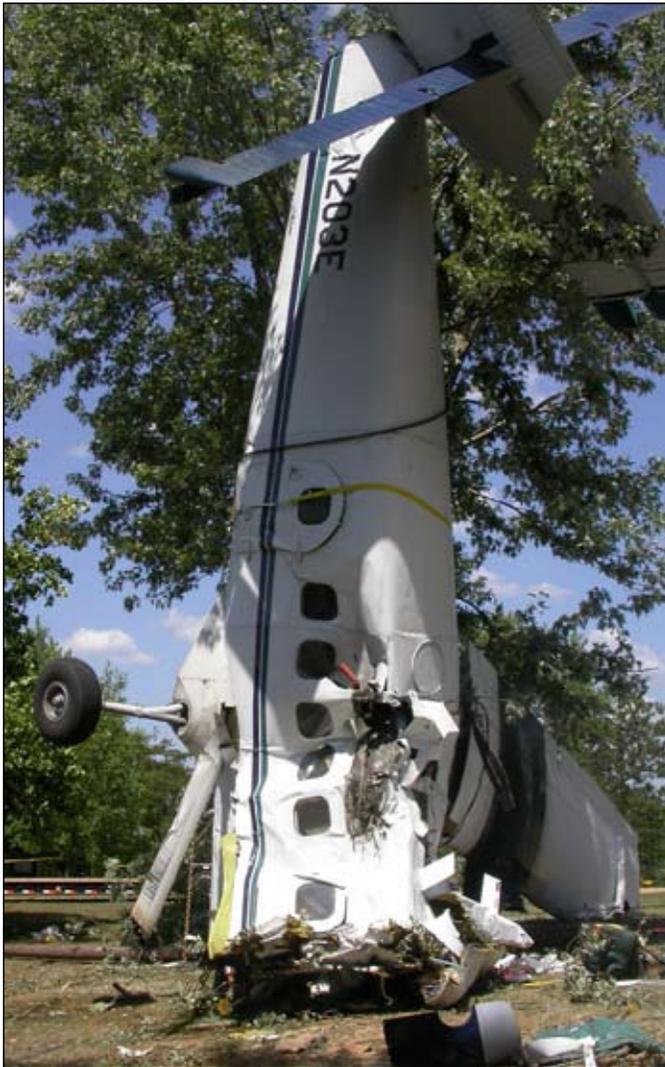
**Figure 4.** Photograph of the crush damage on the fuselage (right wing removed from wreckage).

were seated showed little crush intrusion. In fact, the crush damage observed on the wreckage showed that only the space where the pilot was seated was subjected to nonsurvivable crush intrusion. The airplane's nose,<sup>27</sup> cockpit, and cabin were crushed aft to an area immediately forward of the second window in the cabin passenger compartment. (See figure 4.)

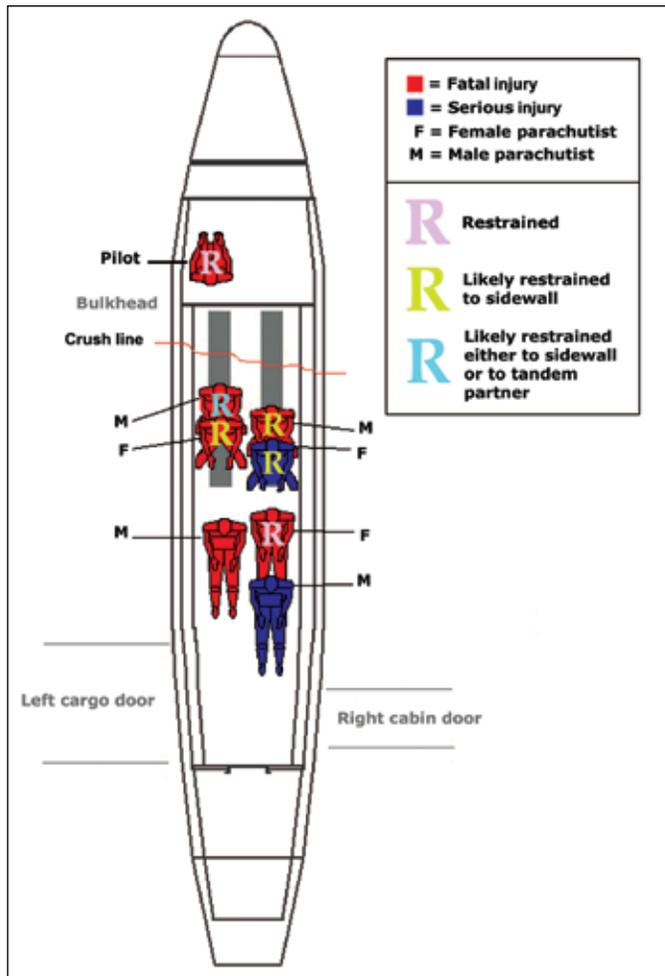
**Figure 5.** Seating diagram showing the approximate pre-accident locations of the parachutists and the pilot with respect to the crush-intrusion line.
