Ground Fire Aboard Cargo Airplane
ABX Air Flight 1611
Boeing 767-200, N799AX
San Francisco, California
June 28, 2008

Aircraft Accident Summary Report

NTSB/AAR-09/04/SUM
PB2009-910404

**National
Transportation
Safety Board**

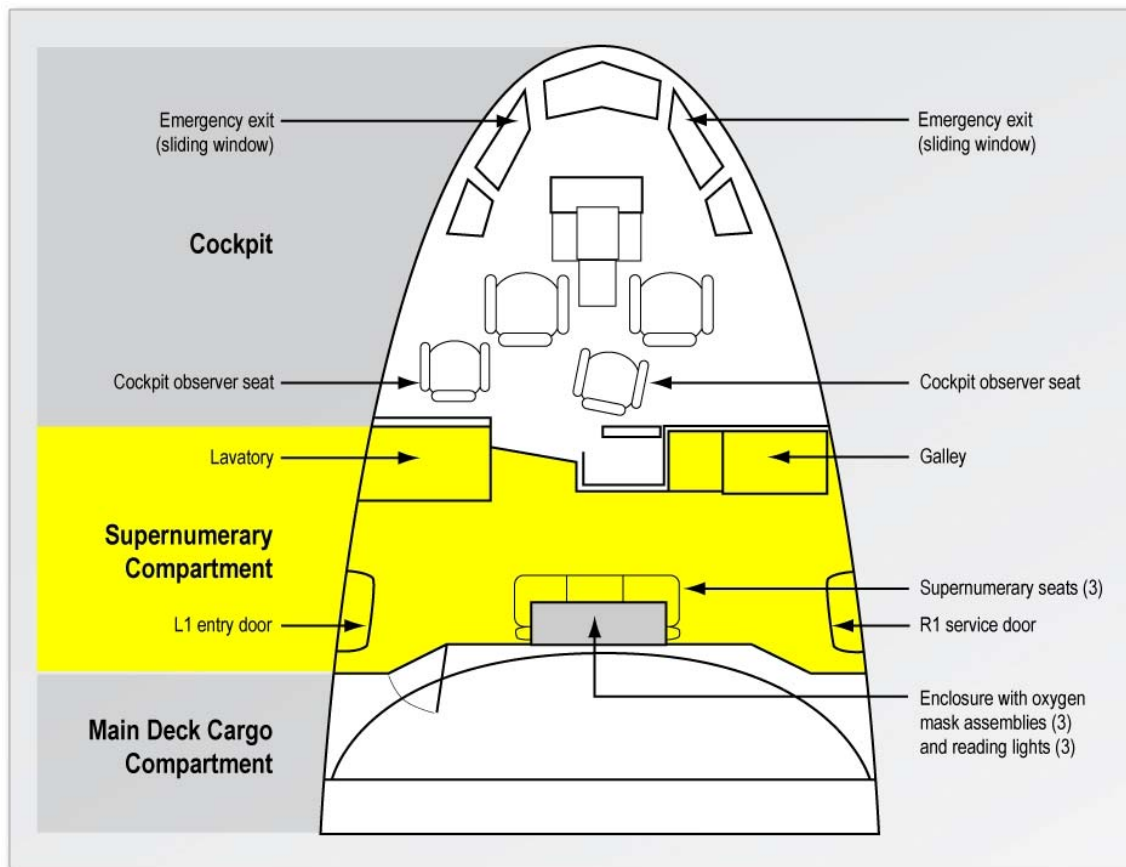
Figure 1. Cockpit and Forward Cabin of Airplane

The flight crew conducted preflight checks, including one for the supplemental oxygen system in the cockpit. The captain stated that he pushed the oxygen switch, tested his oxygen mask, and verified oxygen pressure using the engine indicating and crew alerting system. The captain reported that oxygen was flowing during the test and had stopped once the test was

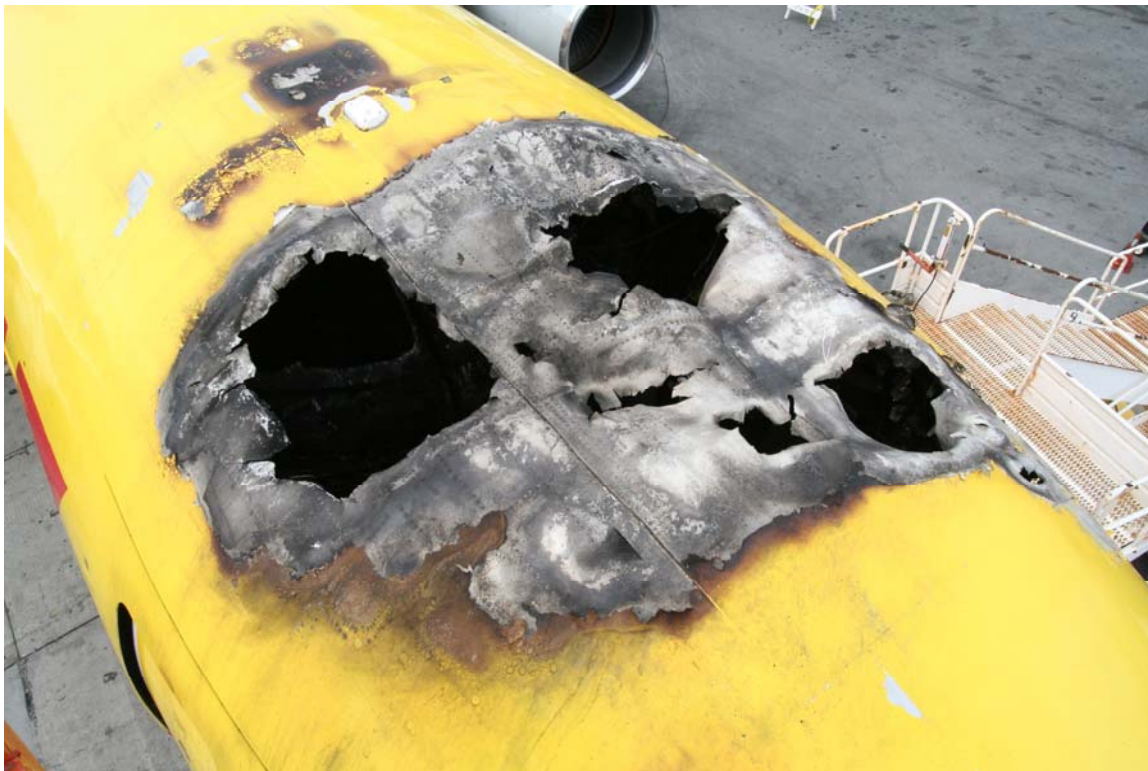
Figure 2. Fire Damage to Top of Airplane

In the cockpit, the ceiling and other surfaces were covered with soot. Extensive thermal damage was also present on the cockpit ceiling, especially in the aft portion. The bulkhead separating the cockpit and the supernumerary compartment was damaged by fire and had burn-through areas, especially in the upper portions of the bulkhead. Flight control cables to the tail were routed vertically along the aft side of this bulkhead, and their upper mounting point had fallen to the floor structure.

In the supernumerary compartment, the fire completely consumed the seat cushions and most of the seat structure; only small portions of the seat frame remained. The floor beneath the seats was fire damaged. The fire consumed most of the ceiling panels, and charred ceiling portions were found on the floor. Large burn-through areas were located to the left and the right of the crown centerline, and a smaller burn-through area was located on the skin above the lavatory. Two smaller burn-through holes were also found in the crown centerline. All of these burn-through areas were visible from outside the airplane, as shown in figure 2. Recovered electrical wiring from above the supernumerary compartment ceiling panels was found on the floor.

The L1 and R1 doors were extensively fire damaged. The operating mechanism for the L1 door and the tracks for both doors, which allowed them to be opened upward and inward, had melted away, causing the doors to be inoperable. The door leading from the supernumerary compartment to the cockpit showed heavy soot in most areas but was not compromised by the

fire. The lavatory (on the left side of the supernumerary compartment) sustained heavy fire damage. Most of the walls in the galley area (on the right side of the supernumerary compartment) were charred and covered with heavy soot. The left-most galley wall, located next to the center of the cockpit bulkhead, had buckled and collapsed as a result of fire damage. The ceiling above the galley area was mostly missing.

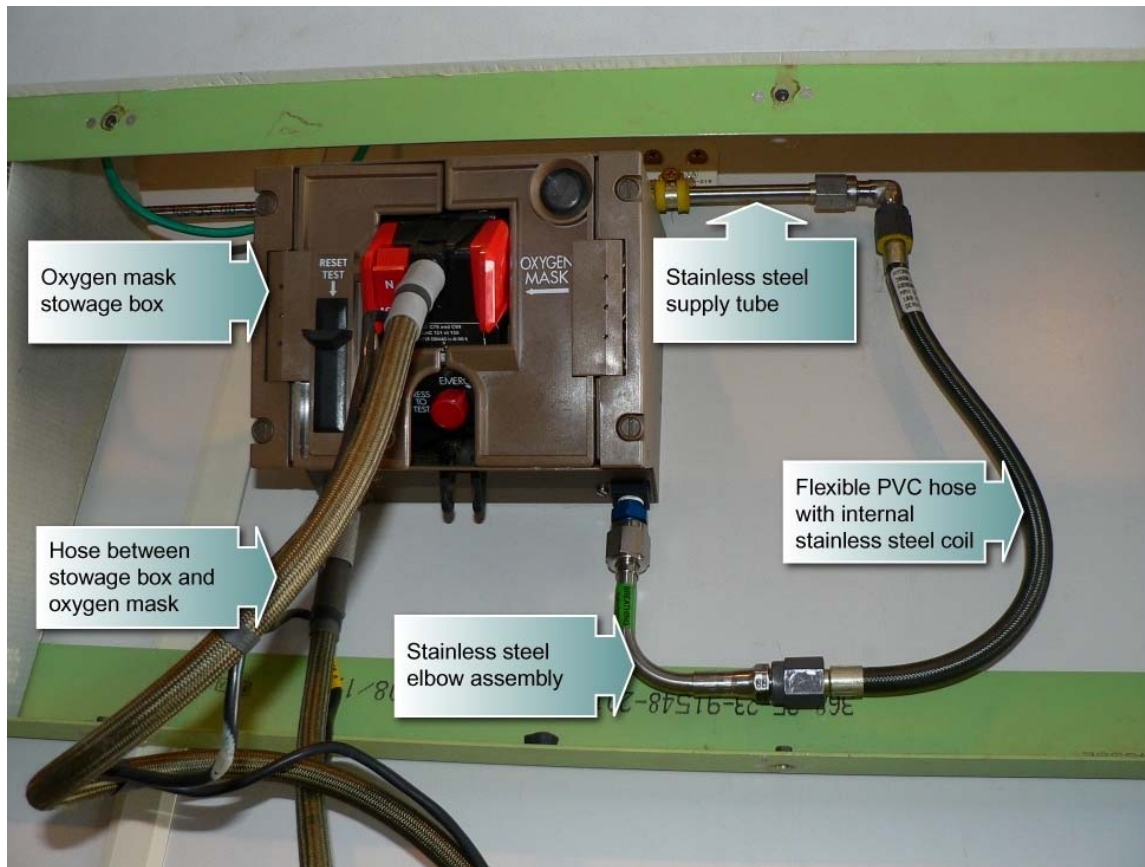
Figure 3. Oxygen System Components in Supernumerary Compartment

The supernumerary compartment was constructed with low-flammability materials, in accordance with Federal regulations. The enclosure above the supernumerary occupant seats, the top right of which was consistent with the location where the first officer initially observed the fire, included panel material, an aluminum subframe, and three oxygen mask stowage boxes. The brief time during which the fire developed, the intensity of the fire, and the pop and hissing noises heard by the flight crew indicated that a source of pressurized oxygen was involved in the fire. Also, the supernumerary oxygen bottle was found empty (compared with the cockpit oxygen bottle, which was found almost full), further indicating that the oxygen system supplying the supernumerary compartment had been compromised.

Each of the three oxygen mask stowage boxes (in the enclosure above the supernumerary occupant seats) included an oxygen mask assembly, a flexible hose that was primarily made of polyvinyl chloride (PVC),¹⁴ and rigid stainless steel supply tubing, as shown in figure 3. The manufacturer of the PVC flexible oxygen hoses installed a stainless steel coil spring in the hoses, as shown in figure 4, to prevent bends from collapsing the hose and disrupting the oxygen supply. The stainless steel coil was loosely attached to the aluminum fittings at each hose end, making the hoses electrically conductive.

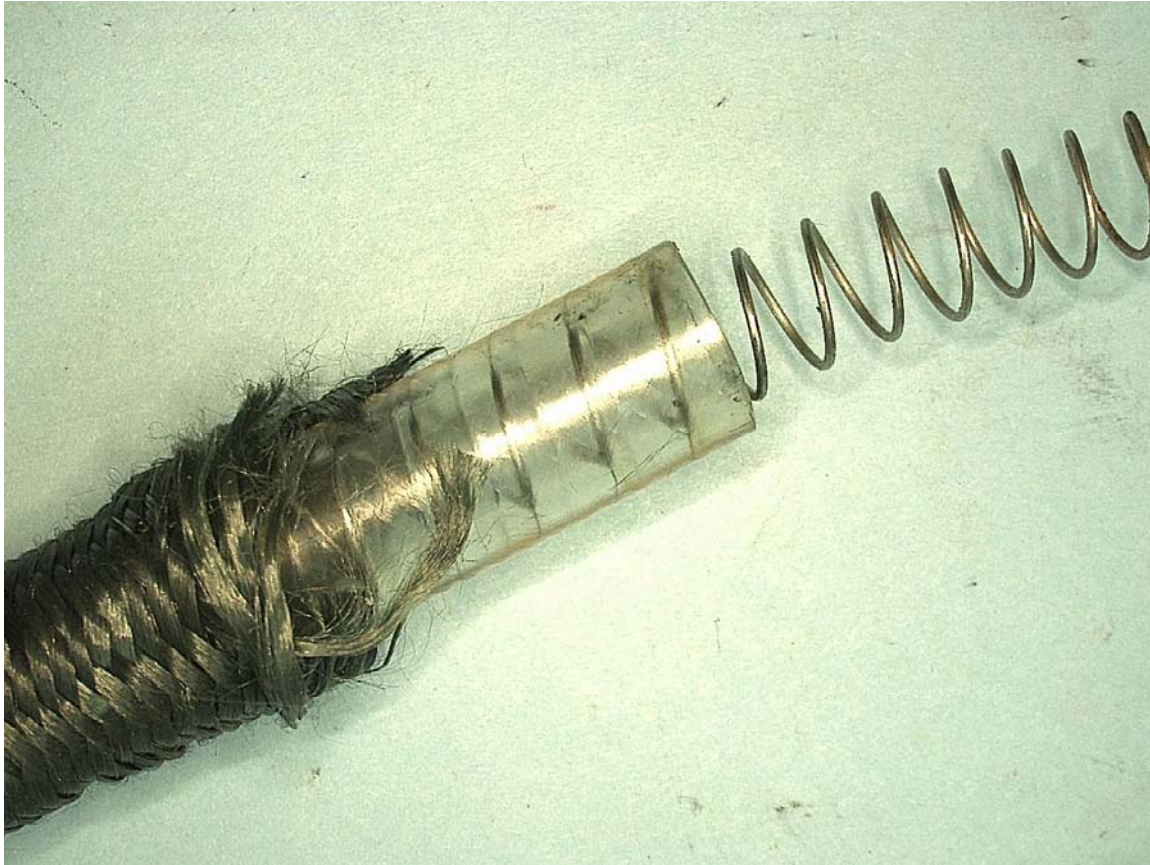
Figure 4. Stainless Steel Coil Spring Within Flexible Oxygen Hose

The National Transportation Safety Board (NTSB) performed tests on PVC flexible oxygen hose assemblies that had been removed from the accident airplane and other ABX Air 767 airplanes to evaluate whether electrically energized hoses could cause a fire. The hoses were pressurized with oxygen, and a 120-volt AC electrical current¹⁵ was passed through the internal stainless steel coil spring by attaching electrical conductors to the aluminum fittings at each end of the hose assemblies, which resulted in the hoses becoming part of an electrical circuit. Discrete tests at various energy levels evaluated the hose assemblies' response to becoming electrically energized. (These energy levels were consistent with those that were available on the airplane in the areas where the oxygen system components were routed.) At low energy levels, the heating of the internal spring by the electrical current passing through it (known as resistance heating) caused the PVC hose material to heat enough to soften and allowed the oxygen pressure to rupture the hose. At higher energy levels, the internal spring could be heated until it became an ignition energy source, causing the flexible oxygen hose to ignite and sustain a fire. The time to failure during the tests ranged from 6 to 180 seconds depending on the amount of energy supplied to the internal spring.

Each hose ignition that resulted from heating the internal spring was preceded by a loud pop sound (similar to that of a firecracker) that resulted from the combustion of the PVC hose interior wall along with the oxygen within the hose. (The combustion within the hose generated internal pressure and burst the hose.) The sustained burning of the pressurized flexible hose was accompanied by a loud hissing sound. When ignition occurred, the fire would progress upstream toward the source of oxygen. When the ignition took place near the upstream (supply) end of the flexible hose, the resulting fire would extinguish quickly once it consumed the PVC hose material upstream of the failure location. When the ignition took place near the downstream end, the resulting fire would steadily burn until either the oxygen was manually shut off or all of the PVC hose material was consumed.

The NTSB concludes that the pop and hissing sounds heard by the flight crew immediately before the fire was discovered were consistent with the ignition of an oxygen hose by an internal rather than external heat source. The NTSB further concludes that the design of the oxygen hose assembly allowed the internal spring to become a source of ignition when it was electrically energized, the PVC hose material to act as a fuel, and the oxygen within the hose to promote burning.

when heated by the spring, would generate combustible gases as a result of a process known as pyrolysis.³² As a result, the NTSB concludes that combustible oxygen hoses with an electrically nonconductive design would prevent the internal coil spring from becoming electrically energized, mitigating the possibility that the hoses would melt and ignite. Therefore, the NTSB recommends that the FAA require operators to replace electrically conductive combustible oxygen hoses with electrically nonconductive hoses so that the internal hose spring cannot be energized. Because Boeing continues to stock conductive hoses (they are still a certified part) and provide them to customers who request the original part number for the hose, and because other manufacturers may have the same practice, the NTSB further recommends that the FAA prohibit the use of electrically conductive combustible oxygen hoses unless the conductivity of the hose is an intentional and approved parameter in the design.

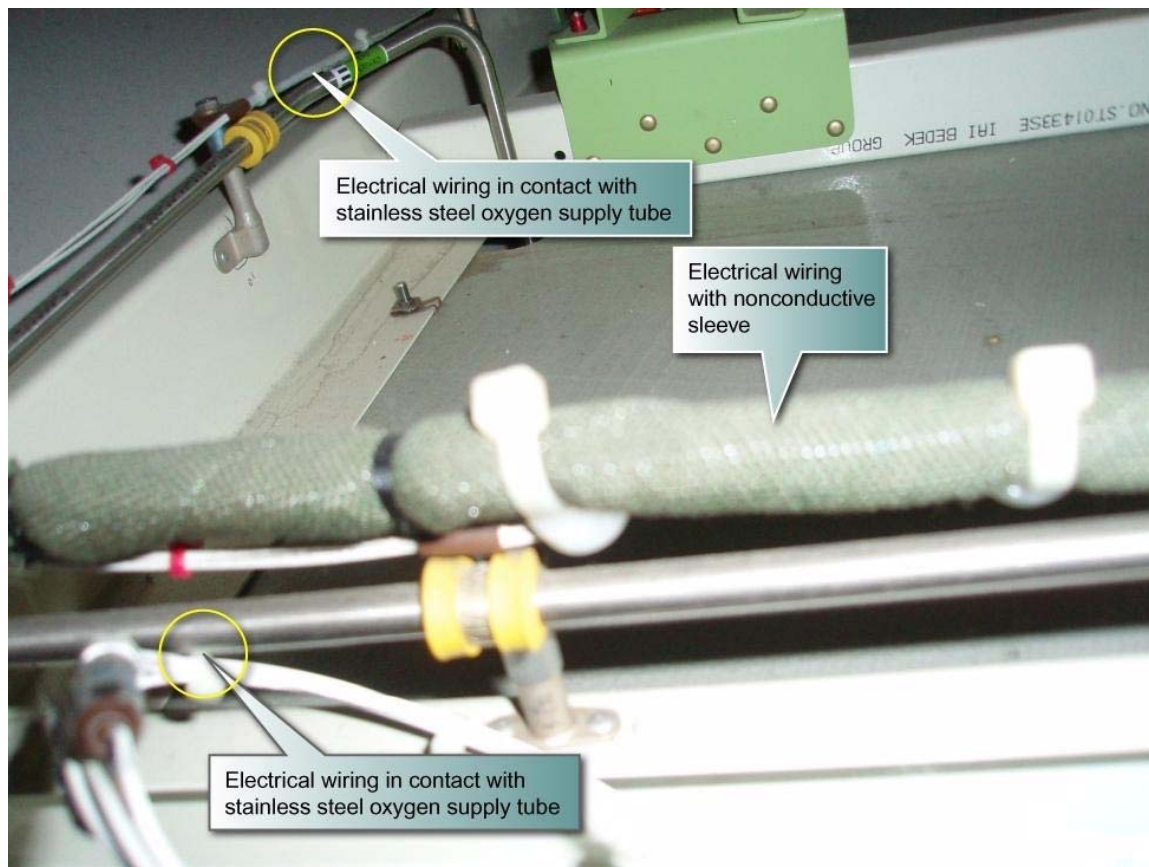
Figure 5. Proximity of Electrical Wiring to Oxygen System Tubing

During the inspections of other ABX Air 767 airplanes, electrical wiring was found in contact with or routed near the stainless steel oxygen supply tubing, as shown in figure 5. A short circuit from this close-contact wiring would be the most likely source to provide electrical energy to the spring. No direct evidence of a short circuit (that is, no beading on wires or arc marks on the oxygen supply tubing) was found, but most of the wiring near the supply tubing and portions of the tubing were missing.

Boeing guidance stated that oxygen installations should include a minimum of 2 inches between oxygen lines (that is, hoses and tubing) and electrical wiring. The guidance also advised securing the wiring so that it could not reach oxygen lines and installing the wiring beneath oxygen lines in case the wiring sagged over time. During postaccident inspections of other ABX Air 767 airplanes that were modified by IAI, some installations were found to have electrical wiring in proximity to the stainless steel oxygen supply tubing. Other installations (both in the cockpit and supernumerary compartment) were found to have electrical wiring that was routed above and in direct contact with the oxygen tubing, even though the supplemental type certificate provided for positive separation. This routing created the potential for electrical short circuits to reach the flexible oxygen hoses. (Figure 5 in section 2.1 shows electrical wiring in contact with the supply tubing located just above the ceiling in the supernumerary compartment.) The investigation of the fire aboard the accident airplane found that a short circuit from electrical wiring was the most likely source to energize the coil spring inside a supernumerary oxygen system hose, causing the hose material to ignite.

The energy in a short circuit could perforate the rigid stainless steel supply tubing and become an ignition energy source or allow oxygen to reach other fuel and ignition sources. The NTSB concludes that protecting oxygen system tubing from inadvertent short circuits is important because of the proximity between the tubing and electrical wiring in a compressed area as well as the potential severity of a fire involving oxygen. Because the general wire routing guidelines in AC 43.13-1A and AC 65-15 were advisory only and specific installations can deviate from airplane manufacturer wiring guidance, the NTSB recommends that the FAA require airplane manufacturers, modifiers, and maintenance personnel to provide positive separation between electrical wiring and oxygen system tubing according to, at a minimum, the guidance in AC 43.13-1A and AC 65-15. The NTSB further recommends that the FAA require airplane manufacturers and operators to ensure that oxygen system tubing in proximity to electrical wiring is made of, sleeved with, or coated with nonconductive material or that the tubing is otherwise physically isolated from potential electrical sources.
