Ground Fire Aboard Cargo Airplane  
ABX Air Flight 1611  
Boeing 767-200, N799AX  
San Francisco, California  
June 28, 2008

**Aircraft Accident Summary Report**

NTSB/AAR-09/04/SUM  
PB2009-910404

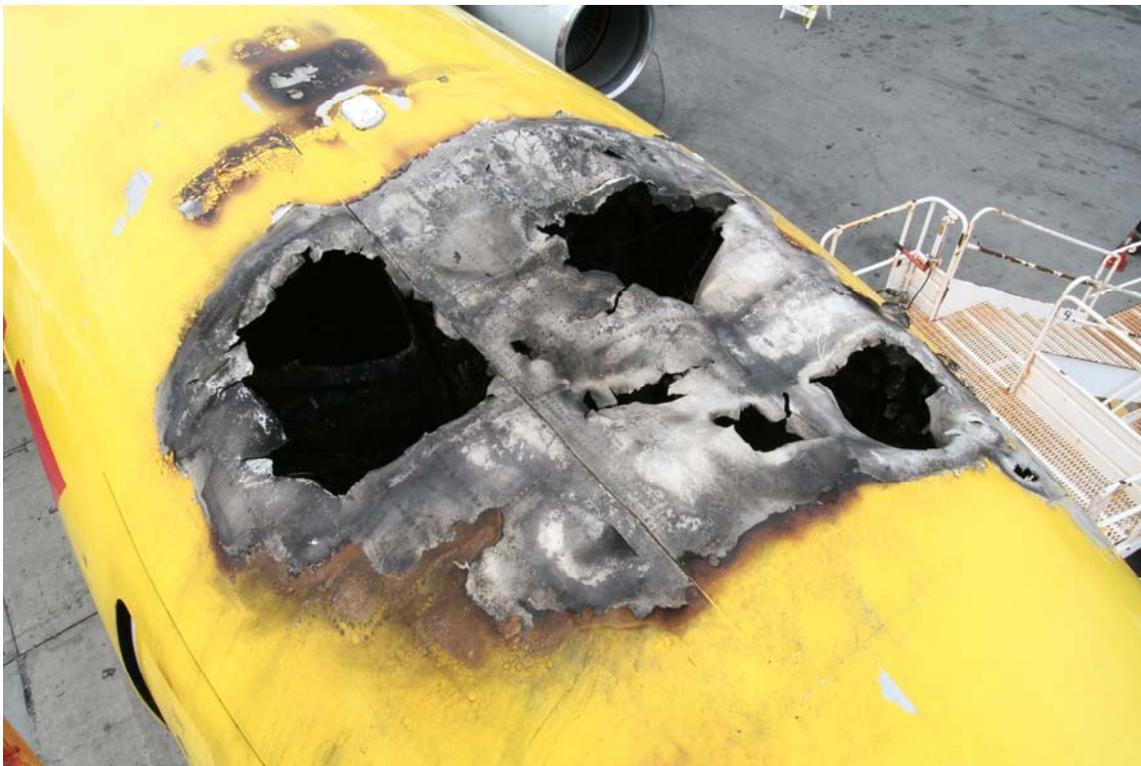
**Figure 2.** Fire Damage to Top of Airplane

In the cockpit, the ceiling and other surfaces were covered with soot. Extensive thermal damage was also present on the cockpit ceiling, especially in the aft portion. The bulkhead separating the cockpit and the supernumerary compartment was damaged by fire and had burn-through areas, especially in the upper portions of the bulkhead. Flight control cables to the tail were routed vertically along the aft side of this bulkhead, and their upper mounting point had fallen to the floor structure.

In the supernumerary compartment, the fire completely consumed the seat cushions and most of the seat structure; only small portions of the seat frame remained. The floor beneath the seats was fire damaged. The fire consumed most of the ceiling panels, and charred ceiling portions were found on the floor. Large burn-through areas were located to the left and the right of the crown centerline, and a smaller burn-through area was located on the skin above the lavatory. Two smaller burn-through holes were also found in the crown centerline. All of these burn-through areas were visible from outside the airplane, as shown in figure 2. Recovered electrical wiring from above the supernumerary compartment ceiling panels was found on the floor.

The L1 and R1 doors were extensively fire damaged. The operating mechanism for the L1 door and the tracks for both doors, which allowed them to be opened upward and inward, had melted away, causing the doors to be inoperable. The door leading from the supernumerary compartment to the cockpit showed heavy soot in most areas but was not compromised by the

fire. The lavatory (on the left side of the supernumerary compartment) sustained heavy fire damage. Most of the walls in the galley area (on the right side of the supernumerary compartment) were charred and covered with heavy soot. The left-most galley wall, located next to the center of the cockpit bulkhead, had buckled and collapsed as a result of fire damage. The ceiling above the galley area was mostly missing.

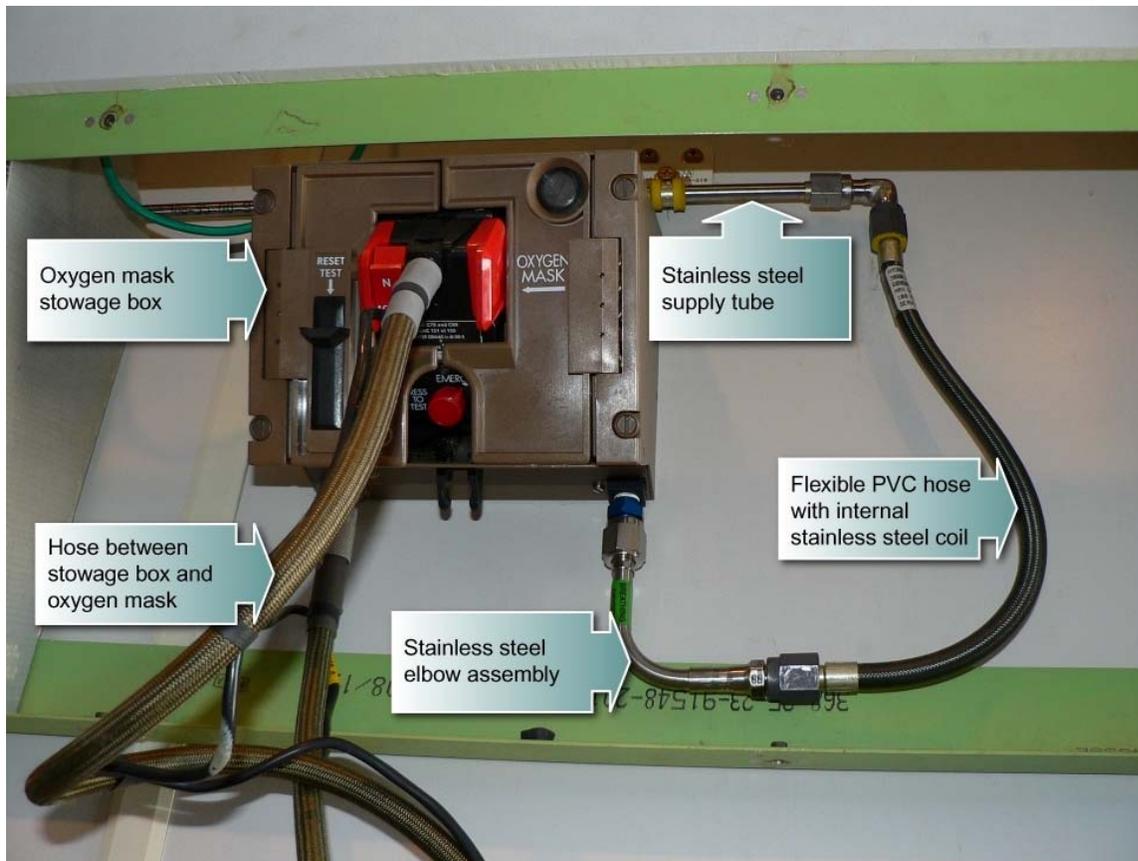
**Figure 3.** Oxygen System Components in Supernumerary Compartment

The supernumerary compartment was constructed with low-flammability materials, in accordance with Federal regulations. The enclosure above the supernumerary occupant seats, the top right of which was consistent with the location where the first officer initially observed the fire, included panel material, an aluminum subframe, and three oxygen mask stowage boxes. The brief time during which the fire developed, the intensity of the fire, and the pop and hissing noises heard by the flight crew indicated that a source of pressurized oxygen was involved in the fire. Also, the supernumerary oxygen bottle was found empty (compared with the cockpit oxygen bottle, which was found almost full), further indicating that the oxygen system supplying the supernumerary compartment had been compromised.

Each of the three oxygen mask stowage boxes (in the enclosure above the supernumerary occupant seats) included an oxygen mask assembly, a flexible hose that was primarily made of polyvinyl chloride (PVC),<sup>14</sup> and rigid stainless steel supply tubing, as shown in figure 3. The manufacturer of the PVC flexible oxygen hoses installed a stainless steel coil spring in the hoses, as shown in figure 4, to prevent bends from collapsing the hose and disrupting the oxygen supply. The stainless steel coil was loosely attached to the aluminum fittings at each hose end, making the hoses electrically conductive.

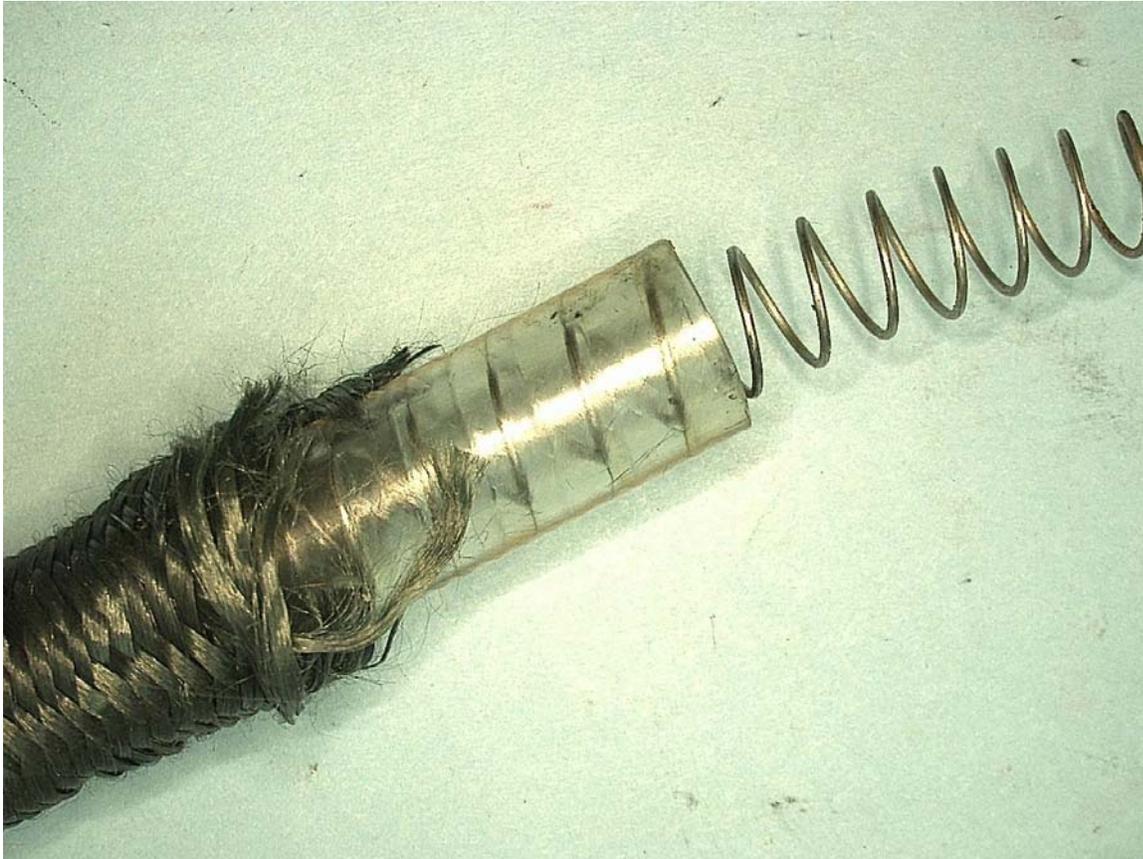
**Figure 4.** Stainless Steel Coil Spring Within Flexible Oxygen Hose

The National Transportation Safety Board (NTSB) performed tests on PVC flexible oxygen hose assemblies that had been removed from the accident airplane and other ABX Air 767 airplanes to evaluate whether electrically energized hoses could cause a fire. The hoses were pressurized with oxygen, and a 120-volt AC electrical current<sup>15</sup> was passed through the internal stainless steel coil spring by attaching electrical conductors to the aluminum fittings at each end of the hose assemblies, which resulted in the hoses becoming part of an electrical circuit. Discrete tests at various energy levels evaluated the hose assemblies' response to becoming electrically energized. (These energy levels were consistent with those that were available on the airplane in the areas where the oxygen system components were routed.) At low energy levels, the heating of the internal spring by the electrical current passing through it (known as resistance heating) caused the PVC hose material to heat enough to soften and allowed the oxygen pressure to rupture the hose. At higher energy levels, the internal spring could be heated until it became an ignition energy source, causing the flexible oxygen hose to ignite and sustain a fire. The time to failure during the tests ranged from 6 to 180 seconds depending on the amount of energy supplied to the internal spring.

Each hose ignition that resulted from heating the internal spring was preceded by a loud pop sound (similar to that of a firecracker) that resulted from the combustion of the PVC hose interior wall along with the oxygen within the hose. (The combustion within the hose generated internal pressure and burst the hose.) The sustained burning of the pressurized flexible hose was accompanied by a loud hissing sound. When ignition occurred, the fire would progress upstream toward the source of oxygen. When the ignition took place near the upstream (supply) end of the flexible hose, the resulting fire would extinguish quickly once it consumed the PVC hose material upstream of the failure location. When the ignition took place near the downstream end, the resulting fire would steadily burn until either the oxygen was manually shut off or all of the PVC hose material was consumed.

The NTSB concludes that the pop and hissing sounds heard by the flight crew immediately before the fire was discovered were consistent with the ignition of an oxygen hose by an internal rather than external heat source. The NTSB further concludes that the design of the oxygen hose assembly allowed the internal spring to become a source of ignition when it was electrically energized, the PVC hose material to act as a fuel, and the oxygen within the hose to promote burning.

when heated by the spring, would generate combustible gases as a result of a process known as pyrolysis.<sup>32</sup> As a result, the NTSB concludes that combustible oxygen hoses with an electrically nonconductive design would prevent the internal coil spring from becoming electrically energized, mitigating the possibility that the hoses would melt and ignite. Therefore, the NTSB recommends that the FAA require operators to replace electrically conductive combustible oxygen hoses with electrically nonconductive hoses so that the internal hose spring cannot be energized. Because Boeing continues to stock conductive hoses (they are still a certified part) and provide them to customers who request the original part number for the hose, and because other manufacturers may have the same practice, the NTSB further recommends that the FAA prohibit the use of electrically conductive combustible oxygen hoses unless the conductivity of the hose is an intentional and approved parameter in the design.

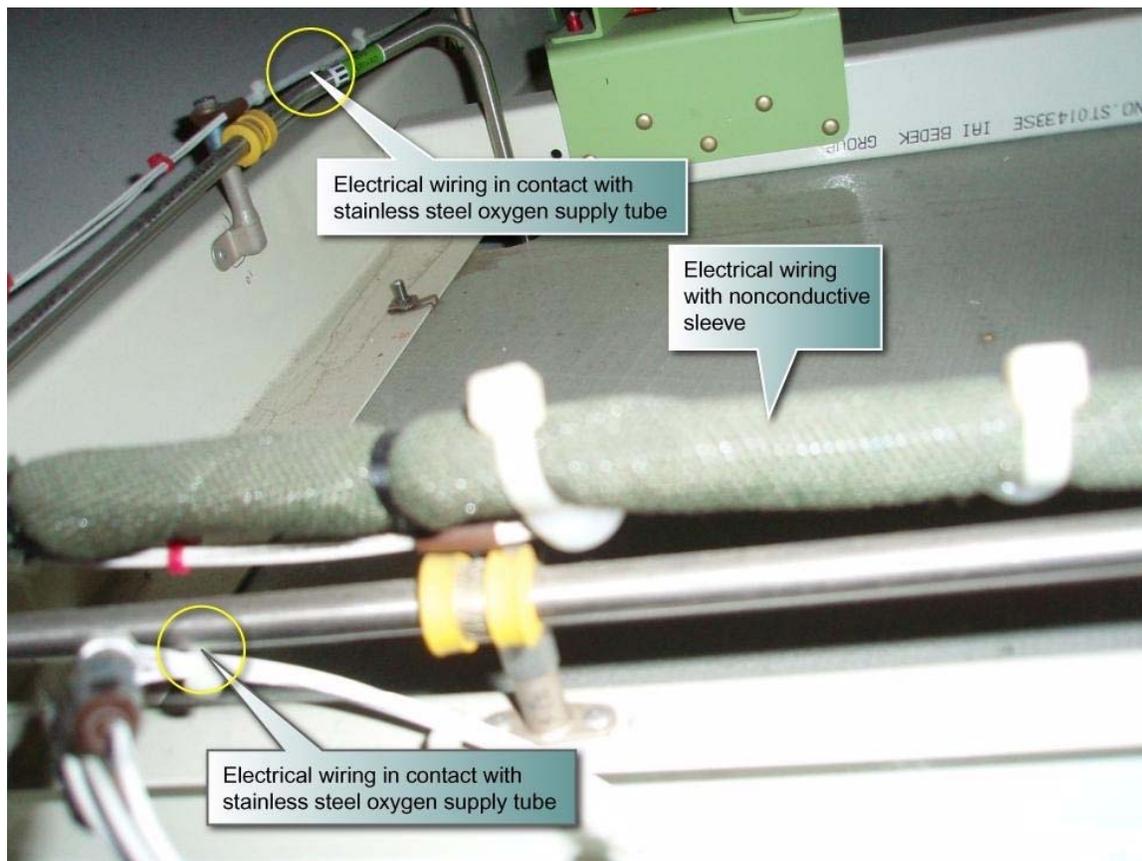
**Figure 5.** Proximity of Electrical Wiring to Oxygen System Tubing

During the inspections of other ABX Air 767 airplanes, electrical wiring was found in contact with or routed near the stainless steel oxygen supply tubing, as shown in figure 5. A short circuit from this close-contact wiring would be the most likely source to provide electrical energy to the spring. No direct evidence of a short circuit (that is, no beading on wires or arc marks on the oxygen supply tubing) was found, but most of the wiring near the supply tubing and portions of the tubing were missing.

Boeing guidance stated that oxygen installations should include a minimum of 2 inches between oxygen lines (that is, hoses and tubing) and electrical wiring. The guidance also advised securing the wiring so that it could not reach oxygen lines and installing the wiring beneath oxygen lines in case the wiring sagged over time. During postaccident inspections of other ABX Air 767 airplanes that were modified by IAI, some installations were found to have electrical wiring in proximity to the stainless steel oxygen supply tubing. Other installations (both in the cockpit and supernumerary compartment) were found to have electrical wiring that was routed above and in direct contact with the oxygen tubing, even though the supplemental type certificate provided for positive separation. This routing created the potential for electrical short circuits to reach the flexible oxygen hoses. (Figure 5 in section 2.1 shows electrical wiring in contact with the supply tubing located just above the ceiling in the supernumerary compartment.) The investigation of the fire aboard the accident airplane found that a short circuit from electrical wiring was the most likely source to energize the coil spring inside a supernumerary oxygen system hose, causing the hose material to ignite.

The energy in a short circuit could perforate the rigid stainless steel supply tubing and become an ignition energy source or allow oxygen to reach other fuel and ignition sources. The NTSB concludes that protecting oxygen system tubing from inadvertent short circuits is important because of the proximity between the tubing and electrical wiring in a compressed area as well as the potential severity of a fire involving oxygen. Because the general wire routing guidelines in AC 43.13-1A and AC 65-15 were advisory only and specific installations can deviate from airplane manufacturer wiring guidance, the NTSB recommends that the FAA require airplane manufacturers, modifiers, and maintenance personnel to provide positive separation between electrical wiring and oxygen system tubing according to, at a minimum, the guidance in AC 43.13-1A and AC 65-15. The NTSB further recommends that the FAA require airplane manufacturers and operators to ensure that oxygen system tubing in proximity to electrical wiring is made of, sleeved with, or coated with nonconductive material or that the tubing is otherwise physically isolated from potential electrical sources.
