Loss of Control and Crash  
Marlin Air  
Cessna Citation 550, N550BP  
Milwaukee, Wisconsin  
June 4, 2007

NTSB/AAR-09/06  
PB2009-910406

# Aircraft Accident Report

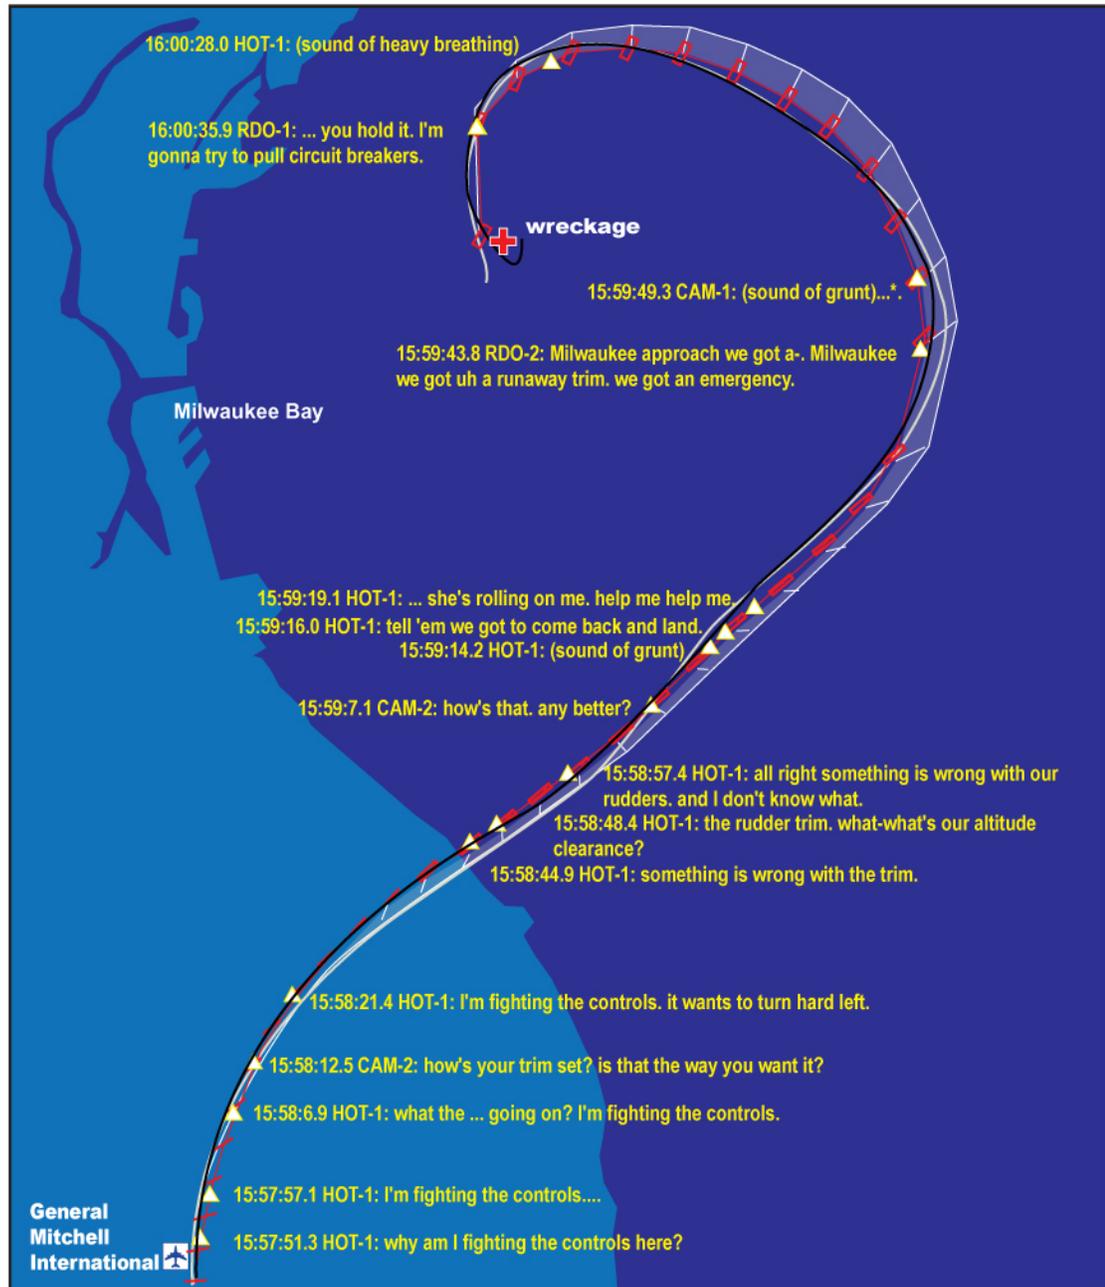
The fragmented airplane wreckage was recovered from Lake Michigan during multiple dives. Physical evidence indicated that the airplane impacted Lake Michigan at a speed of about 243 knots, in a steep (about 42°) nose-down, left-wing-low attitude. Figure 1 shows the accident airplane’s ground track, based on radar data, from liftoff to impact, with selected CVR quotes shown.

**Figure 1.** The accident airplane's ground track from liftoff to impact, based on radar data. Selected CVR excerpts are shown. (Figure not to scale.)

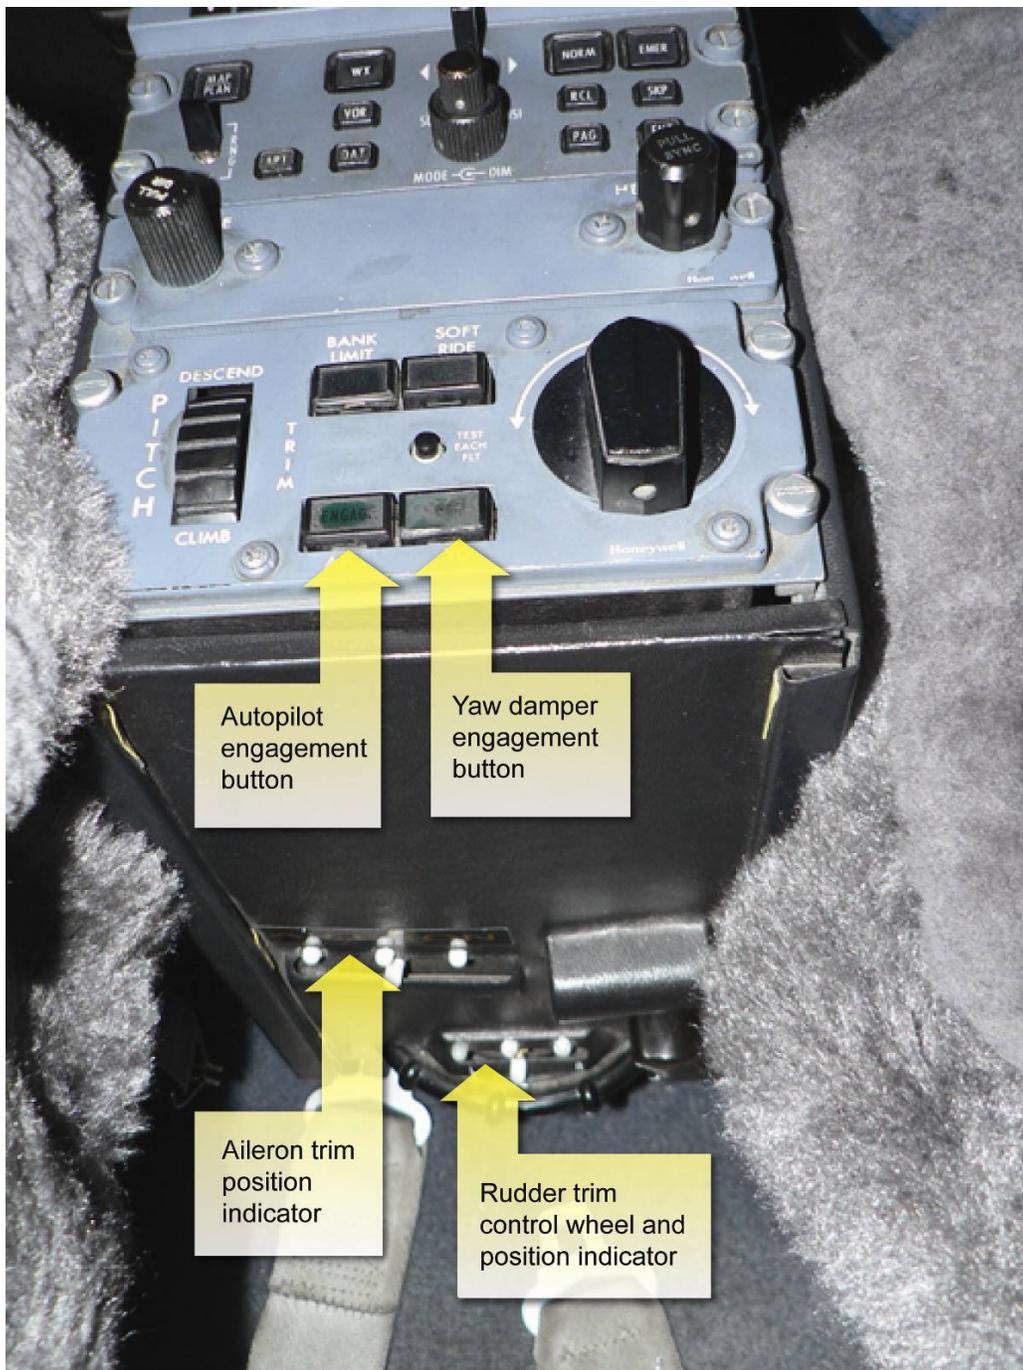
**Figure 5.** Photograph showing a closer view of the autopilot control panel at the aft end of the center console's upper surface, between the pilots' seats.

Examination of the light bulbs that were in the recovered autopilot control panel from the throttle console revealed that the filament light bulb associated with the TRIM UP status light had stretched filaments that were partially wrapped around the support post within the bulb. This stretched filament indicated that the autopilot control panel (and the autopilot computer, which provided power to the autopilot control panel) was powered and functioning at impact.<sup>42</sup> However, the autopilot pilot engaged light bulb filaments were not stretched; this bulb was tested and found functional after the accident. Examination of the yaw damper engaged bulb filaments revealed that they were more stretched than the AP ENGAGE status bulb filaments.

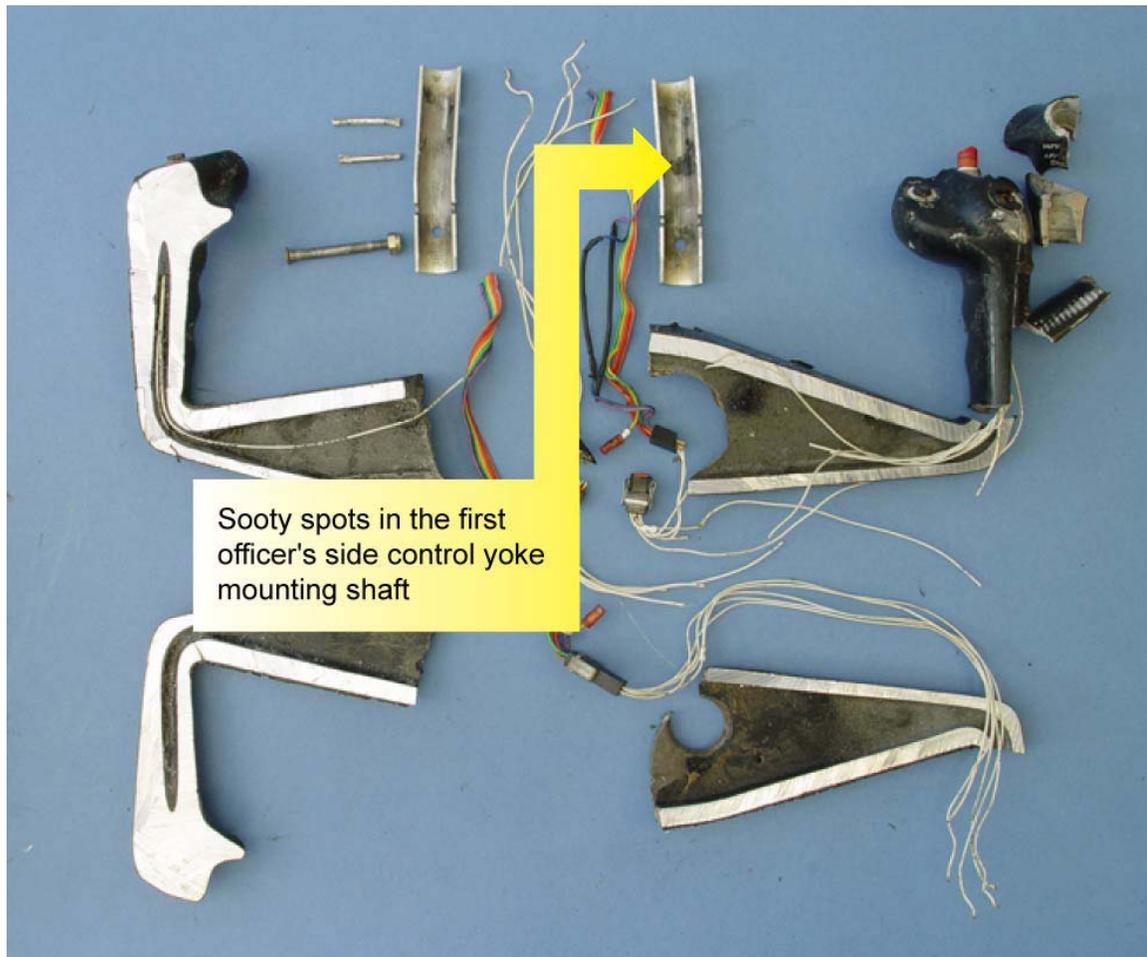
**Figure 6.** Photograph of the sections of the first officer's control yoke and mounting shaft with associated wiring.

the motor, the other to a ground path for the motor. Wreckage examination also showed that, sometime before the accident, at least two short circuits occurred in a bundle of wires in the first officer's control yoke/column. Investigators also found evidence of heat damage consistent with the short circuits and found chafing on some unrelated wires in this area.<sup>44</sup> One of the short circuits occurred between the pitch trim power supply wire and the adjacent steel surface of the first officer's control yoke shaft;<sup>45</sup> the recovered wires were chafed around the area where the exposed wire had become welded to the steel of the control shaft. In addition, a possible ground path was found in the pitch trim microswitch assembly from the first officer's control yokes. Although one of the normally-fixed contacts was found bent toward the center reed and the switch appeared to be closed when visually inspected, after rinsing silt from the switch, electrical tests found no continuity.

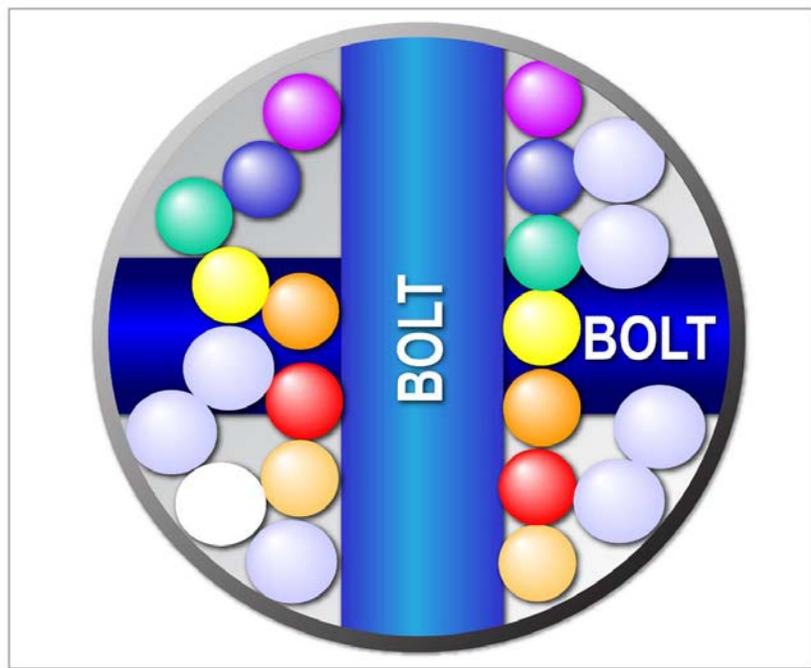
Investigators recovered wires from both control yokes/columns. Examination of the wires revealed some wires that were enclosed in sleeves where repairs had previously been accomplished and several instances of damaged, chafed, or punctured wire insulation. Damage was observed on individual wires, as well as wires contained in flat ribbon cable bundles that were 0.38-inches wide and 0.07-inches thick. Two such ribbon cables were routed through each of the control yoke mounting shafts, along with individual wires. In addition, two mounting bolts passed through the control yoke mounting shaft at its widest point, restricting the available space in that part of the shaft to less than the 0.38-inch dimension of the ribbon wire, creating at least four potential chafe locations. (Figure 7 is an illustration of the wiring and bolts in the control yoke mounting shaft.)

**Figure 7.** Illustration of the wiring and bolts in the control yoke mounting shaft. (Figure not to scale.)

Postaccident examination also revealed some individual wires that had been folded back among the wires and pressed into the shafts, apparently when they were reinstalled after

maintenance. (Anecdotal information indicates that such wiring installations in control shafts are common.) Other recovered wires were found stretched and severed at the ends of the shafts. The observed wiring installations were inconsistent with the wiring practices described in FAA Advisory Circular (AC) 43.13-1B and -2A.

After the right side control yoke and shaft were bisected, detailed examination revealed several areas of damaged wiring and that remnants of copper wire had adhered to the interior of the steel yoke mounting shaft. For example, the pitch trim system power wire had an extensive area of exposed copper core that had previously melted and resolidified, with some missing copper strands, signs of a mechanical imprint, and a kink that was not observed in other wires from that area. This portion of the pitch trim system power wire was found near an area of copper deposits, similar in shape and appearance, that had adhered to the inner wall of the steel mounting shaft. Additionally, wires adjacent to this portion of the pitch trim system power wire exhibited extensive insulation damage.
