Runway Overrun During Rejected Takeoff  
Global Exec Aviation  
Bombardier Learjet 60, N999LJ  
Columbia, South Carolina  
September 19, 2008

NTSB/AAR-10/02  
PB2010-910402

# Aircraft Accident Report

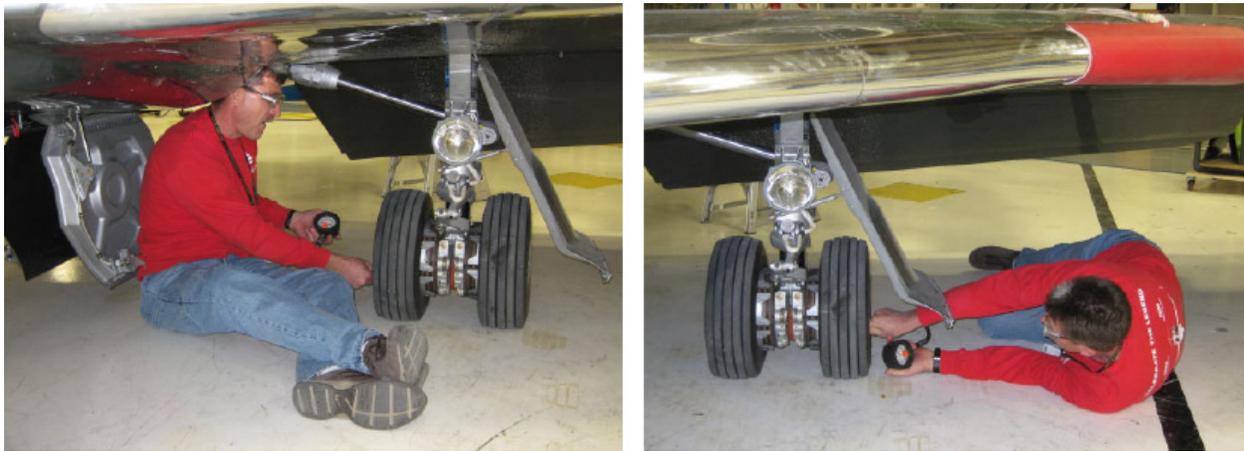
As shown in figure 1 below, to check tire pressures on the Learjet 60, the person performing the check must crouch or crawl under the wing of the airplane to gain access to the MLG tire pressure valves. The landing gear doors may conceal the valves for the outboard tires, requiring a person to lie on the ground to gain access.

**Figure 1.** Learjet factory technician checking inboard tire pressure (left image) and outboard tire pressure (right image).

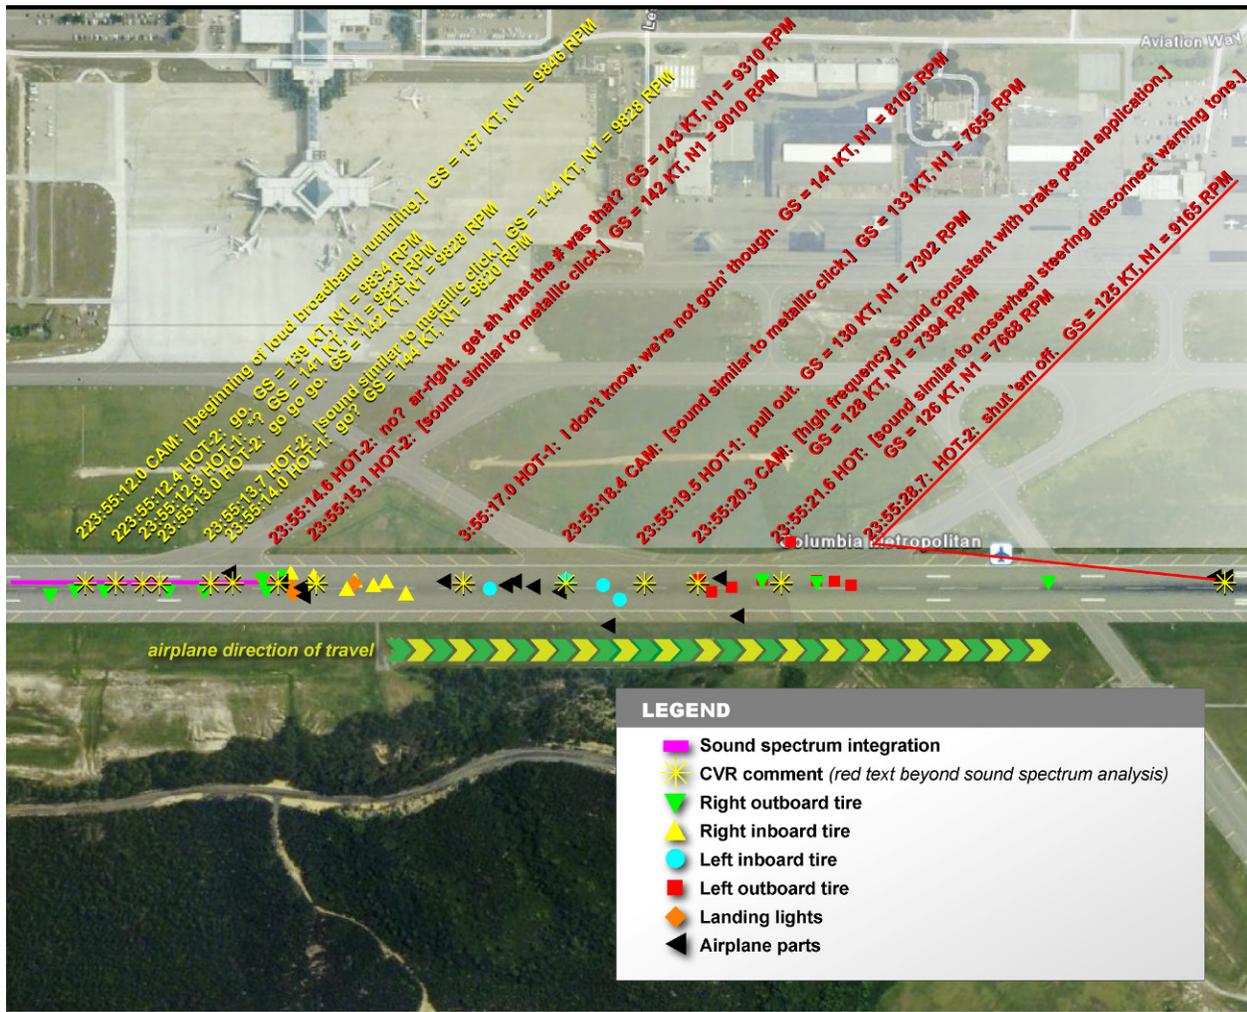
**Figure 6.** Map of Columbia Metropolitan Airport showing integrated sound spectrum data, cockpit voice recorder comments, and wreckage locations plotted.

The sound spectrum study speed analysis ends at 2355:14 (when sound signatures are no longer clearly discernible); information derived from the integration of that portion of the sound spectrum is shown in pink. CVR comments, engine N<sub>1</sub>, and ground speed from the same timeframe are shown in yellow text. For the purpose of positioning the remaining CVR comments in the approximate locations where they occurred, the airplane performance study further extrapolated the airplane's ground speed to 2255:31 through a visual examination of the sound spectrum illustration. This extrapolated information is shown in red text. Wreckage and tire debris found on the runway are also shown as marked.

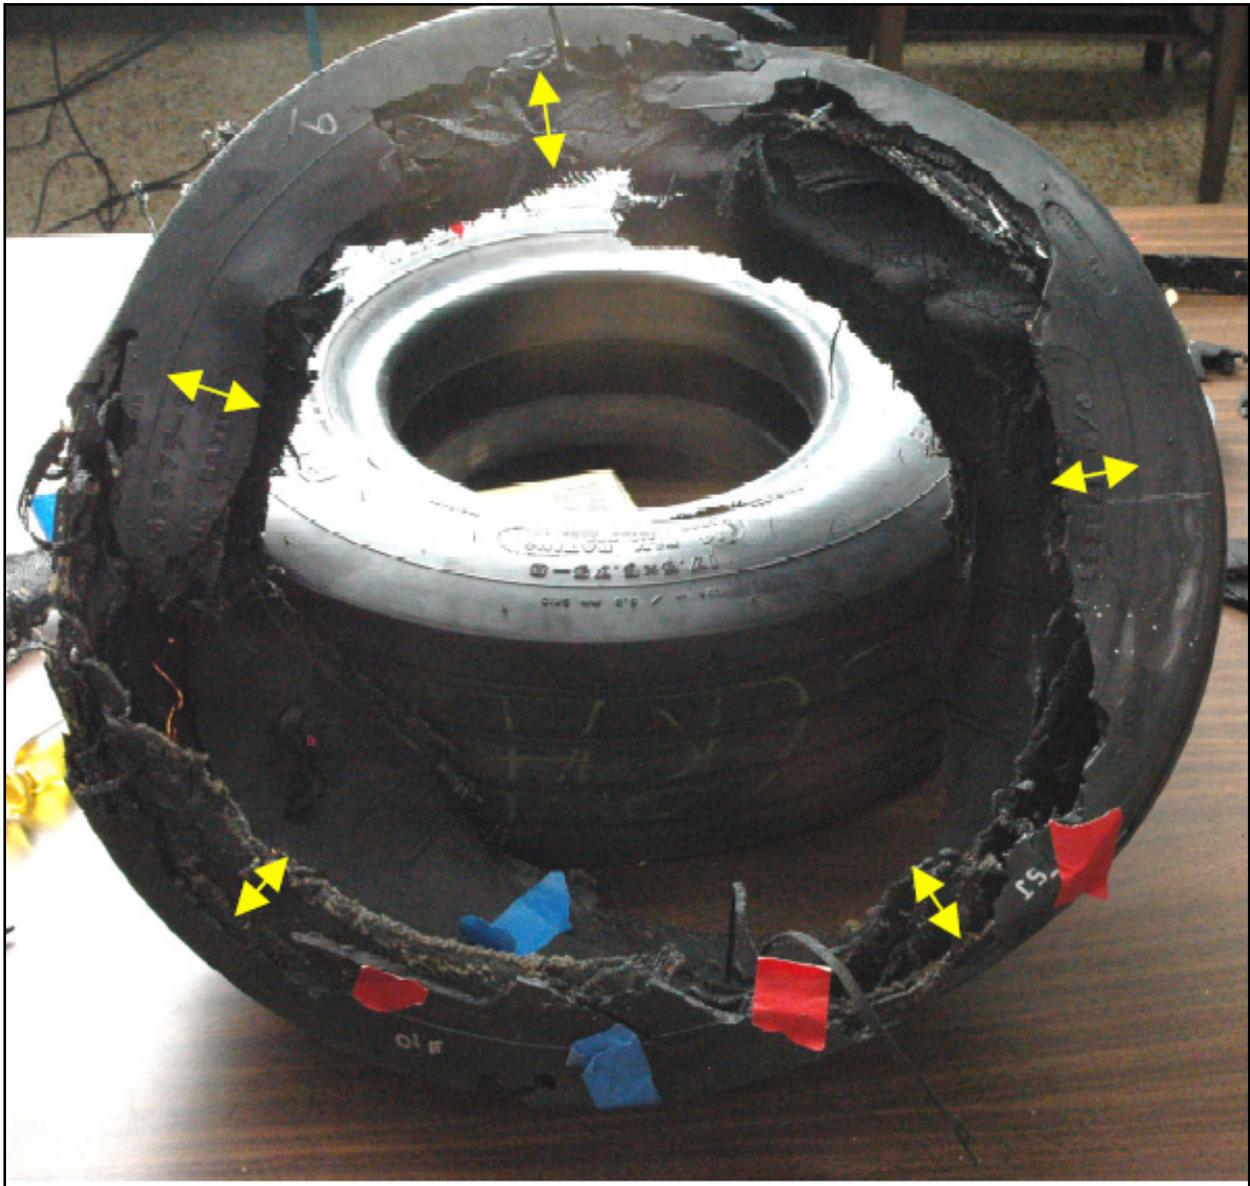
Pieces of the right outboard tire, which were the first debris found on the runway, were identified as fragments of the tire's sidewall. About 80 percent of the tire was reconstructed. Both sidewalls showed damage around the entire circumference of the tire; the damage had a ragged appearance and was located at a generally uniform distance from the wheel rim, as shown in figure 7 on the following page.

**Figure 7.** Reconstruction of the right outboard main landing gear tire showing outboard sidewall damage. Arrows depict the generally uniform location of the damage.

The characteristics of the sidewall damage observed on all four of the accident airplane's tires were consistent with a photograph in a Goodyear publication showing typical heat damage sustained from sidewall overdeflection and flexing fatigue.<sup>38</sup> Goodyear engineers and the Goodyear publication noted that previous tire testing found that aircraft tire sidewall damage from flexing fatigue is predominantly consistent with taxi-cycle operations while the tire is

Because either underinflation or overloading can result in tire sidewall overdeflection, tire testing data for both scenarios were reviewed. According to estimated static load deflection charts created during the investigation for the accident tires, the amount of underinflation needed for a loaded tire to produce the type of overdeflection damage observed on the accident airplane's tires (specifically, the damage location on the sidewall) would be about 36-percent underinflation. Alternatively, testing data showed that the amount of overload needed for a properly inflated tire to produce the amount of overdeflection consistent with the sidewall damage observed on each of the accident airplane's tires would be about 12,200 pounds.

Other damage observed on fragments from each of the accident airplane's tires included blue to purple heat discoloration indicative of moderate to severe heat damage. According to the Goodyear publication, blue tinting appears at temperatures from 210° to 230° F. Microscopic examination of fragments from all four tires revealed that the tires' nylon fibers (which are generally soft and fabric-like when undamaged) had melted and resolidified into single strands that had a stiffness resembling that of broom bristles. The Goodyear publication noted that the melting point of nylon is greater than 400° F. Rubber reverts to an uncured state and loses strength and adhesion at temperatures from 280° to 320° F, then becomes hard and dry at temperatures from 355° to 390° F.

Fragments from all four tires showed abrasion and rub marks on the inner liner and heat damage to the rubber and nylon fibrous cord materials. Goodyear engineering personnel and investigators experienced in tire failure examinations noted that, although heat and rolling distance could affect the start of wrinkling, they were not aware of wrinkling or liner damage ever occurring in aircraft tires that had been properly inflated.

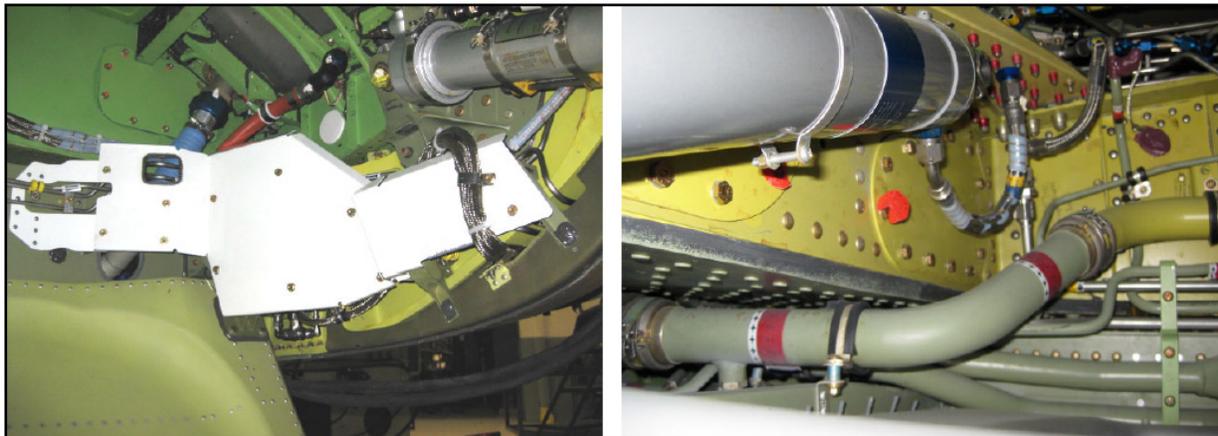
With the exception of the Learjet 45, the MLG is similar throughout the series of Learjet airplane models and is based on similarities to the initial 1960s models that had been certificated before more stringent regulatory requirements existed. Components in the wheel wells of the Learjet 45 have protective plating and revised routing that provide more protection. Differences in the Learjet 45's and the Learjet 60's protection of system components in the MLG well, for which 14 CFR 25.1309 applies, are illustrated in figure 8 below, which shows protection in the inboard aft corner of the MLG wheel well for each airplane. Notable is the white shield that protects the Learjet 45's hydraulic and electrical system components, whereas components in the Learjet 60 are more exposed.

**Figure 8.** Inboard aft corner of the left main landing gear wheel well for the Learjet 45 (left) and the inboard after corner of the right main landing gear wheel well for the Learjet 60 (right).
