Aircraft Accident Report
Crash During Takeoff of Carson Helicopters, Inc.
Firefighting Helicopter Under Contract to the
U.S. Forest Service
Sikorsky S-61N, N612AZ
Near Weaverville, California
August 5, 2008

NTSB/AAR-10/06
PB2010-910406

Crash During Takeoff of Carson Helicopters, Inc.,
Firefighting Helicopter Under Contract to
the U.S. Forest Service
Sikorsky S-61N, N612AZ
Near Weaverville, California
August 5, 2008

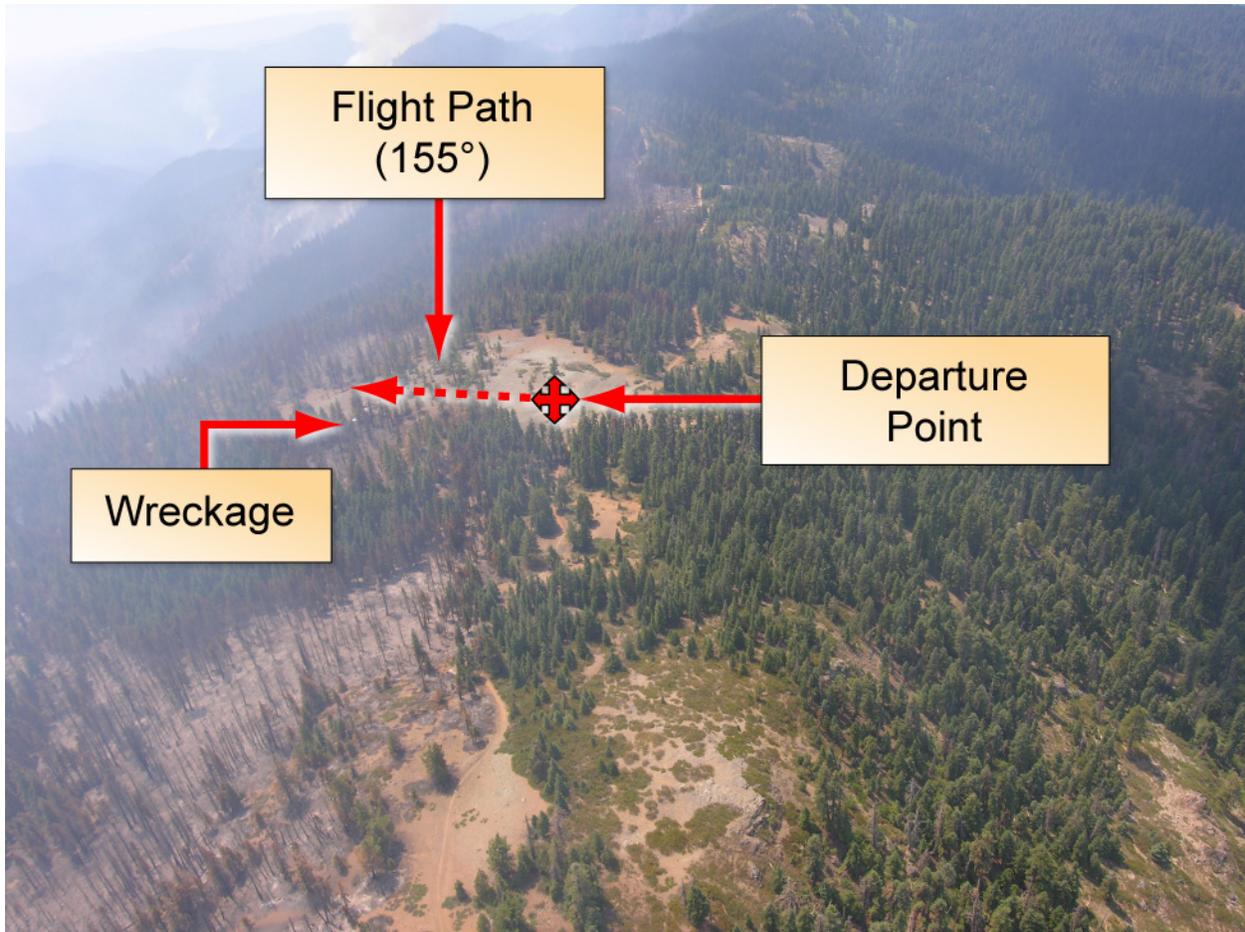
The helicopter collided with the trees and subsequently impacted the down sloping terrain, coming to rest on its left side. (See figure 2 for an aerial view of H-44 and N612AZ's departure path.) Almost immediately after the impact, witnesses saw smoke and fire coming from the wreckage. One witness reported that both engines continued to run for about 30 seconds after the helicopter impacted the ground.

Figure 2. Aerial photograph of H-44. Red dashed arrow shows approximate departure path of helicopter.

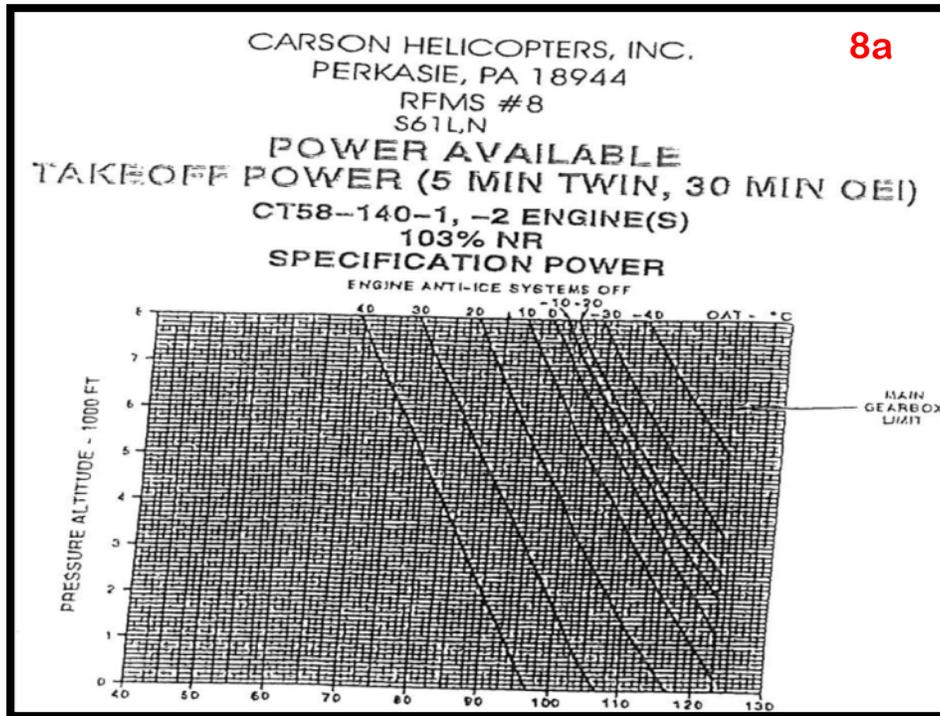
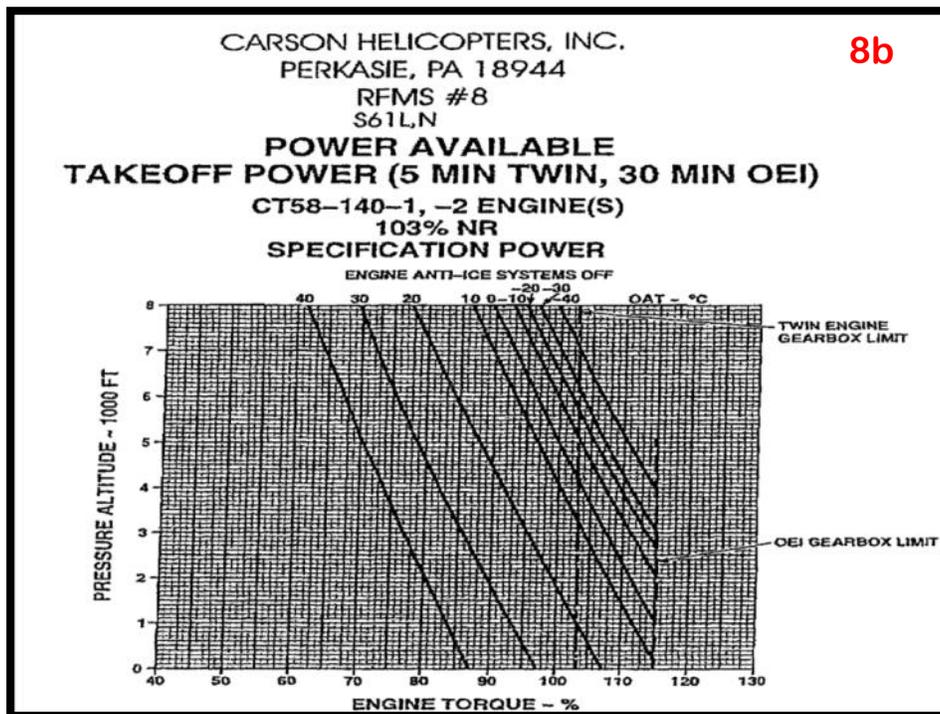
During its review of the CHSI-provided copy of RFMS #8 contained in the Trinity helibase binder for the helicopter, NTSB investigators noted that figure 4 was slightly askew on the page and had less crisp, distinct lines than the other charts in the RFMS (see figure 8a). Investigators also noted that the figure’s graphical section had only a single reference line for the main gearbox limit, whereas this type of chart would typically include two reference lines: one each for the twin engine and OEI gearbox limits. NTSB investigators compared the graphical section of RFMS #8 Figure 4 with that of other figures in RFMS #8 and found that it appeared to be identical to the graphical section of RFMS #8 Figure 1, Power Available, 2.5 Minute Power, 100 percent N_R . No difference existed in the torque values given by the two graphical sections.

For example, at 6,000 feet PA and 32° C, the torque value from both figures was 82.5 percent. Typically, for a given PA and temperature, the torque value from a takeoff power available chart, commonly referred to as 5-minute power, would be less than the torque value from a 2.5-minute power available chart.

Figure 8. Figures from RFMS #8: a) CHSI-provided Figure 4 and b) FAA-provided Figure 4.

A copy of RFMS #8 was obtained from the FAA's New York Aircraft Certification Office (ACO) that had approved RFMS #8. The FAA-provided RFMS #8 Figure 4 looked identical in format to the CHSI-provided RFMS #8 Figure 4, with the same text at the top and bottom of the figures, and both figures were date-stamped as FAA-approved on February 7, 2008. The notable difference was that the graphical sections were not the same. The graphical section of the FAA-provided chart had crisp, distinct lines and two reference lines: one each for the twin engine and OEI gearbox limits (see figure 8b). The torque value from the FAA-provided figure at 6,000 feet PA and 32° C was 73 percent.

The altered RFMS #8 Figure 4 chart was distributed as an attachment to a July 7, 2008, email from the CHSI chief pilot to all of the company's pilots, including the accident pilots. The email's subject line read "New load Calc info" and stated, in part, to "take out the 5 min power 103%, page 15 of 19 in your aircraft's RFM hoist supplement and replace it with the new 5 min power chart in this email, both are dated 7 Feb 2008."

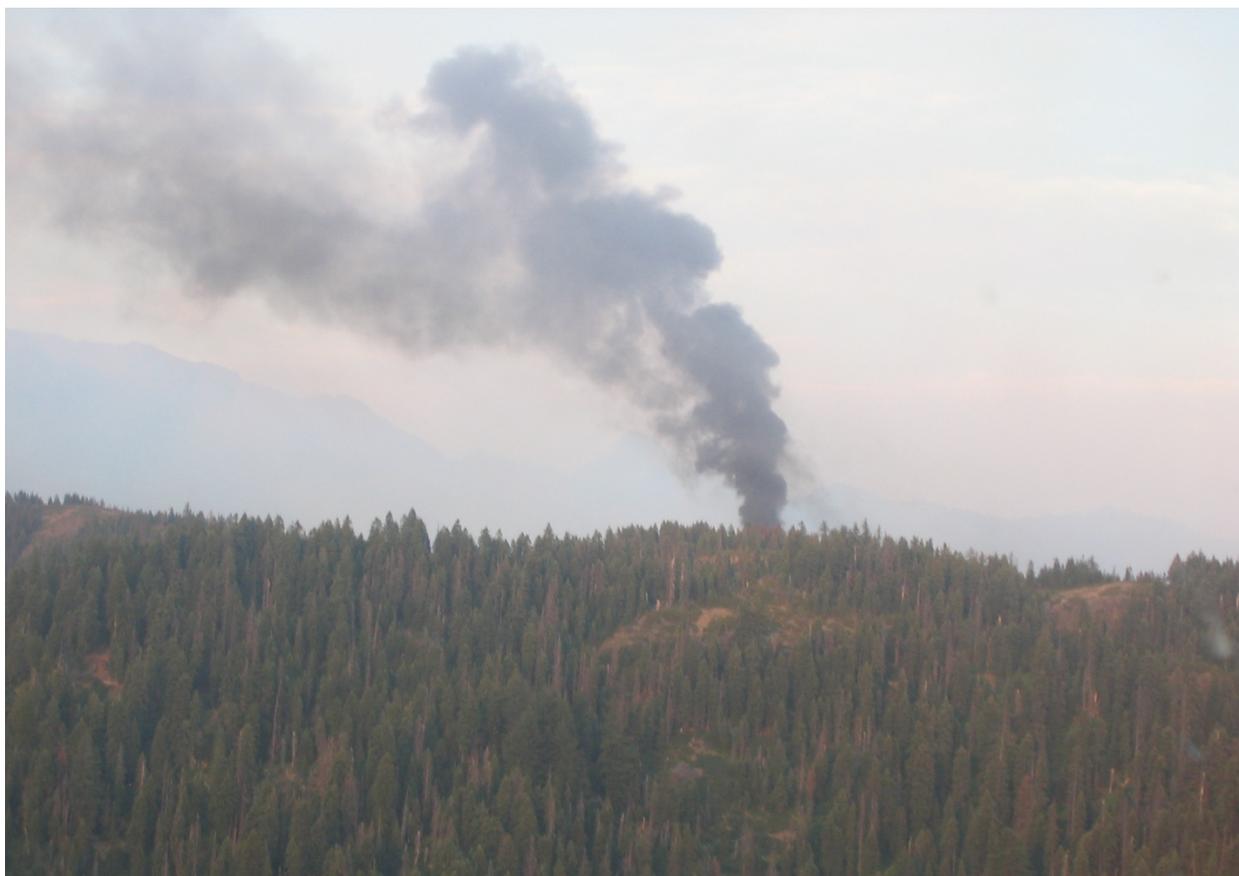
A passenger in a helicopter that arrived over the accident site about 5 minutes after the accident reported that the smoke from the postcrash fire rose vertically for about 400 to 500 feet before it began drifting to the northwest. Photographs taken by the passenger show a nearly vertical smoke plume at low levels that gradually began to dissipate downwind to the north (see figure 9).

Carson Helicopters does not agree with the NTSB’s estimate of the temperature and winds (23° C and calm) at the time of the accident takeoff and takes the position that the temperature and wind observations recorded by the CVR (20° C and southerly winds at 3 to 5 kts) accurately represent the conditions at the time of the accident takeoff.

Figure 9. Photograph of smoke plume at the accident site taken about 1946.

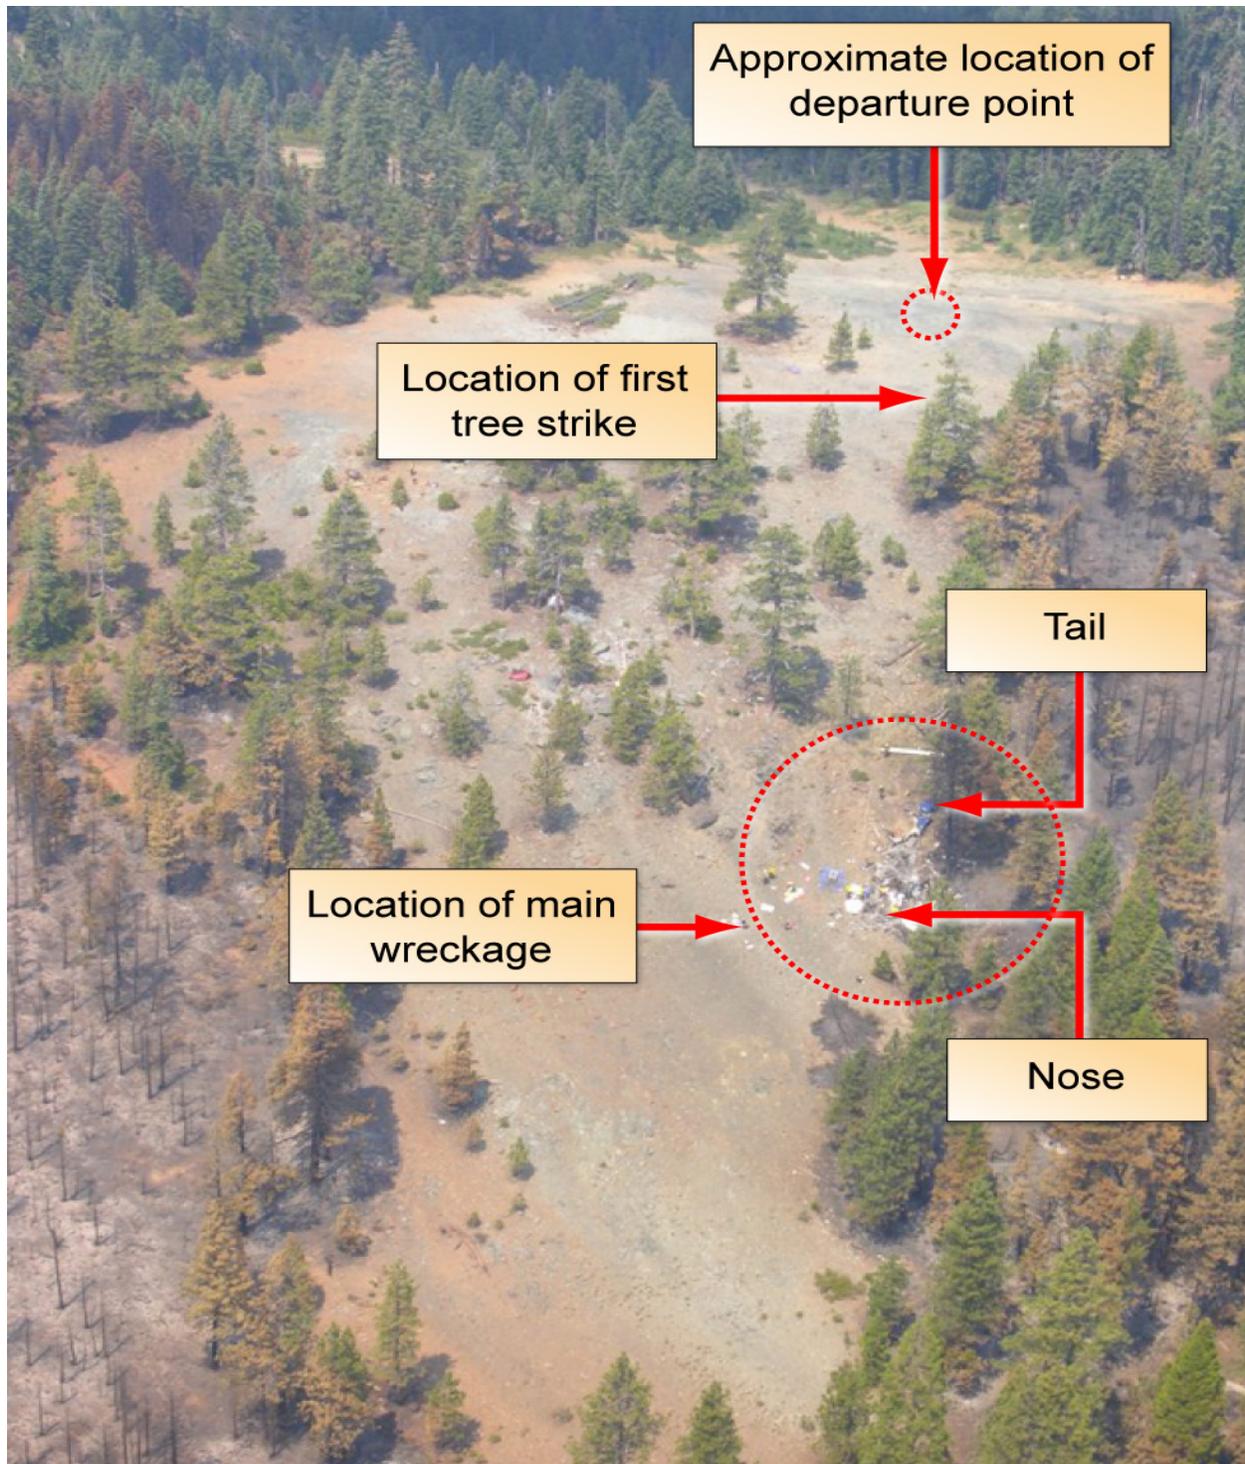
Figure 10. Aerial photograph of accident site.

An assessment of the surrounding trees revealed evidence of main rotor blades contacting several trees between the departure point and the main wreckage. Of these trees, the one closest to the departure point was a pine tree located about 65 yards south-southeast of the departure point. The ground elevation of the tree was 5,931.6 feet, and the height from the base of the tree

to the blade contact point was about 49.5 feet. To inspect the blade contact point, the tree was cut down. Examination showed that the tip of a retreating⁶⁵ main rotor blade contacted the tree, consistent with the fuselage being to the right of the tree at the time of contact.

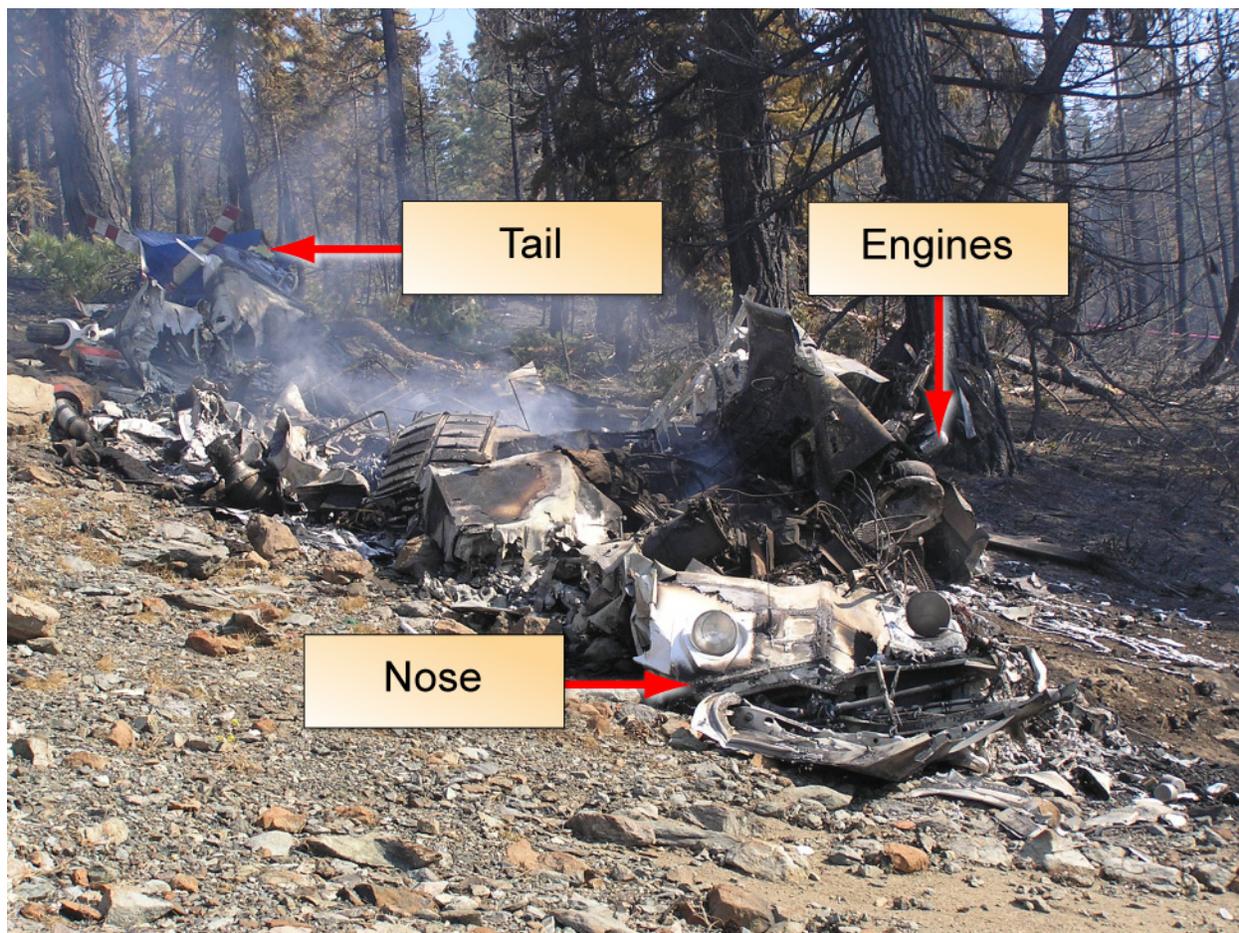
The helicopter was found on a downward slope of about 15° to 20°; it was resting on its left side with its nose down slope from its tail boom. The magnetic heading of the wreckage was about 155°. A postcrash fire had consumed most of the helicopter's airframe and structure forward of the tail boom. Solidified molten metal was noted in several areas of the wreckage and in the impact area. Sections of the helicopter's lower fuselage structure, including all fuel tank cells and the cabin flooring, were consumed by the postcrash fire. Most of the forward fuselage, including the cockpit and the electronics compartment, was inverted and consumed by fire (see figure 11).

Figure 11. Photograph of main wreckage.

Fragmented sections of all five main rotor blades were located in the immediate area around the main wreckage of the helicopter. A visual assessment of the main rotor blades revealed that all damage was consistent with multiple leading edge impacts with trees.

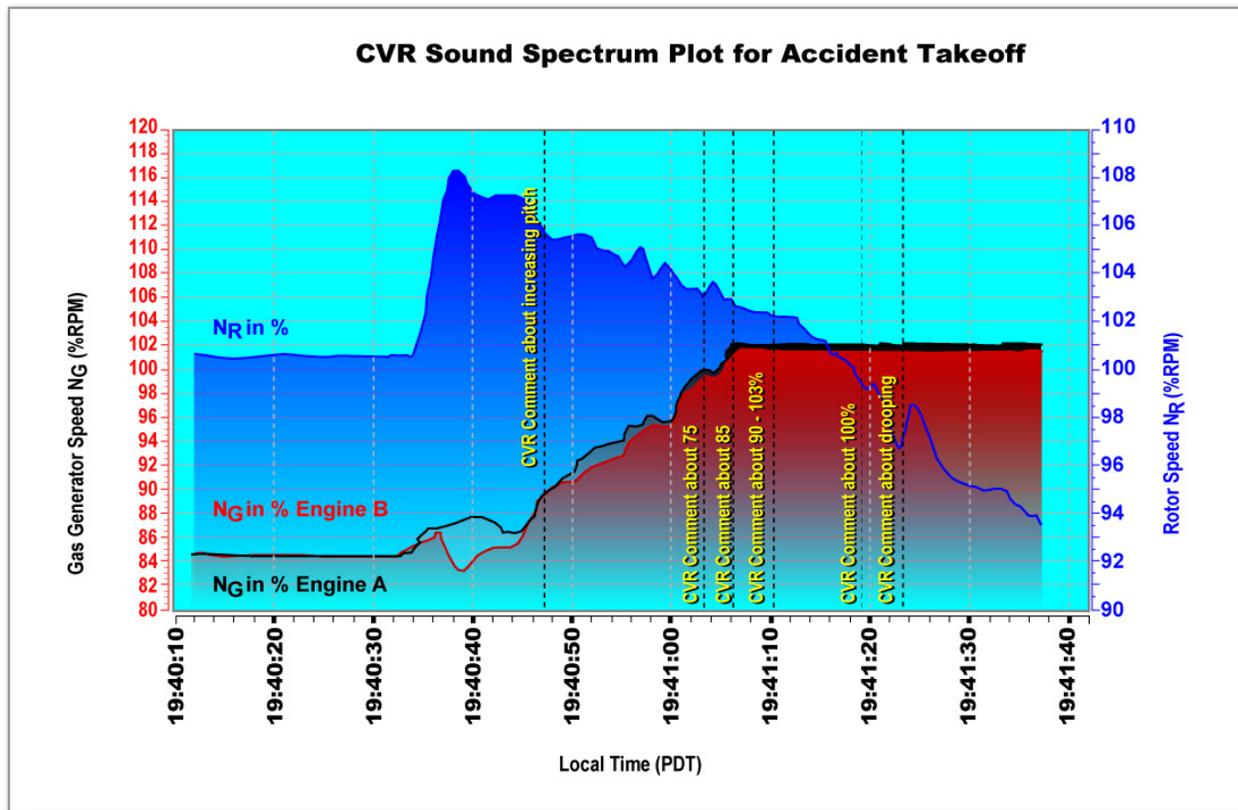
Figure 13. Plot of N_G and N_R versus time for accident takeoff.

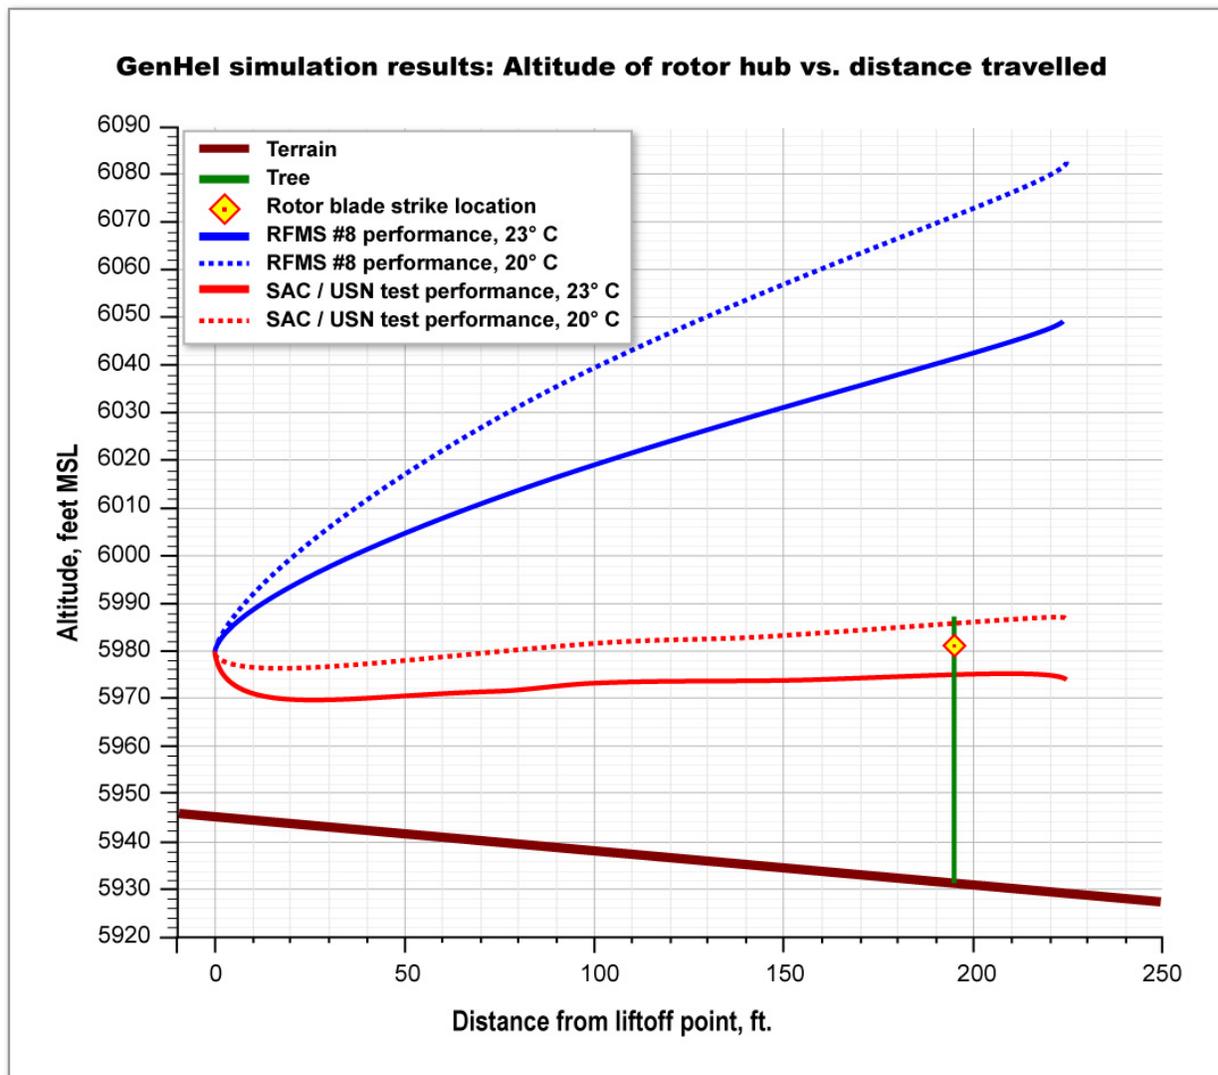
All simulations were performed using a helicopter gross weight of 19,008 lbs and no headwind. The results of the simulations are shown in figure 14.

Figure 14. GenHel simulation plots. In all the simulations, the helicopter is assumed to lift off and HIGE at a wheel height of about 20 ft before accelerating forward toward the tree.
