Crash During Attempted Go-Around After Landing  
East Coast Jets Flight 81  
Hawker Beechcraft Corporation 125-800A, N818MV  
Owatonna, Minnesota  
July 31, 2008

NTSB/AAR-11/01  
PB2011-910401

# Aircraft Accident Report

**Abstract:** This accident report discusses the July 31, 2008, accident involving East Coast Jets flight 81, a Hawker Beechcraft Corporation 125-800A, N818MV, which crashed while attempting to go around after landing on runway 30 at Owatonna Degner Regional Airport, Owatonna, Minnesota. The two pilots and six passengers were killed, and the airplane was destroyed by impact forces. The nonscheduled, domestic passenger flight was operating under the provisions of 14 *Code of Federal Regulations* (CFR) Part 135. An instrument flight rules flight plan had been filed and activated; however, it was canceled before the landing. Visual meteorological conditions prevailed at the time of the accident. The safety issues discussed in this report relate to flight crew actions; lack of standard operating procedures requirements for 14 CFR Part 135 operators, including crew resource management training and checklist usage; go-around guidance for turbine-powered aircraft; Part

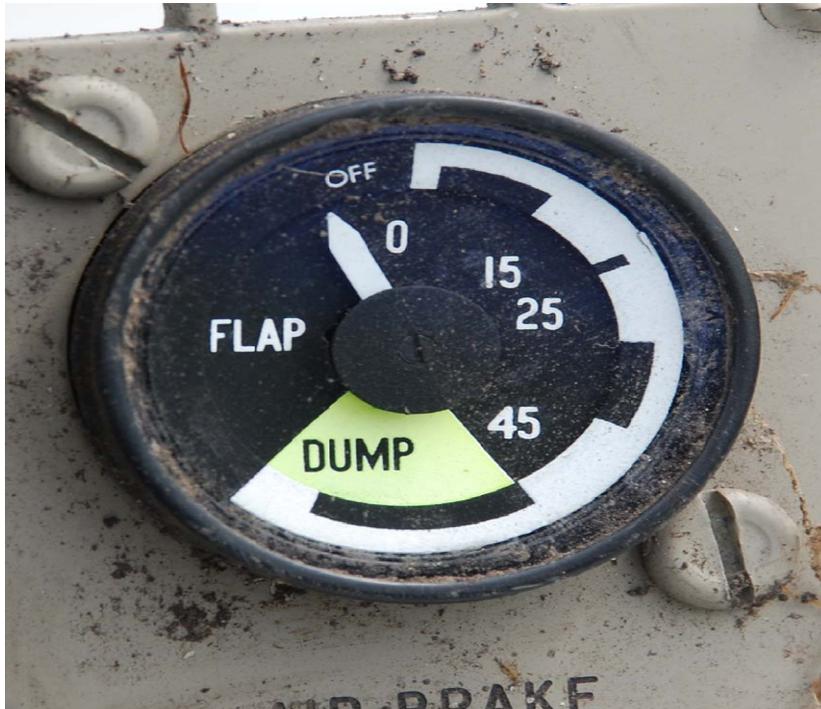
**Figure 2.** Photograph showing the accident airplane's mechanical flaps indicator.

Postaccident examination of the flaps indicated that they were fully retracted (that is, set at 0°). The two flap cables were found intact to a point near the structural separation damage, and both cables were broken at this point. The breaks exhibited a splayed appearance. The pedestal exhibited impact damage, and the airbrake handle could not fully deploy to and lock in the DUMP position, but the flap handle could move through its entire range. The FCU was found in its normal position in the aft fuselage, and all hydraulic connections to the FCU remained intact. The FCU was removed and sent to APPH Houston Inc., Houston, Texas, for testing under NTSB supervision. The unit was functionally tested and operated normally throughout the normal and lift-dump ranges and was within specifications for a newly overhauled unit.

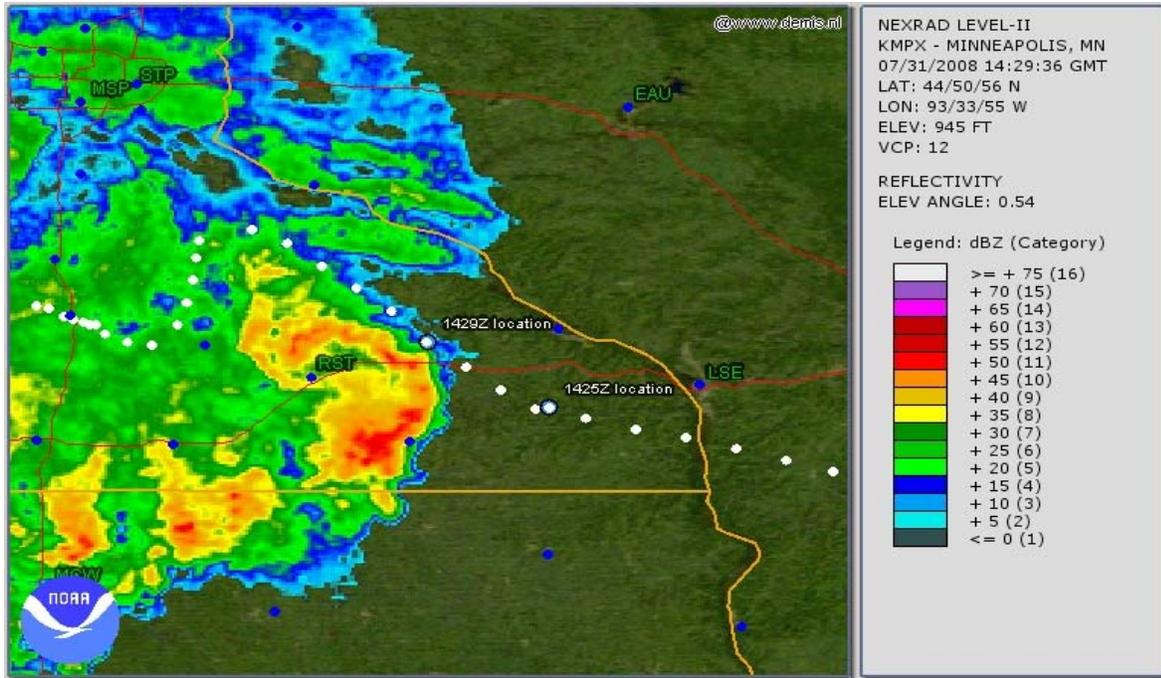
**Figure 3.** The flight track of the accident airplane overlaid on the 0929 base reflectivity data.

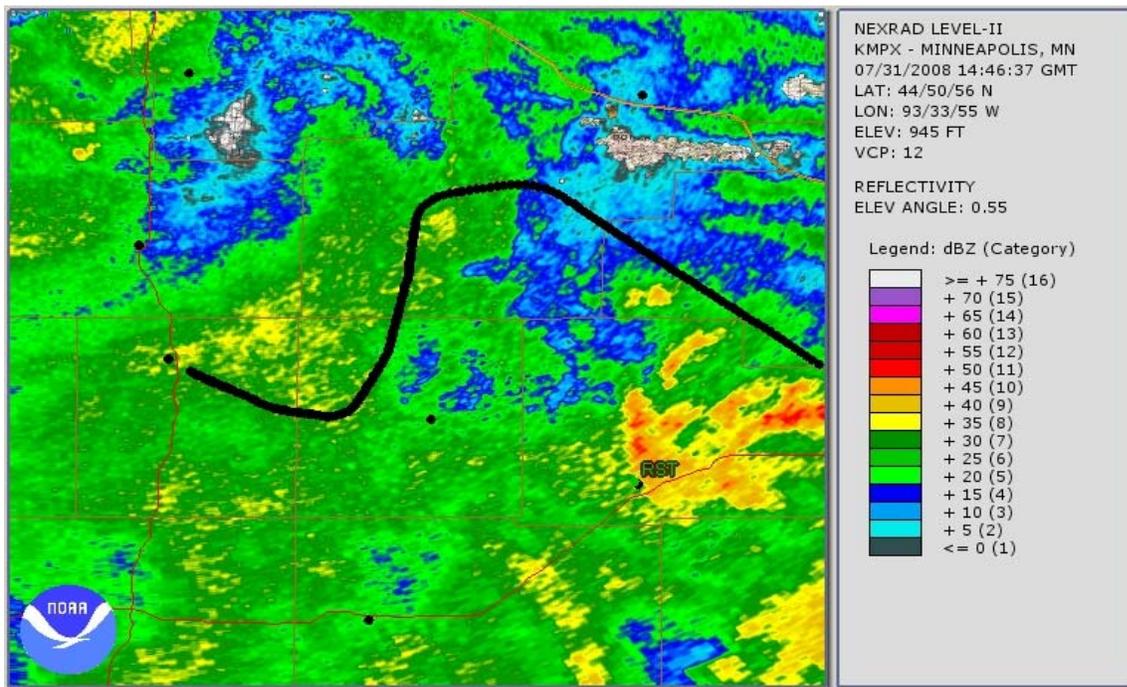
**Figure 4.** The flight track of the accident airplane overlaid on the 0946 base reflectivity data.

The WSR-88D base velocity data for the same period also showed a band of strong westerly winds behind the intense leading edge associated with the bow echo with maximum winds of 65 knots. The NWS Local Analysis and Prediction System upper air sounding (that is, a vertical profile of atmospheric conditions) for 0930 indicated calm surface winds, winds at

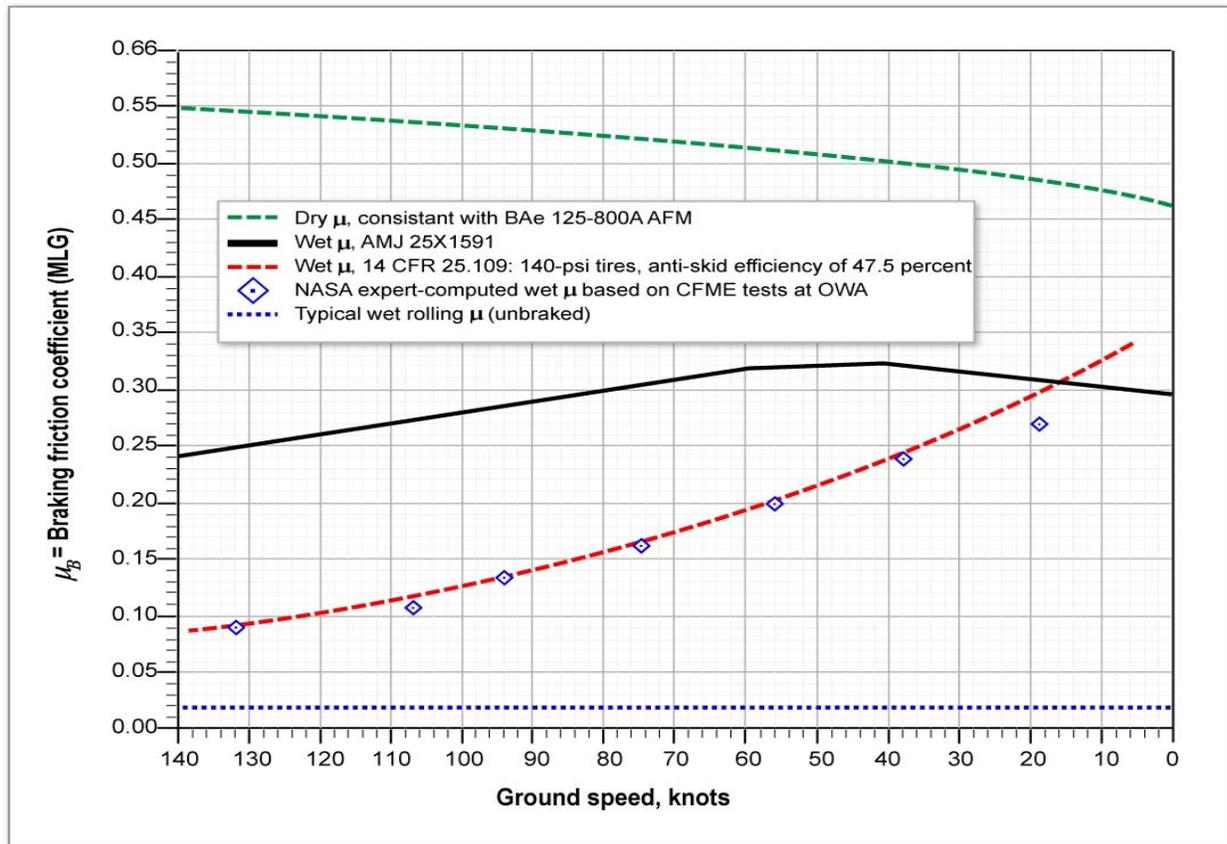
**Figure 5.** Comparison of calculated wet, ungrooved runway MLG effective braking friction coefficient values as a function of ground speed using the BAe 125-800A AFM, NASA CFME-based, and 14 CFR 25.109 methods. BAe 125-800A AFM dry runway and unbraked rolling friction coefficient values are shown for reference.
