Collision with Terrain  
Promech Air, Inc.  
de Havilland DHC-3, N270PA  
Ketchikan, Alaska  
June 25, 2015

NTSB/AAR-17/02  
PB2017-102178

# Aircraft Accident Report

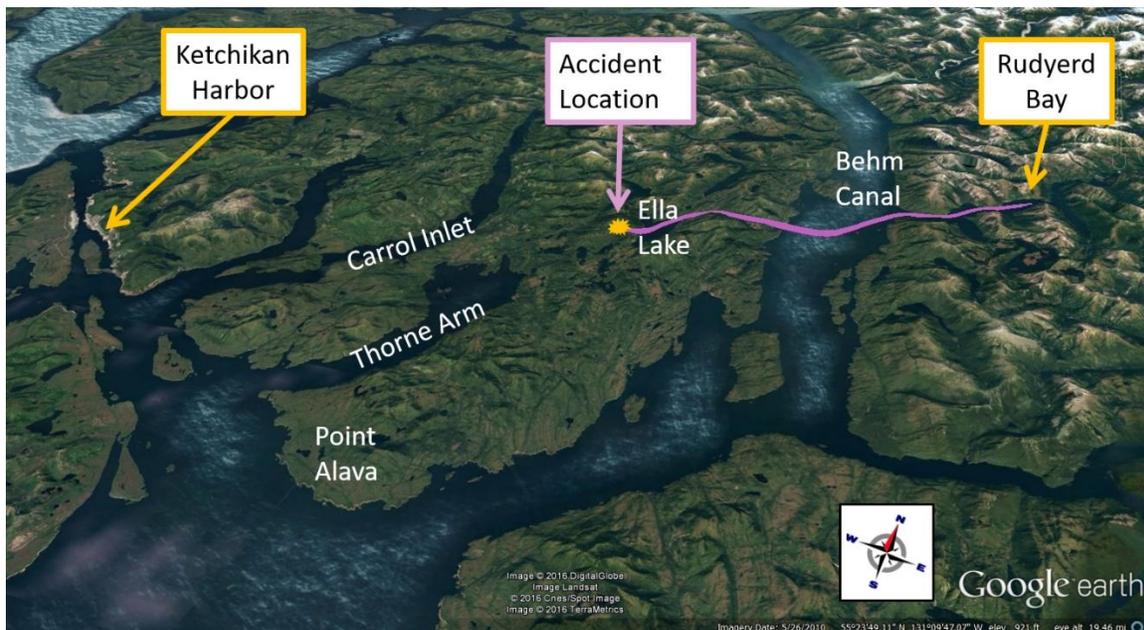
the wreckage about 1429 (see figure 2). Ketchikan Volunteer Rescue Squad (KVRS) team members reached the accident site later that afternoon and confirmed that there were no survivors.

**Figure 2.** Map showing the accident flightpath and wreckage location.

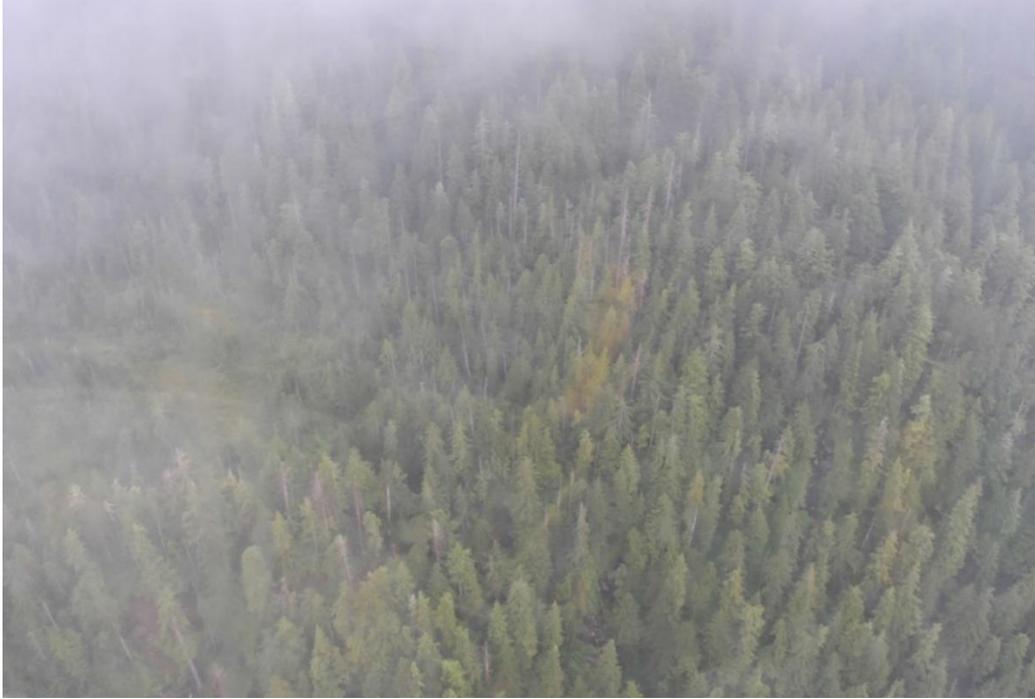
**Figure 3.** Downward-looking photograph showing evergreen trees and visibility that is partially obstructed by thin cloud cover.

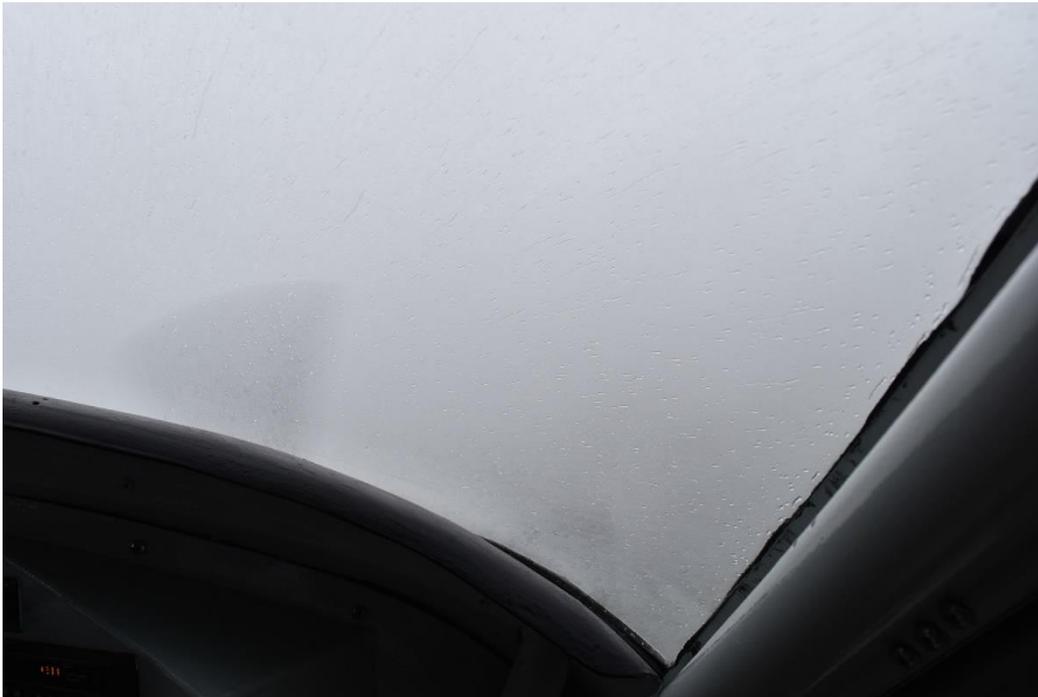
**Figure 4.** Forward-looking photograph through part of right cockpit windscreen. Rain on the windscreen and the propeller arc are visible. The lower right portion of windscreen shows a darker area, similar to mostly obscured terrain.

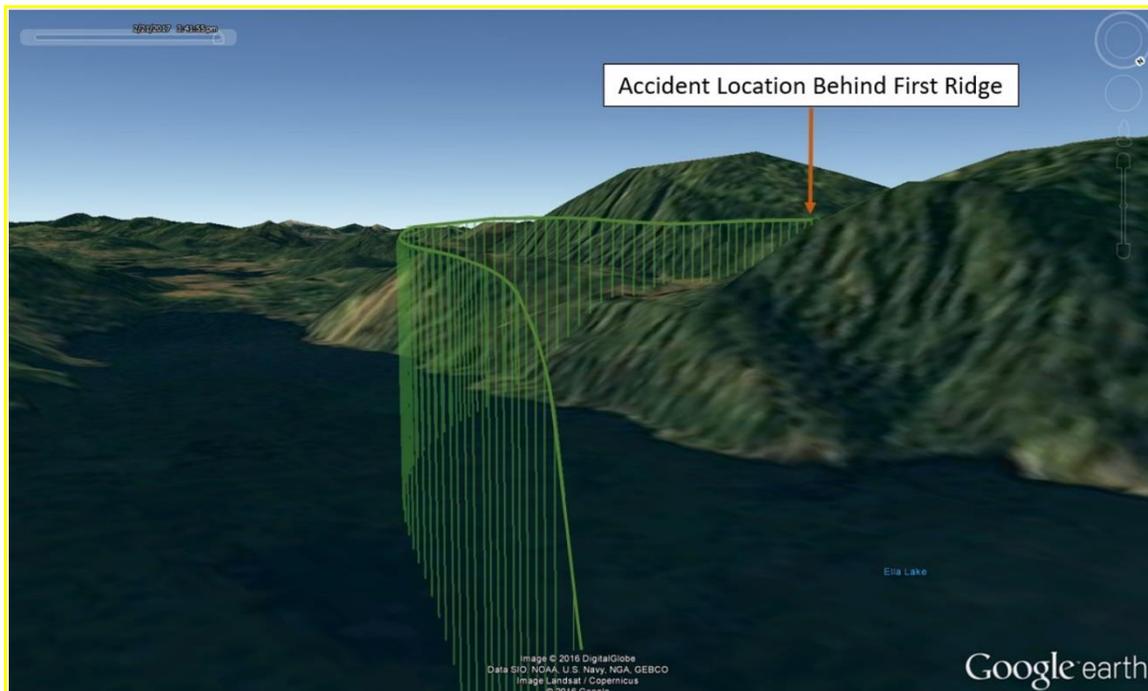
After crossing the ridge, the airplane continued on a relatively constant heading between 1,400 ft and 1,500 ft msl for about 30 seconds. Data from the Chelton EFIS showed that, about 2 seconds before the collision, the airplane began to pitch up rapidly, experiencing about +2 Gs of vertical acceleration and climbing before it collided with terrain.<sup>9</sup> The airplane struck the terrain at an elevation of about 1,600 ft msl. The accident flight's west turn over the lake differed from the standard route, which would have continued past the high terrain before turning west (see figure 5).

**Figure 5.** The path flown by the accident airplane (green), viewed from the approximate altitude of the accident airplane, is shown turning to the west (right) toward high terrain.

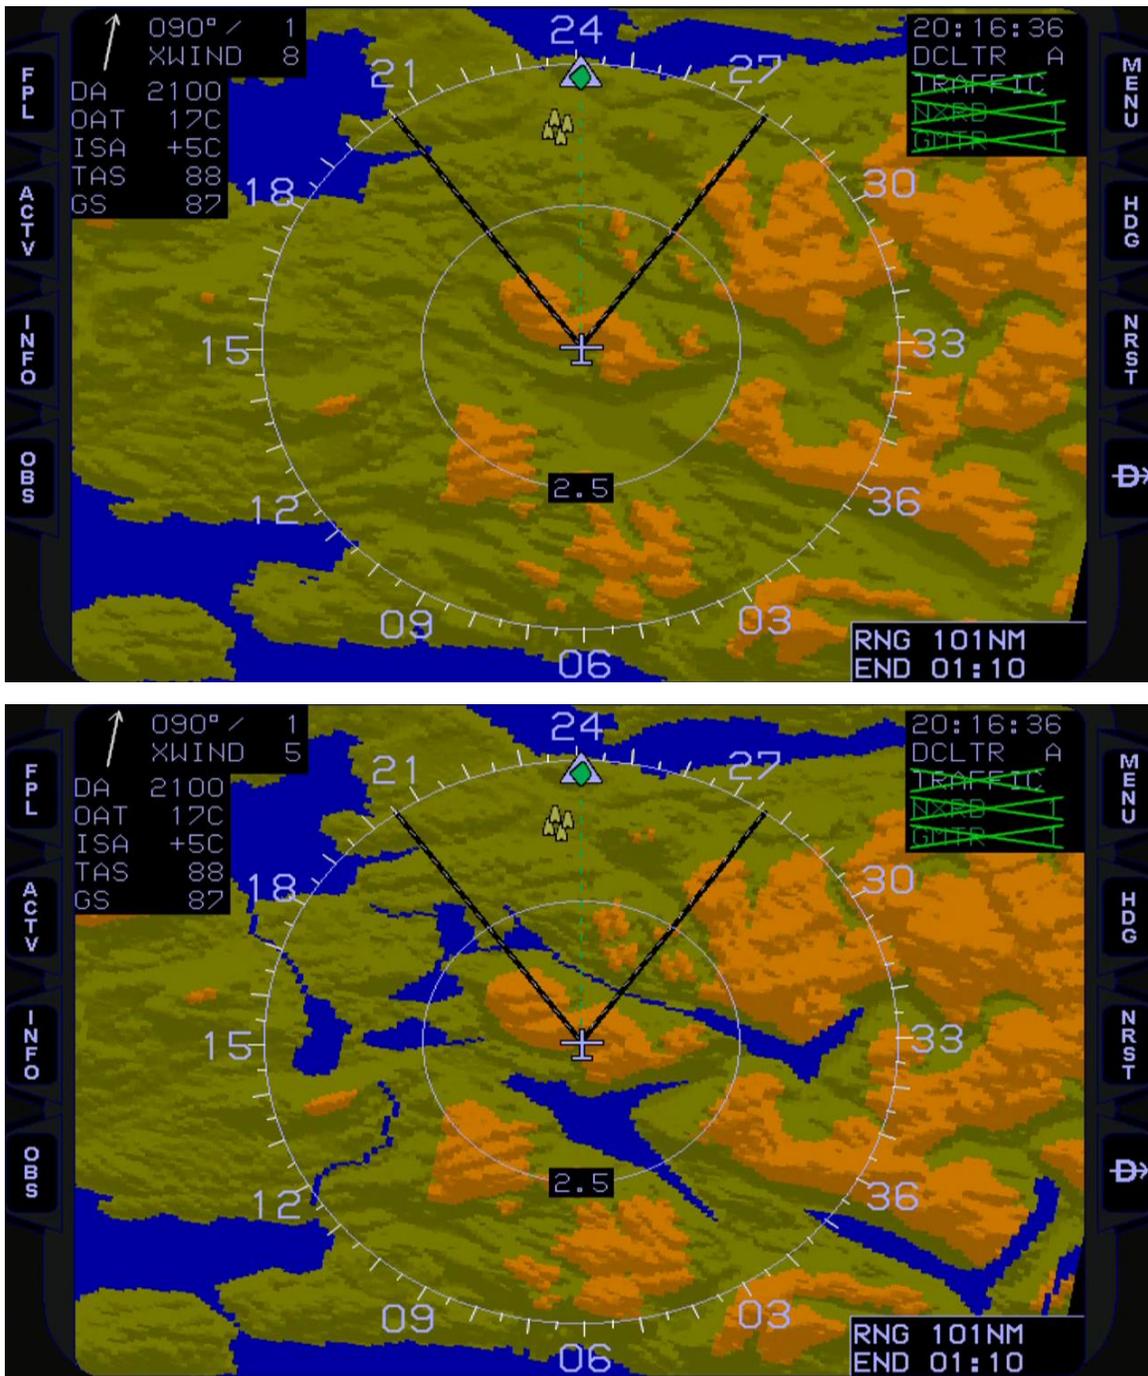
NTSB investigators reviewed a simulation of the MFD terrain moving map using data from the accident flight and noted that the moving map depiction of terrain did not use color-coding to differentiate between terrain and inland bodies of water. The database card recovered from the accident airplane's IDU was the original 2003 terrain database (a 2007 terrain database is the most current database update available for Chelton units). One pilot interviewed explained that one

database did not show bodies of water on the display, whereas another does. The original 2003 database does not distinguish inland bodies of water, but the 2007 database update displays them in blue. (See figure 7.)

**Figure 7.** The top image shows how the Chelton EFIS's original 2003 database depicts the Ella Lake area, and the bottom image shows how the 2007 database update depicts the same area. Note that, in the most current database, the inland bodies of water are shown in blue.

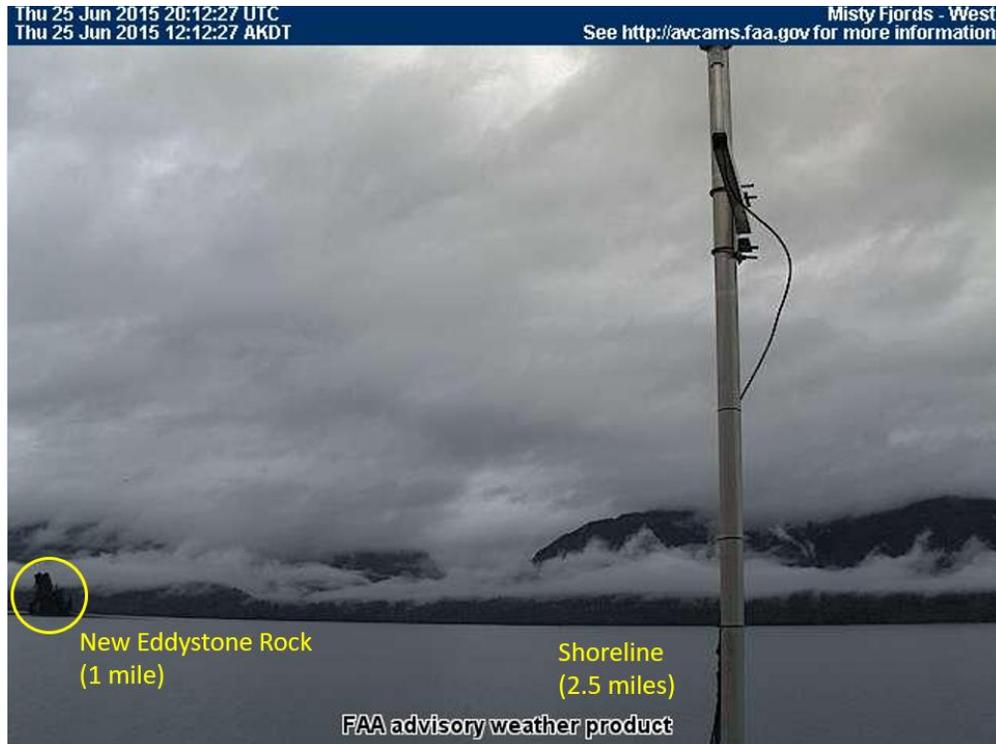
**Figure 11.** Image from west-facing (196°) Misty Fjords camera at 1212, about 3 minutes before the accident.

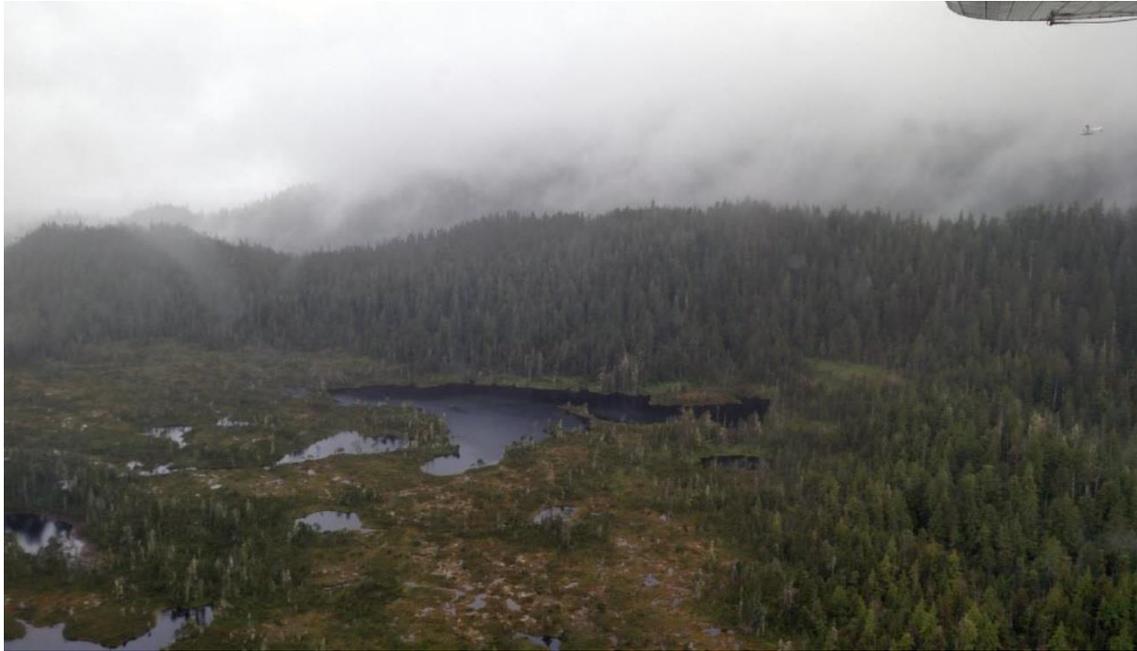
Digital photographs taken by a passenger on board this first Promech flight provided information about the weather conditions encountered when the airplane was about 0.5 nm south of Ella Lake. The most distant landmarks visible in the photographs are estimated to be about 1.5 nm away. Landmarks in the photographs provide a basis to estimate that the first Promech airplane transited this area about 300 to 400 ft agl. The southeast face of a large mountain is visible in the photographs and is completely obscured by clouds above about 1,000 ft msl, with some scattered clouds hanging down the mountainsides to lower elevations. This is the same mountain that the accident airplane subsequently struck about 1 nm to the north. A DHC-2 airplane operated by another tour company is visible in the upper right corner of the photograph. (See figure 14.)

**Figure 14.** Southwest-looking photograph taken about 0.3 nm south of Ella Lake and 1.3 nm south of the accident location by a passenger on board the first Promech airplane.

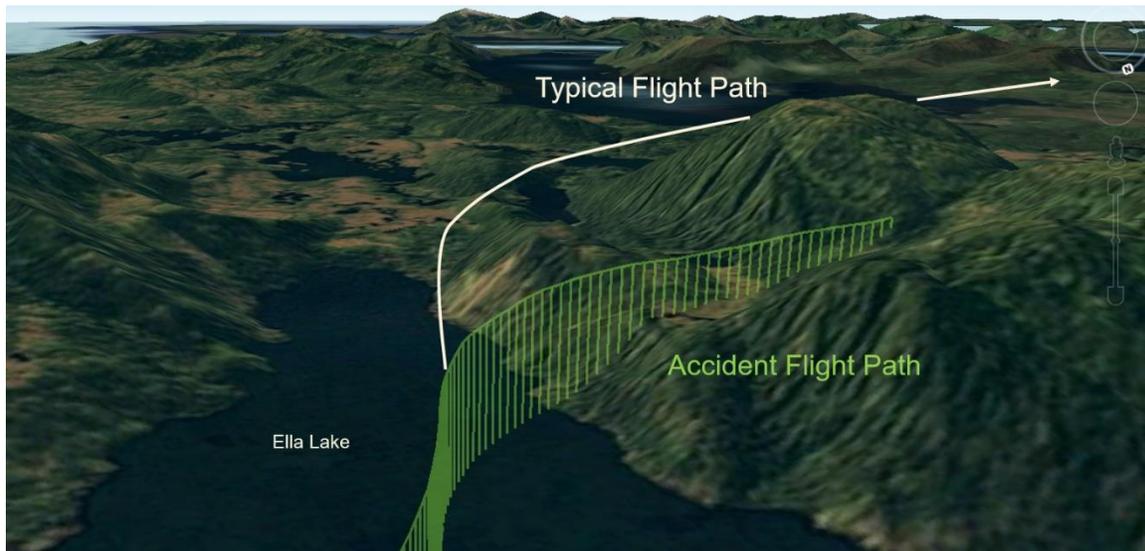
Despite the deteriorating weather conditions in the Ella Lake area, the two other Promech pilots on the short route (one who departed before the accident flight and one who departed after) successfully completed their trips. In reduced visibility weather conditions, Promech pilots typically fly southwest over Ella Lake and proceed beyond the south end of the lake before turning west. This route allows the flights to avoid the high terrain located west of the lake, which includes two similarly shaped mountains. (See figure 16.)

**Figure 16.** The typical flight route (white) passes two similarly shaped mountains before turning west. For comparison, the path flown by the accident pilot is shown in green.

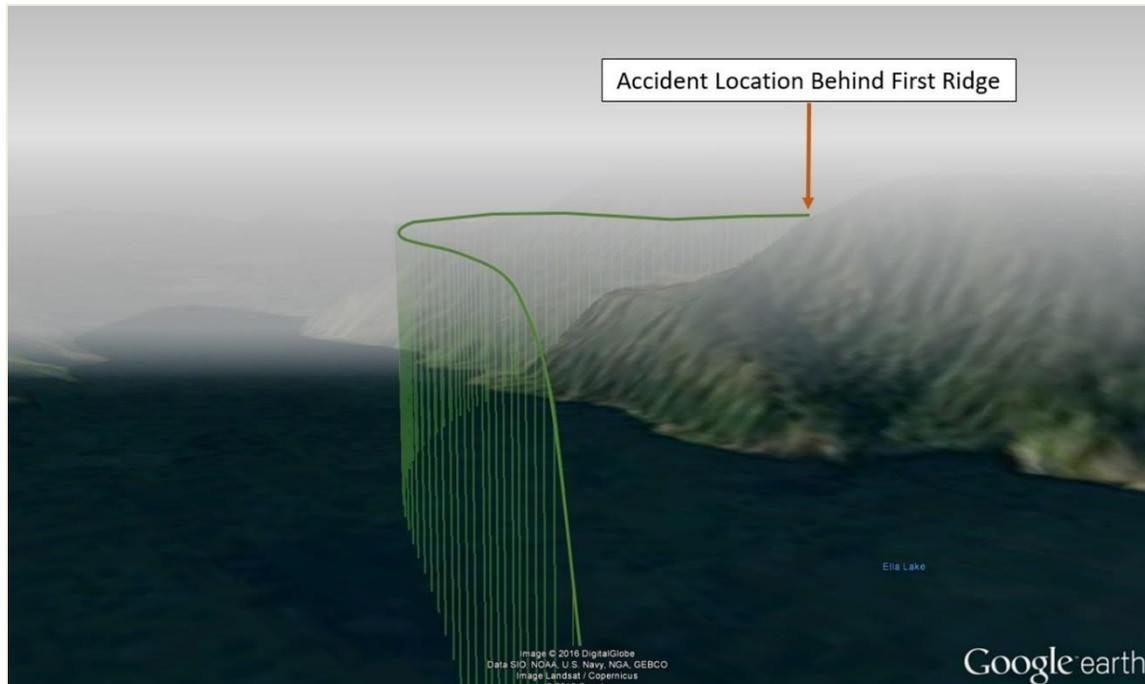
Although the accident pilot climbed the airplane to an altitude that would have provided safe terrain clearance along the typical route, he deviated from that route and turned the airplane west after it passed only the first of the two mountains. The pilot's route deviation placed the airplane on a collision course with the 1,900-ft second mountain, which it struck at an elevation of about 1,600 ft msl. (See figure 17.)

**Figure 17.** The path flown by the accident pilot (green), viewed from the approximate altitude of the accident airplane, is shown turning to the west (right) after passing the first mountain.
