Midair Collision over George Inlet
de Havilland DHC-2, N952DB,
and de Havilland DHC-3, N959PA
Ketchikan, Alaska
May 13, 2019

NTSB/AAR-21/04
PB2021-100915

Aircraft Accident Report

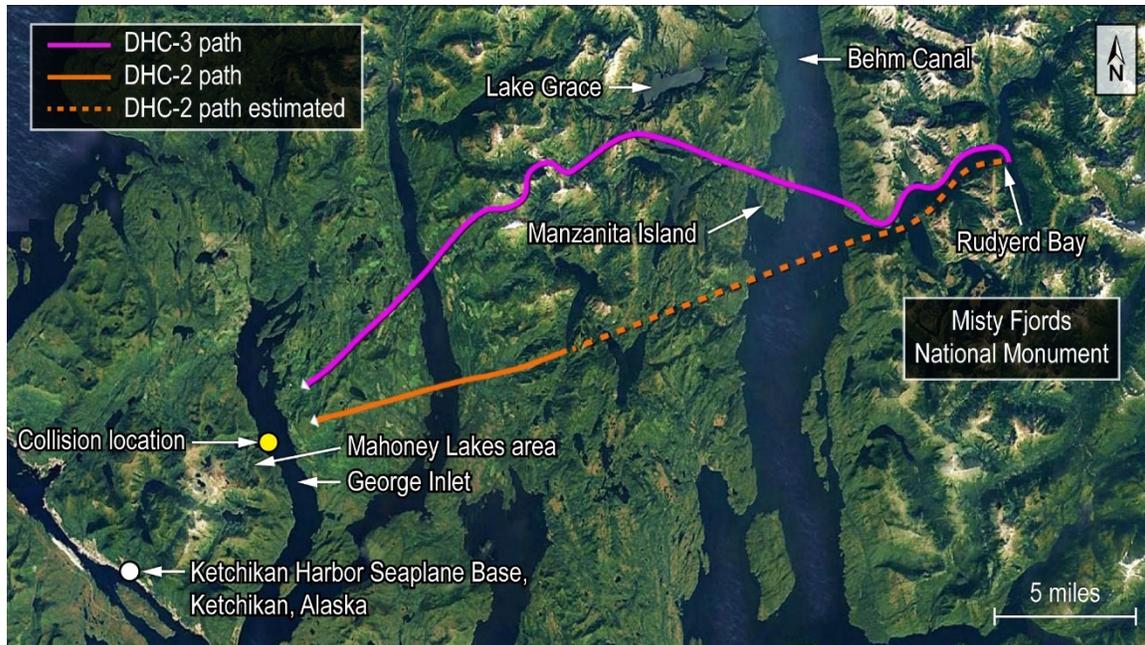
Figure 1. Map showing departure area, flightpaths, and collision location.

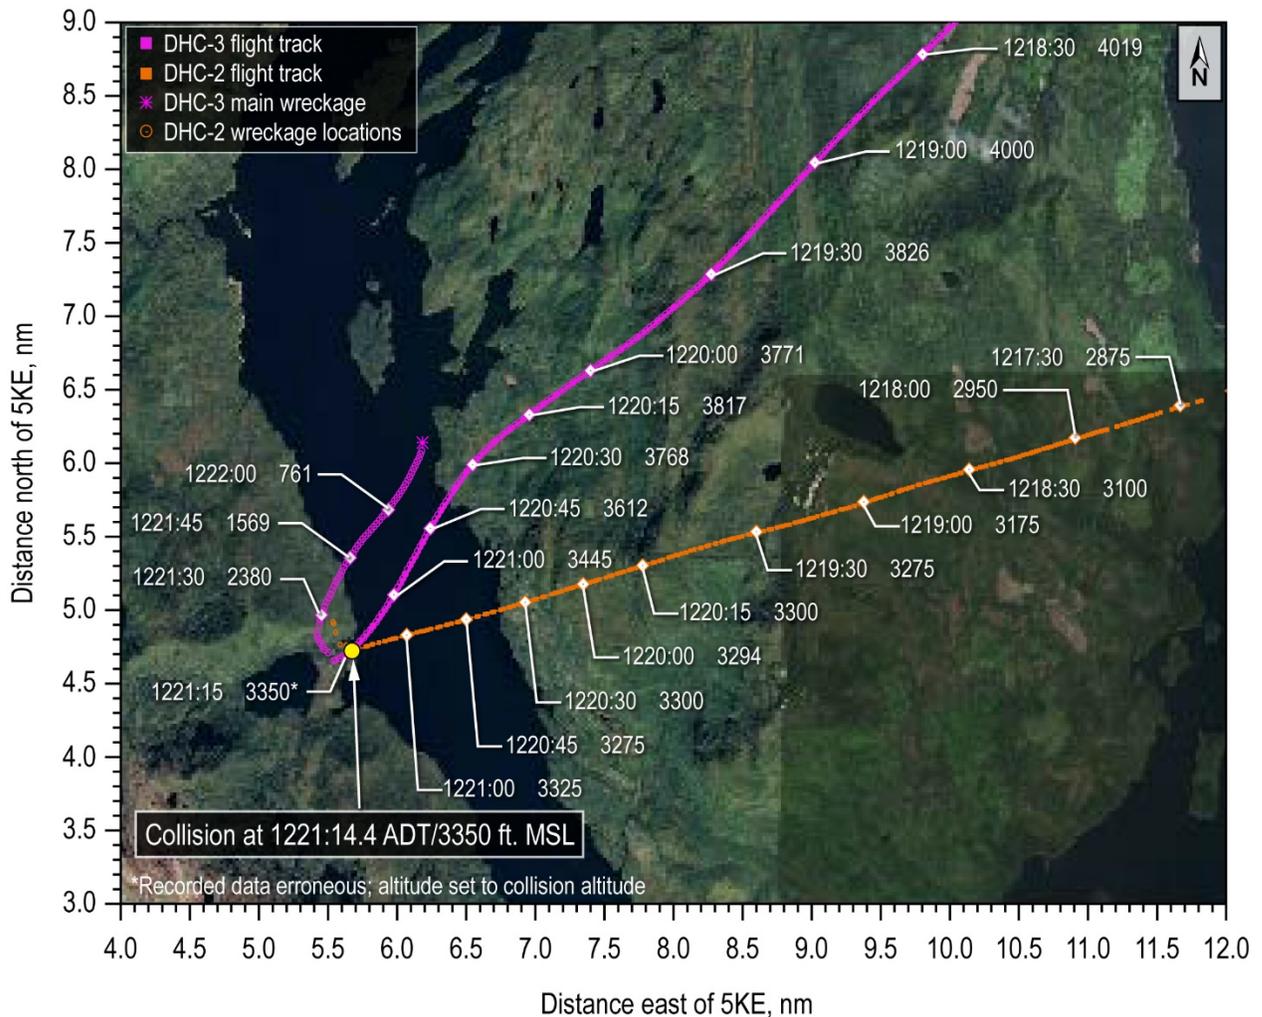
Figure 2. Map showing flight tracks for both airplanes and collision location. Times and altitudes are depicted along the flight tracks.

The ADS-B data for both airplanes end about the time of the collision. The DHC-2 was fractured into multiple pieces and impacted the water and terrain northeast of Mahoney Lake. Recorded avionics data for the DHC-3 indicate that at 1221:14, the DHC-3 experienced a brief upset in vertical load factor and soon after entered a right bank, reaching an attitude about 50° right wing down at 1221:19 and 27° nose down at 1221:22. The DHC-3 began descending and completed a 180° turn before impacting George Inlet at 1222:15 along a northeast track.⁸

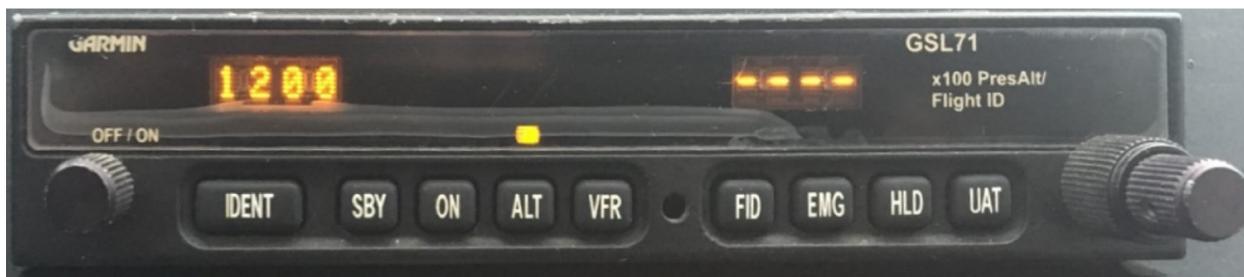
The DHC-3 was equipped with ADS-B Out and In through a RANGR 978 transceiver. A Garmin GSL 71 control panel provided pressure altitude and mode 3A “squawk” code to the RANGR 978 transceiver datalink for transmission.²⁰ The Garmin GSL 71 control head selector knob must be placed in the ON position and the ALT mode selected for the unit to provide pressure altitude to the RANGR 978 transceiver (see figure 7).

Figure 7. Photo of an exemplar GSL 71 that is transmitting pressure altitude.

- A procedural safeguard, such as a checklist item that addresses the position of the Garmin GSL 71 control head selector knob, can mitigate the hazard of the selector knob being inadvertently and indefinitely placed in the OFF position.

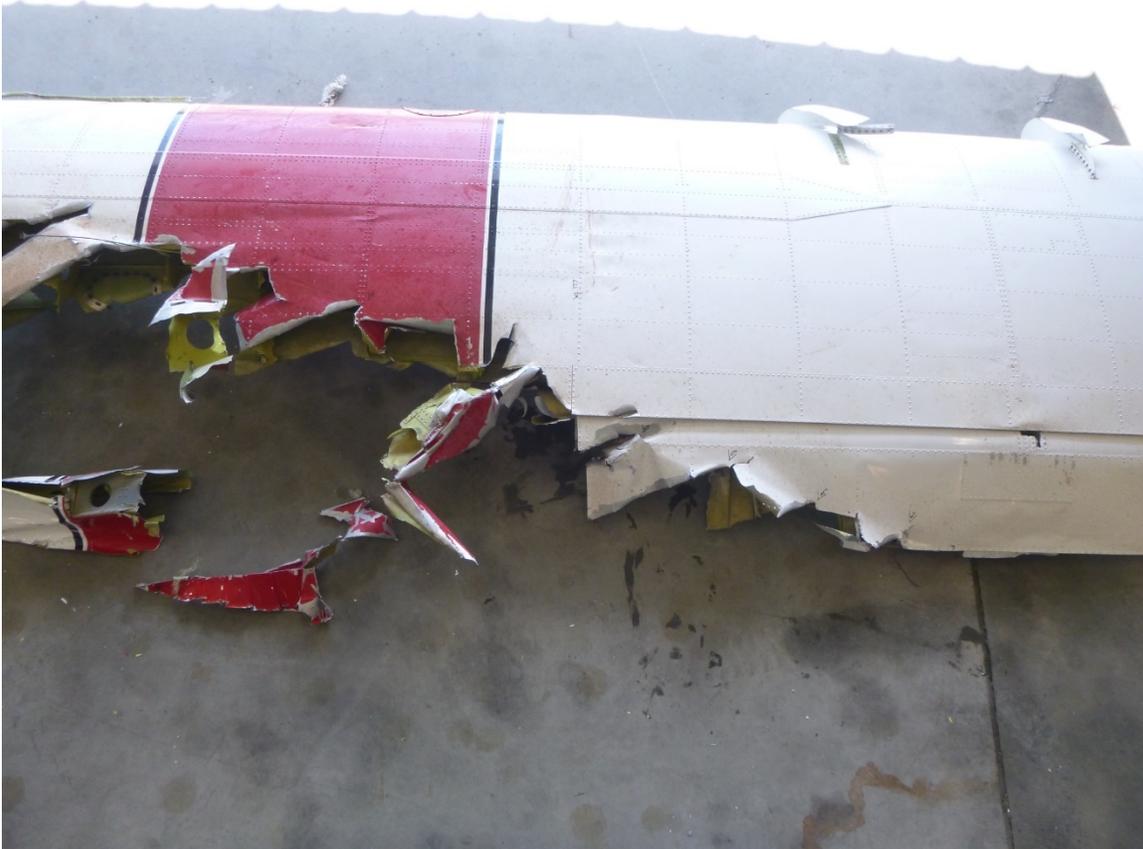
Postaccident examination of the DHC-2 revealed that the right wing was in multiple pieces and separated from the airplane. An initial impact point was noted on the trailing edge of the right aileron and a series of mechanical cuts were noted on the aft portion of the wing from the right aileron inboard to the wing root. Each successive cut penetrated further inboard and forward into the wing structure. Each cut had sawtooth fracture patterns and distinct downward deformation of the upper and lower wing skins and internal structure (see figure 10).

Figure 10. DHC-2 right wing with mechanical cuts that progressively penetrate inboard.

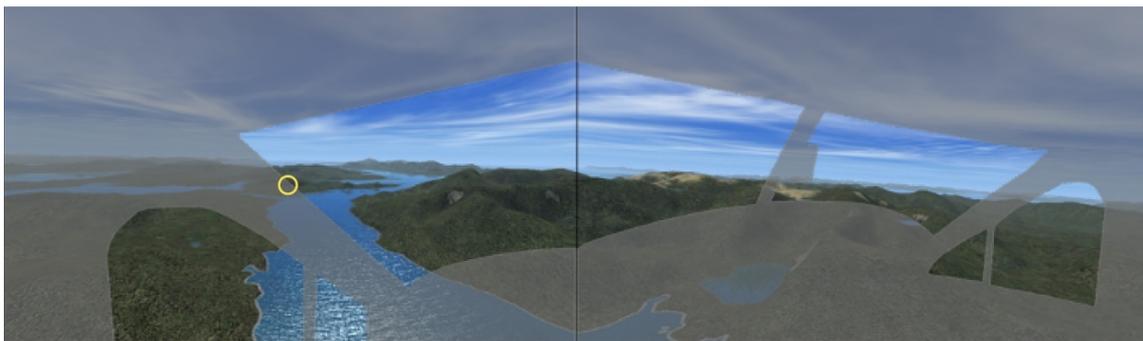
Regarding whether the DHC-3 pilot could have seen the DHC-2, between 1220:39 and 1221:03, the DHC-2 would have appeared slightly ahead of the DHC-3's left window post as a relatively small, slow moving object below the horizon against a background of terrain and water (see figure 11).

Note: A yellow circle superimposed on the left windshield post represents the location of the DHC-2 in the distance.

Figure 11. DHC-3 cockpit view at 1220:44 (30.4 seconds before collision).

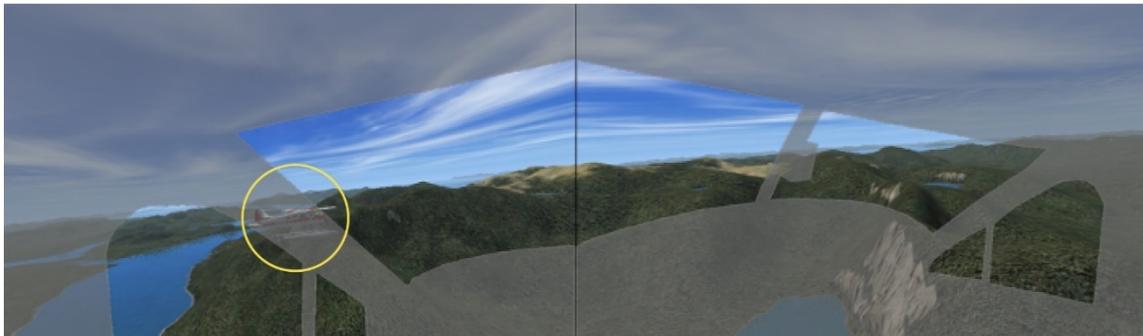
At 1221:13.4 (1 second before the collision), the apparent size of the DHC-2 would have grown large enough in the DHC-3 pilot's field of view that portions of the DHC-2 would have been visible through the left window and ahead of the left window post, though most of the airplane would have remained obscured by the window post (see figure 12).

Note: A yellow circle superimposed on the left windshield represents the DHC-2, which is mostly hidden by the left windshield post.

Figure 12. DHC-3 cockpit view at 1221:13.4 (1 second before collision).

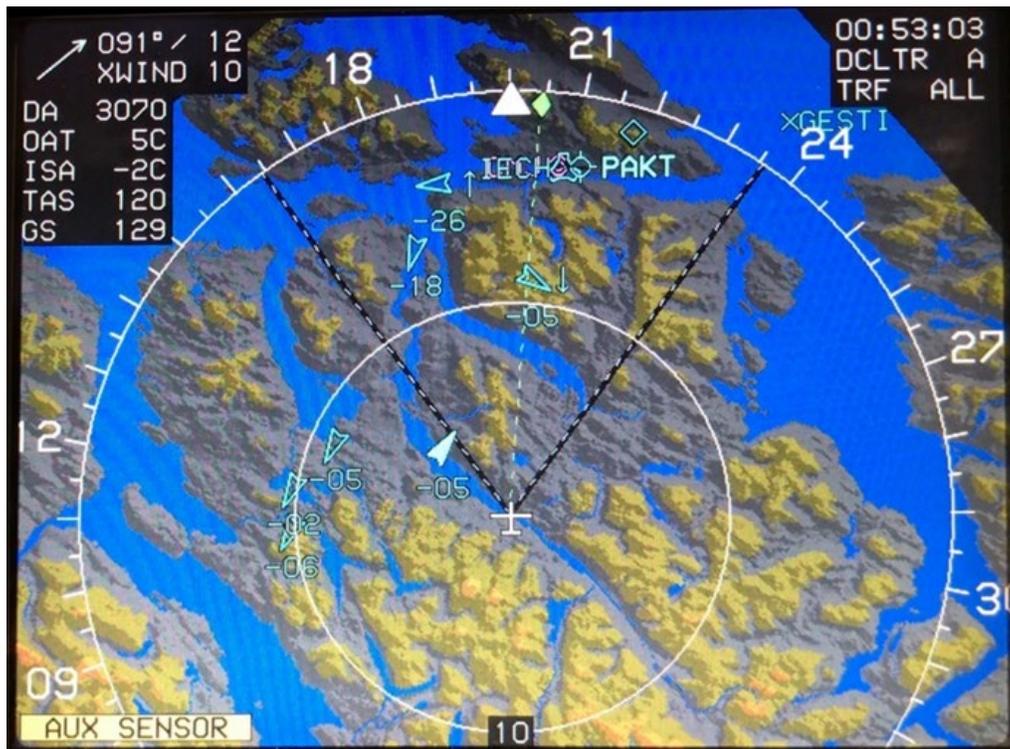
A simulation was produced of the DHC-3's CDTI, which the accident pilot would have viewed on a Chelton EFIS. About 4 minutes before the accident, when the pilot reported he last looked at the CDTI, the screen would have displayed two groups of open cyan (blue) triangles (traffic targets) to the left of and ahead of the DHC-3. A filled cyan triangle (a "proximate" traffic target), representing the DHC-2, would have appeared between the DHC-3 and the open cyan triangles to the left, about the DHC-3's 10 o'clock position (see figure 13).⁴⁴

Note: Because of limitations in the simulation, the -500 ft relative altitude depicted in the image is erroneous and should be disregarded (the true relative altitude would have been displayed during the accident).

Figure 13. Reconstructed DHC-3 CDTI at 1217:15 (4 minutes before the collision) over Carroll Inlet. The accident DHC-2 is represented by a cyan filled arrowhead at the 10 o'clock position.

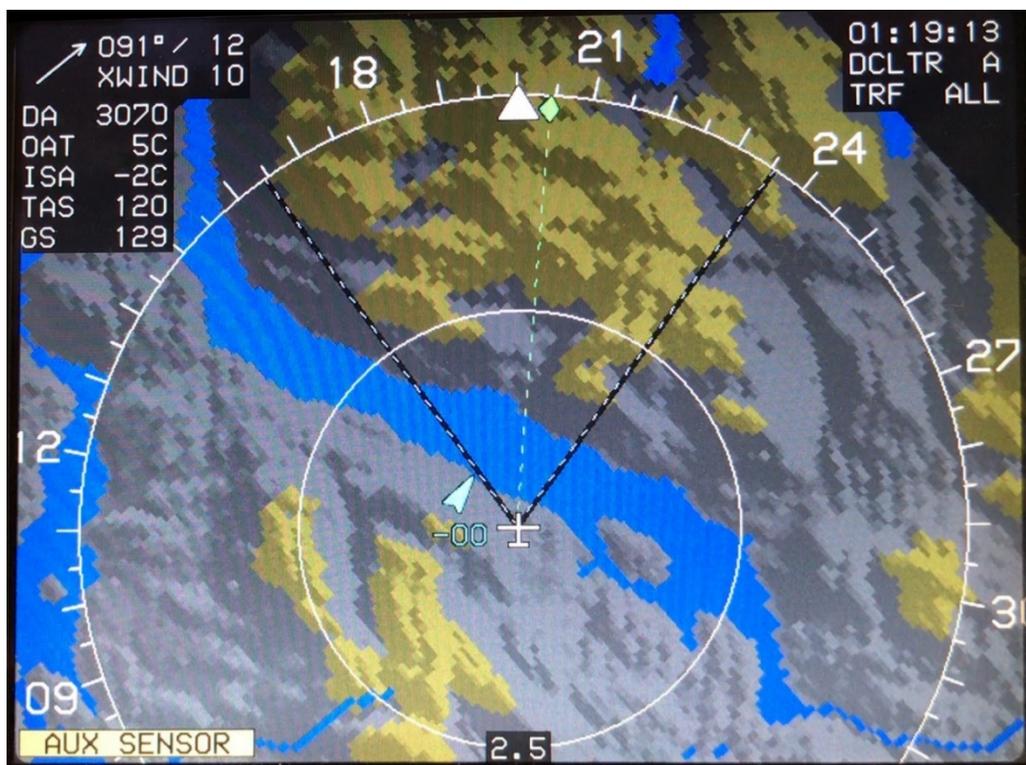
the collision, a Chelton EFIS and a RANGR transceiver would have displayed the DHC-2 as a filled cyan arrowhead on the DHC-3 Chelton EFIS (see figure 14).⁴⁶ However, on a DO-317B-compliant CDTI, the DHC-2 target would have changed from a filled cyan arrowhead to a filled yellow arrowhead with a circle around it (see figure 15).⁴⁷ The DO-317B-compliant CDTI also would have generated an aural alert giving bearing, relative altitude, and range from the target; 7 seconds later, a second aural alert would have been given with the same structure: “traffic, 10 o’clock, same altitude, less than one mile.”

Note: Because of limitations in the simulation, the 0 ft relative altitude depicted in the image is erroneous and should be disregarded (the true relative altitude would have been displayed during the accident).

Figure 14. DHC-3 simulated Chelton EFIS at 1220:37 (37.4 seconds before collision).

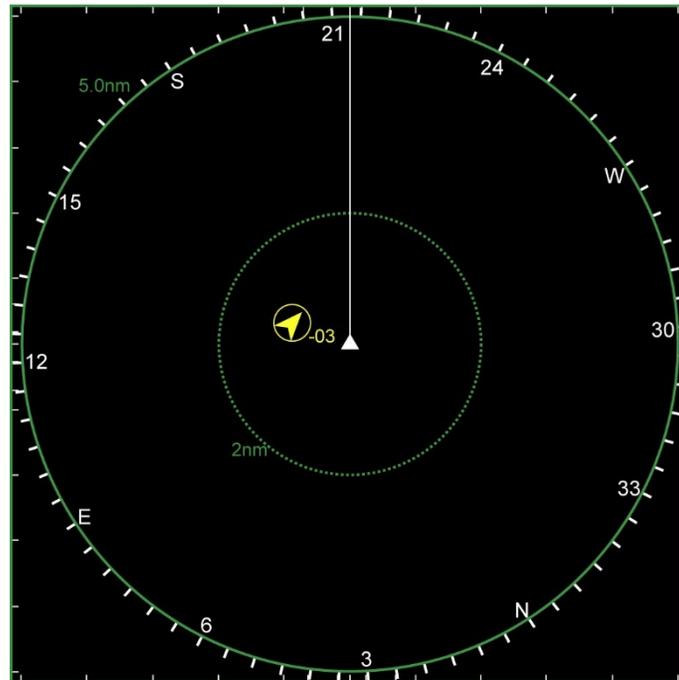
ATAS aural alert:
"Traffic, 10 o'clock, low, less than 1 mile"

Figure 15. DHC-3 simulated DO-317B-compliant CDTI at 1220:37 (37.4 seconds before collision).

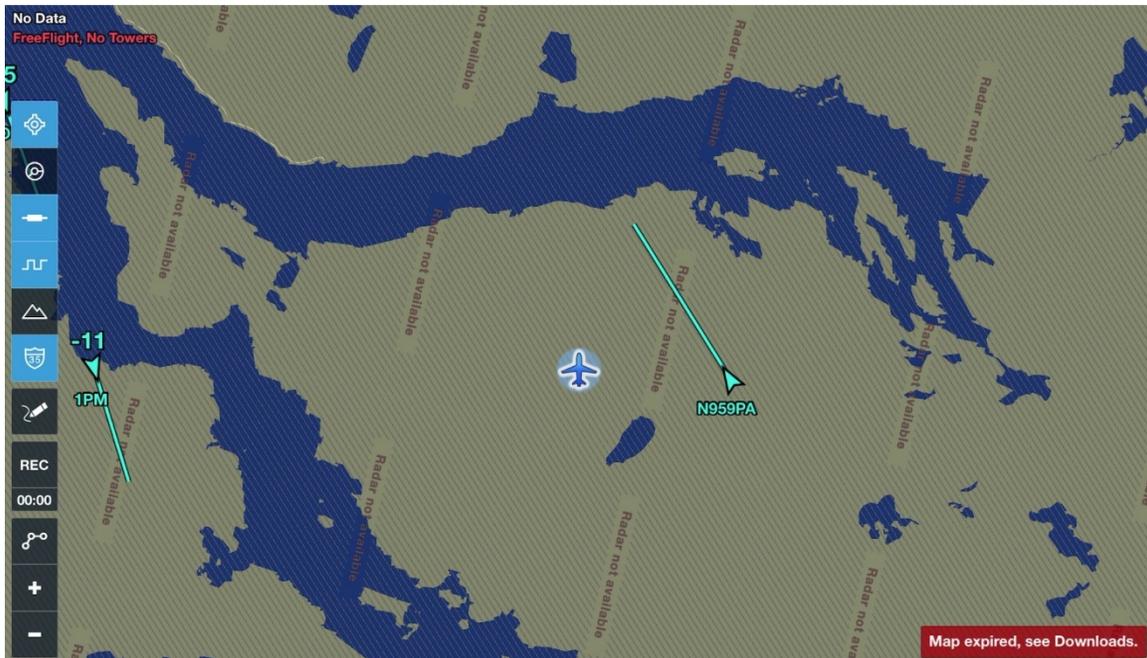
Simulations of the DHC-2's CDTI, which recreated the ForeFlight application on an iPad, were produced to correspond to three possible scenarios. The scenario that was most representative of the accident circumstances included the DHC-3 not broadcasting pressure altitude. About 1 minute 44 seconds before the collision, the DHC-3 with that setting would have appeared on the DHC-2's ForeFlight application as a filled cyan arrowhead about the DHC-2's 3 o'clock position and on a course that would intersect the DHC-2's flightpath. However, no visual or aural alert would have been generated because no altitude information about the DHC-3 would have been available (see figure 16). This scenario assumed the ForeFlight "Display Traffic" option was enabled and the "Hide Distant Traffic" option was turned off.

Note: This scenario assumes the DHC-3 was not providing pressure altitude. The scale is approximately a 6 nm range.

Figure 16. First DHC-2 simulated ForeFlight display at 12:19:30.1 (1 minute 44.3 seconds before collision). A cyan filled arrowhead represents the DHC-3 at the 3 o'clock position.

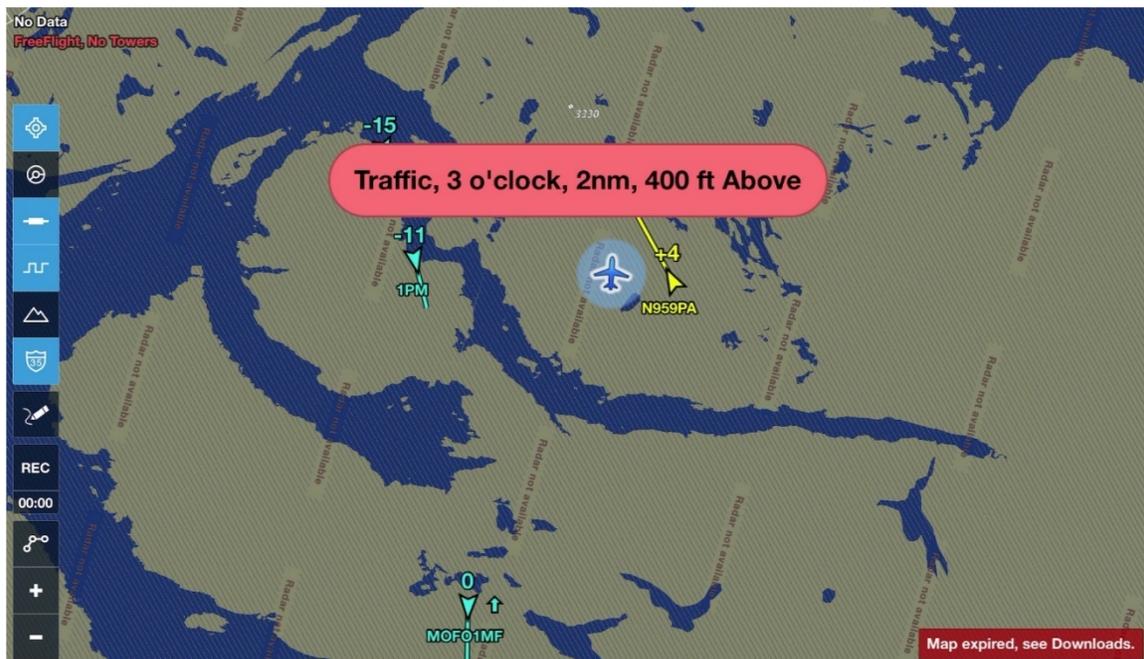
A second simulation was performed to determine the performance of the ForeFlight application if the DHC-3 had been broadcasting pressure altitude. In this scenario, the DHC-2’s ForeFlight application would have generated an aural and visual alert about 1 minute 44 seconds before the collision. The DHC-3 target would have been depicted as a filled yellow arrowhead, and visual and aural alerts would have been generated with the position, distance, and relative altitude of the DHC-3 from the DHC-2 (see figure 17). Between the alert and the collision, the

Note: The scale is approximately a 20 nm range. The alert in the red text box would also be generated aurally.

Figure 17. Second DHC-2 simulated ForeFlight display at 1219:30.1 (1 minute 44.3 seconds before collision).

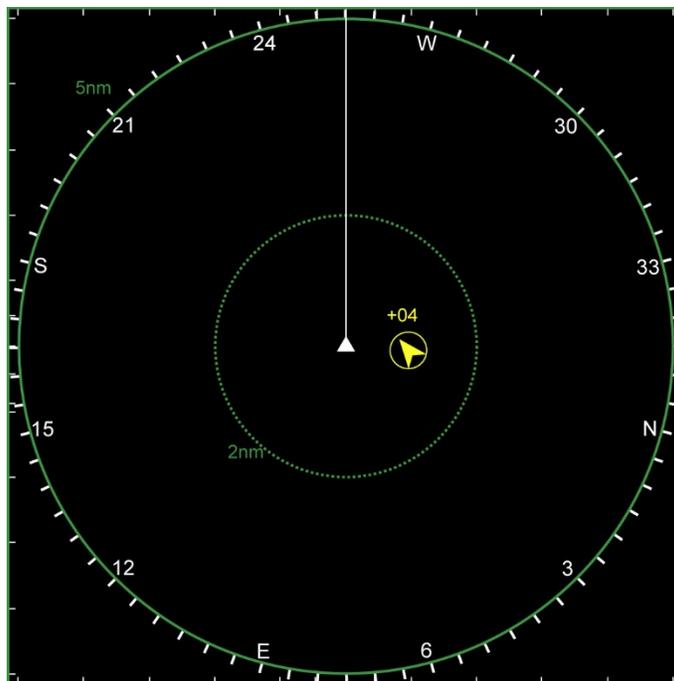
A third simulation assumed that the DHC-2 was equipped with a CDTI that was compliant with the traffic symbols and ATAS alert criteria specified in DO-317B and assumed that the DHC-3 was broadcasting pressure altitude. As in the other simulations, the DHC-3 would have appeared on the DHC-2's display about 1 minute 44 seconds before the collision as a filled cyan arrowhead at the 3 o'clock position. An aural alert would have been generated 35.4 seconds before the collision, and the filled cyan arrowhead would have changed to a filled yellow arrowhead enclosed in a circle (see figure 18). Another aural alert would have been generated 29.4 seconds before the collision, which would have indicated the DHC-3 was at the "same altitude, less than one mile, descending."

ATAS aural alert:

"Traffic, 3 o'clock, high, less than 1 mile, descending"
