AAR-21-05

Runway Overrun During Landing

Peninsula Aviation Services Inc. d.b.a. PenAir flight 3296

Saab 2000, N686PA

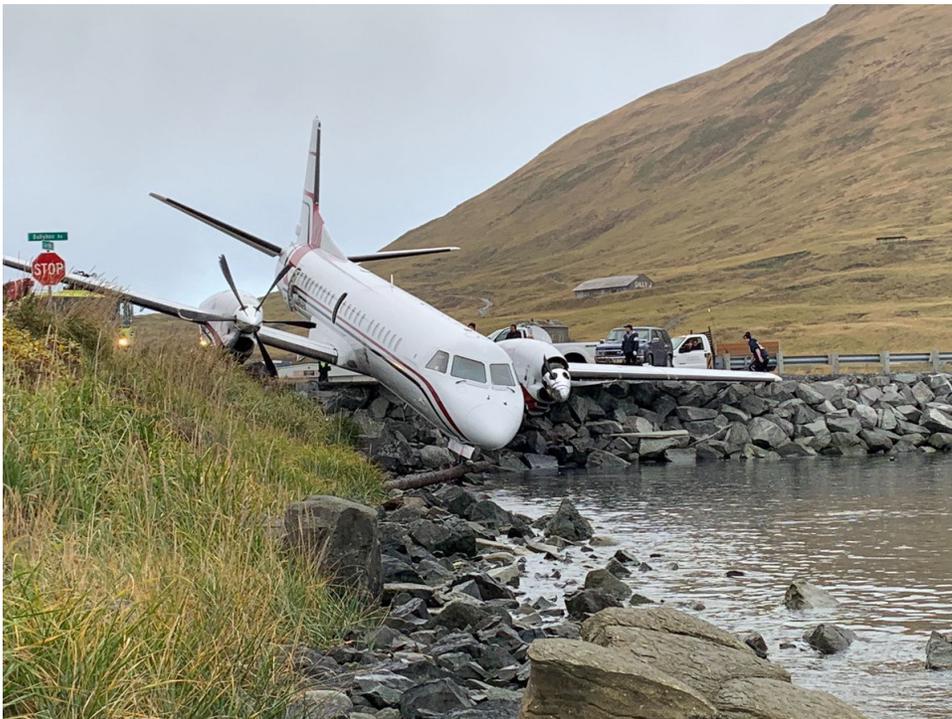
Video from two off-airport security cameras showed that the left engine shed propeller blade fragments and two propeller blades either before or as the airplane traveled across an off-airport road.²⁰ In addition, either the left wing or the left engine propeller struck a 7-ft vertical signal post. The left engine propeller then struck an 8-ft road sign mounted on a metal post, and the left engine shed propeller blade fragments and one propeller blade after contacting the road sign.²¹ The security camera video also showed that the airplane overrun stopped at 1740:29. The airplane came to rest with its nose pitched downward, the nose gear in shallow water at the edge of Dutch Harbor, the left MLG embedded in rocks, and the right MLG on the shoulder of a road intersection, as shown in figure 2.

Figure 2. Airplane in its final resting location (Source: Unalaska Department of Public Safety).

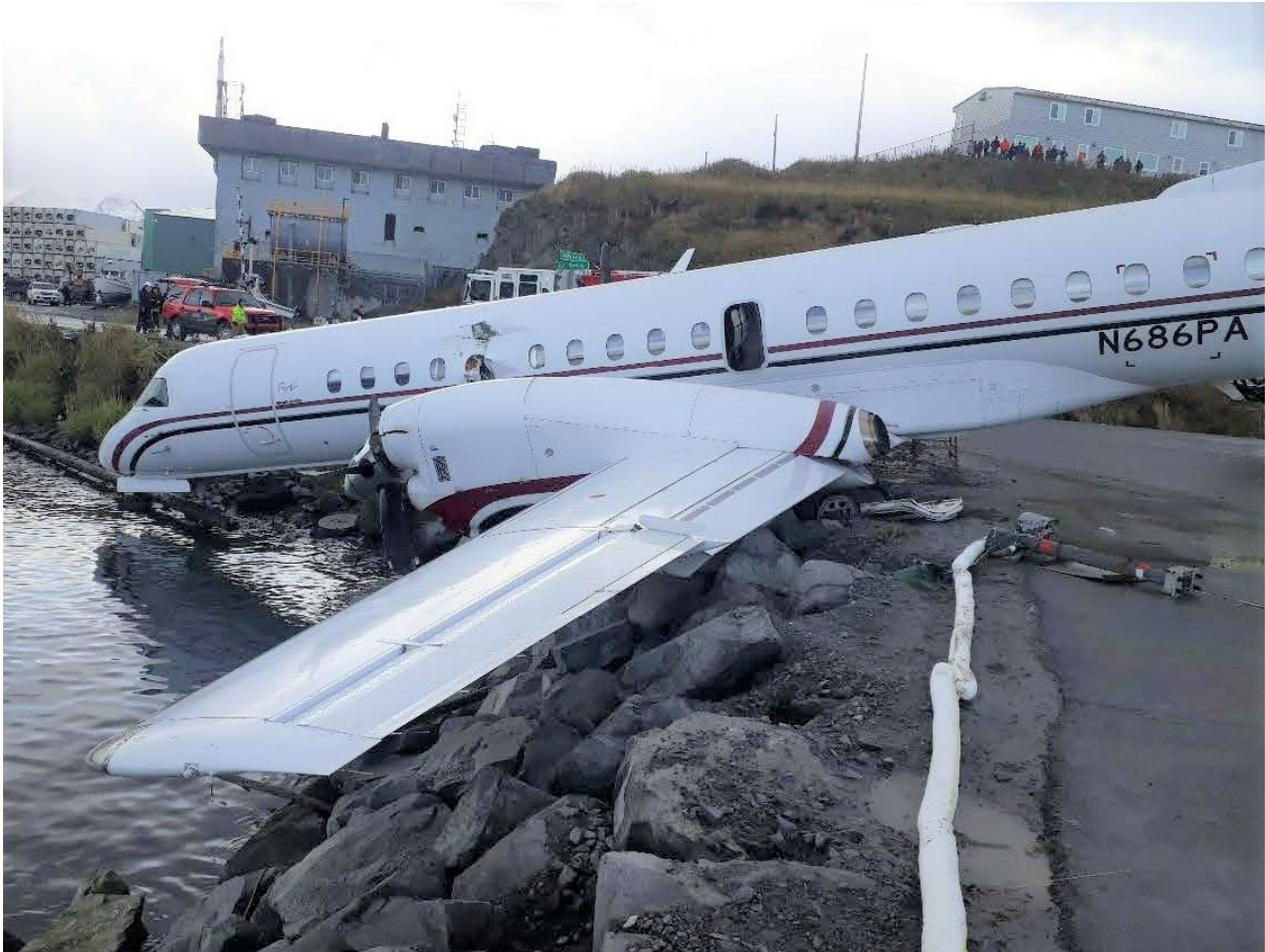
Figure 3 shows a hole and impact damage on the left side of the airplane located near the fifth passenger window on that side. Section 1.9.1 provides additional details about the damage to the airplane in this area.

Figure 3. Left side of accident airplane (Source: Unalaska Department of Public Safety).

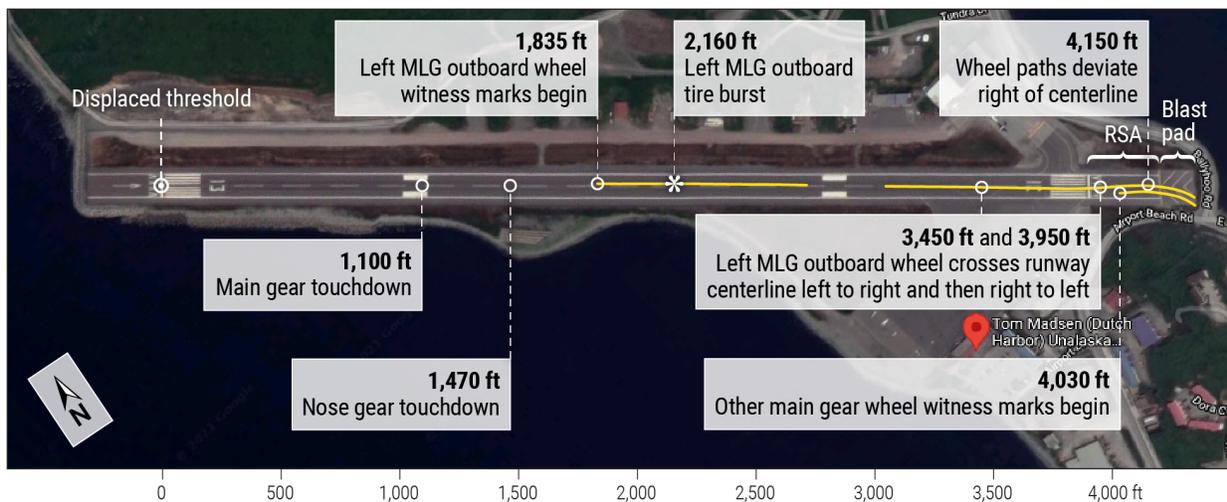
A postaccident GPS survey of runway 13 documented the witness marks associated with the accident airplane's ground track. Witness marks associated with the left MLG outboard tire began about 1,835 ft beyond the runway 13 displaced threshold.²³ The left MLG outboard tire path began on the left side of the runway centerline, crossed over to the right side of the centerline, returned to the left side, and crossed over again to the right side before the airplane overran the blast pad surface. The airplane was estimated to be about 2,160 ft beyond the runway 13 displaced threshold at the time of the tire burst captured on the passenger video. Witness marks associated with the left MLG inboard tire and the right MLG inboard and outboard tires began about 4,030 ft beyond the runway 13 displaced threshold and near the midpoint of the 300-ft RSA. Figure 4 shows the airplane's ground track from the time of the landing rollout to the blast pad departure, including the approximate location where the tire burst.

Figure 4. Airplane ground track overlaid on a Google Earth image.

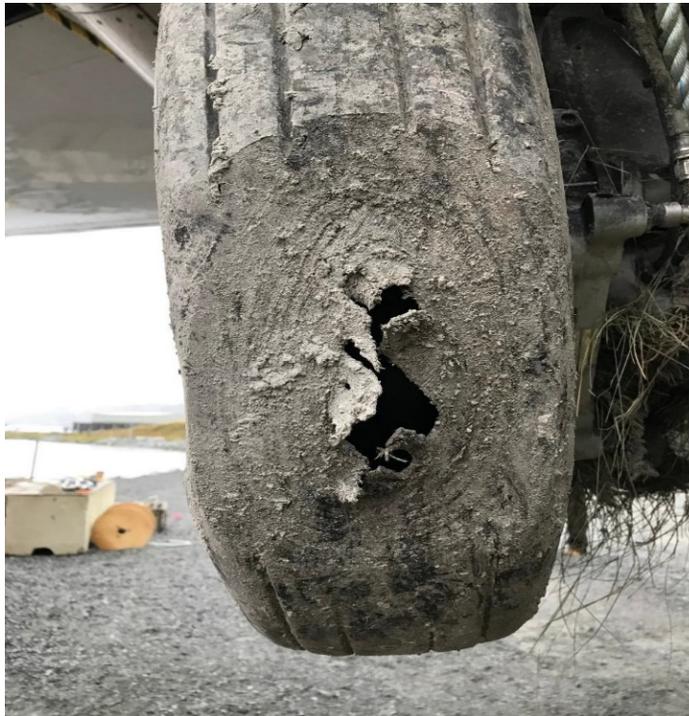
The left outboard tire was found deflated and had an oval-shaped worn area that corresponded with the area on the tire where the first officer documented the flat spot. The worn area measured about 11 inches in length and had a hole in the middle, as shown in figure 5. The left outboard tire also had another oval-shaped worn area that measured about 15 inches in length and had intact tread in the middle, as shown in figure 6. This worn area was about 180° from the flat spot area.

Figure 5. Worn area and hole in left outboard tire.

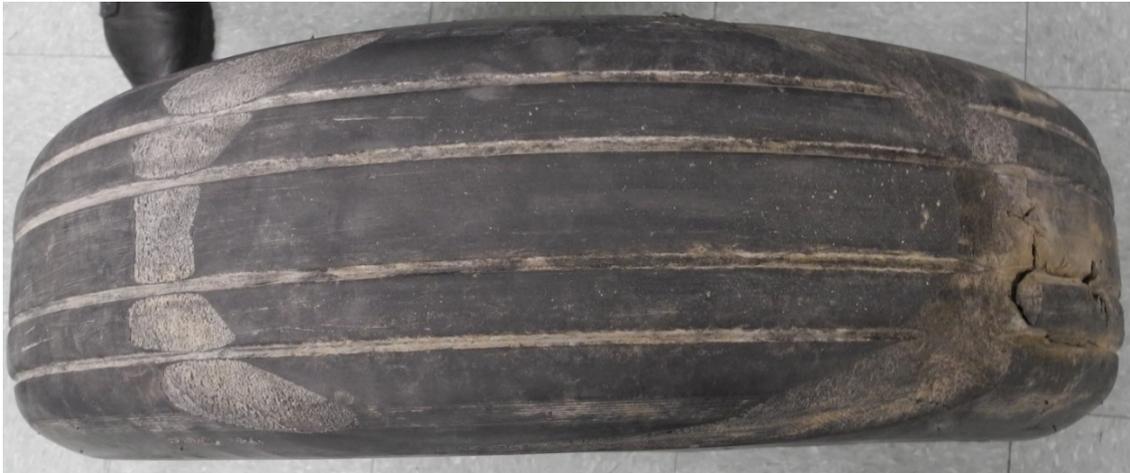
Figure 6. Additional worn area on the left outboard tire.

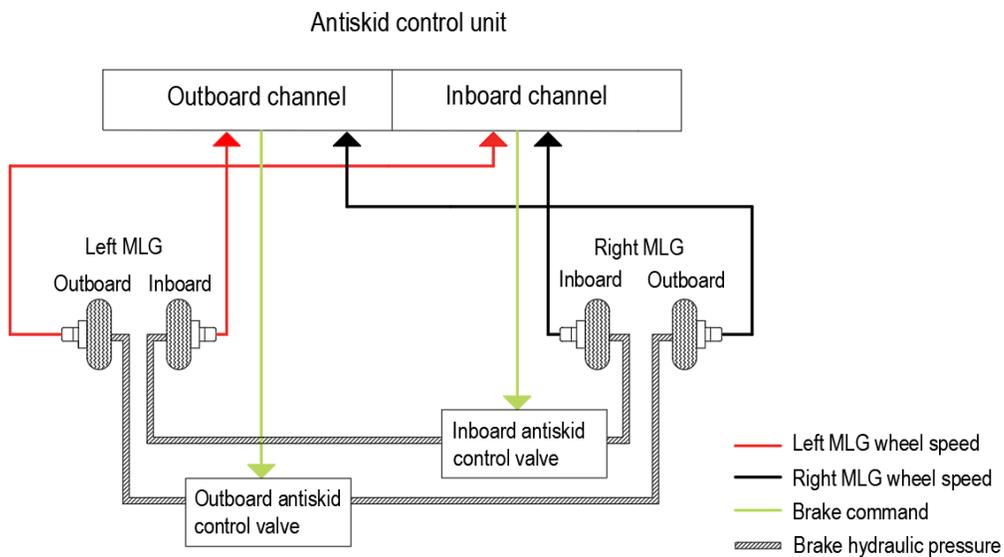
The incorrect wheel speed transducer wiring most likely occurred during the overhaul of the left MLG at the landing gear manufacturer's facility in January 2017, more than 2.5 years before the accident. This cross-wiring condition was not discovered until after the accident in part because the airplane was not in revenue service between the time of left MLG overhaul and PenAir's first revenue flight in June 2019. Also, the antiskid system does not generate a fault based on incorrect wiring. For a cross-wiring condition to potentially be detected, a significant skid event would have to occur for more than 2 seconds (based on the antiskid system's logic) and not be relieved. Saab's design of the wheel speed transducer wire harnesses did not consider that the harnesses could be incorrectly installed during maintenance and overhaul. In addition, three incidents that we investigated showed the potential for cross-wiring of antiskid system components in other airplane types.

The NTSB, Saab, and the accredited representative from the Swedish Accident Investigation Authority examined the recovered wheel speed transducer wire harnesses. During the examination, the participants noted that the left MLG wheel speed transducer wiring harnesses had been constructed differently. Specifically, the left outboard harness was constructed with one filler wire (a nonconducting wire with a fiberglass center used to fill space in the conduit and increase the strength), and the left inboard harness had two filler wires. As a result, the left outboard harness segment could be matched with a short wire segment (about 6.5 inches long) that had a label identifying the harness as 5/6 GA-P4. The short wire segment was also matched with the upper electrical connector with part number MS 27467T9B35P.³⁹ According to the installation instructions, this harness should have been routed to the left inboard wheel and not the left outboard wheel.⁴⁰ Thus, the examination showed that the left MLG wheel speed transducer wire harnesses were incorrectly installed. The examination also showed that the right MLG wire harnesses were correctly installed.⁴¹

Figure 8 shows the correct wiring for the left MLG wheel speed transducer. The crossed wiring of the left MLG wheel speed transducers, as described in the previous section, is shown in figure 9; the crossed wiring is shown in red.

Figure 9. Cross-wiring of left MLG wheel speed transducers.

As a result of its internal investigation to identify potential root causes for the incorrect harness wiring, APPH implemented the following corrective actions:

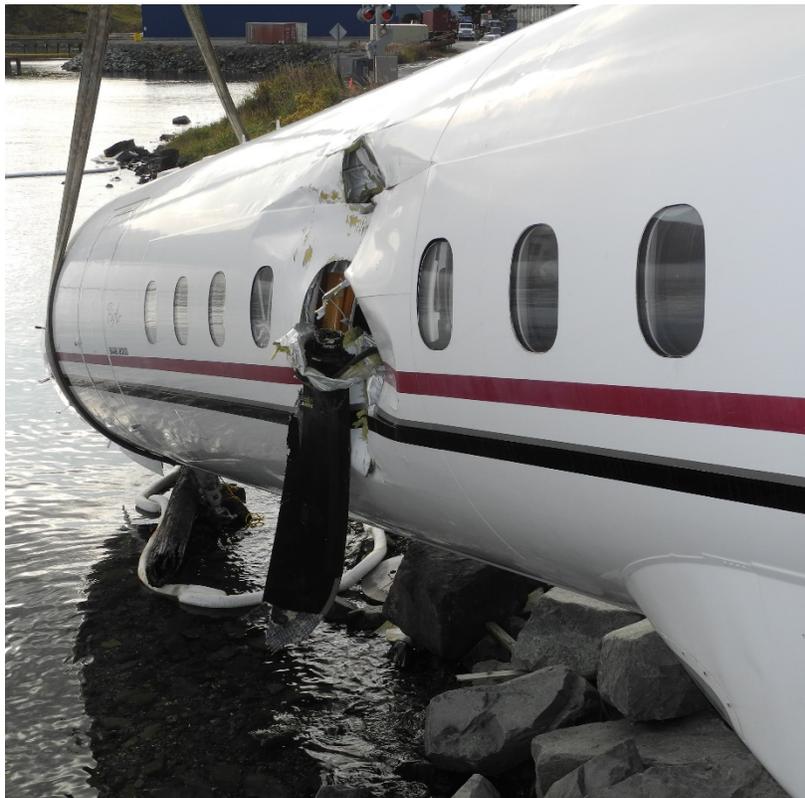
A left propeller blade impacted the left side of the cabin, as shown in figure 11, and damaged the cabin interior in the area between seats 3A and 6A, with extensive damage next to the seat 4A seatback and window. The overhead compartment in that area partially separated from its mounts and descended about 6 to 12 inches. The wall panel separated near seat 3A and was displaced aft and inboard. The wall panel and fuselage skin infringed about 10 inches into the seat 4A area at the lower seatback cushion. The 4A window fuselage frame was located on the cabin floor at row 2.

Figure 11. Impact area of left propeller blade.

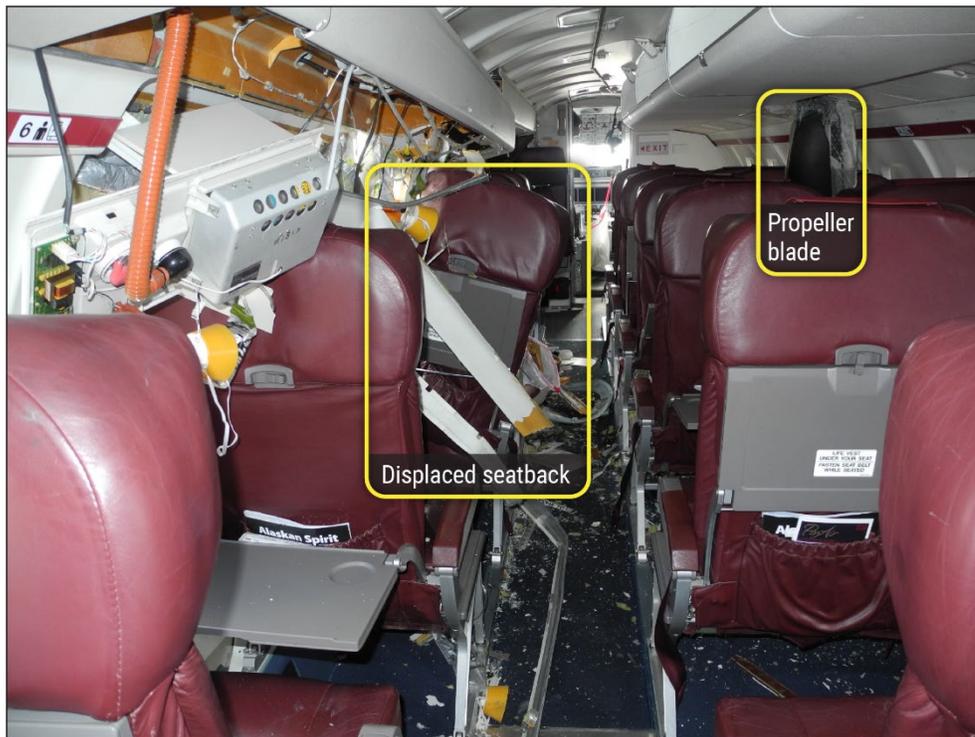
Seat 4A sustained substantial damage. The seatback was displaced inboard toward the center aisle, as shown in figure 12, and the seatback structure was fractured on the left side. The headrest cushion was partially torn away from the seatback, and the left side of the seatback (forward facing) had an 8-inch vertical cut through the foam and cover starting about 4 inches from the top of the seatback. The bottom seat cushion was askew. The right armrest was fractured at the forward mount and displaced inboard about 4 inches. The seat belt was not damaged and was functional. Another propeller blade had entered the left-side fuselage, traversed the cabin, and was in place vertically on the right side of the cabin in front of seat 4F, which can also be seen in figure 12. The blade was wedged between the overhead bin and the floor. There was no damage or scrape marks to the overhead bin, floor, or seats 4D and 4F except for a fracture and slight displacement of the inboard armrest of seat 4D. Seat 5D had a superficial x-shaped tear in the seat cushion.

Figure 12. Forward view of cabin from row 6.
