AIRCRAFT ACCIDENT REPORT

TRANS WORLD AIRLINES, INC
BOEING 707-331C, N787TW
NATIONAL AVIATION FACILITIES
EXPERIMENTAL CENTER
ATLANTIC CITY AIRPORT
POMONA, NEW JERSEY
JULY 26, 1969

AIRCRAFT ACCIDENT PRELIMINARY REPORT

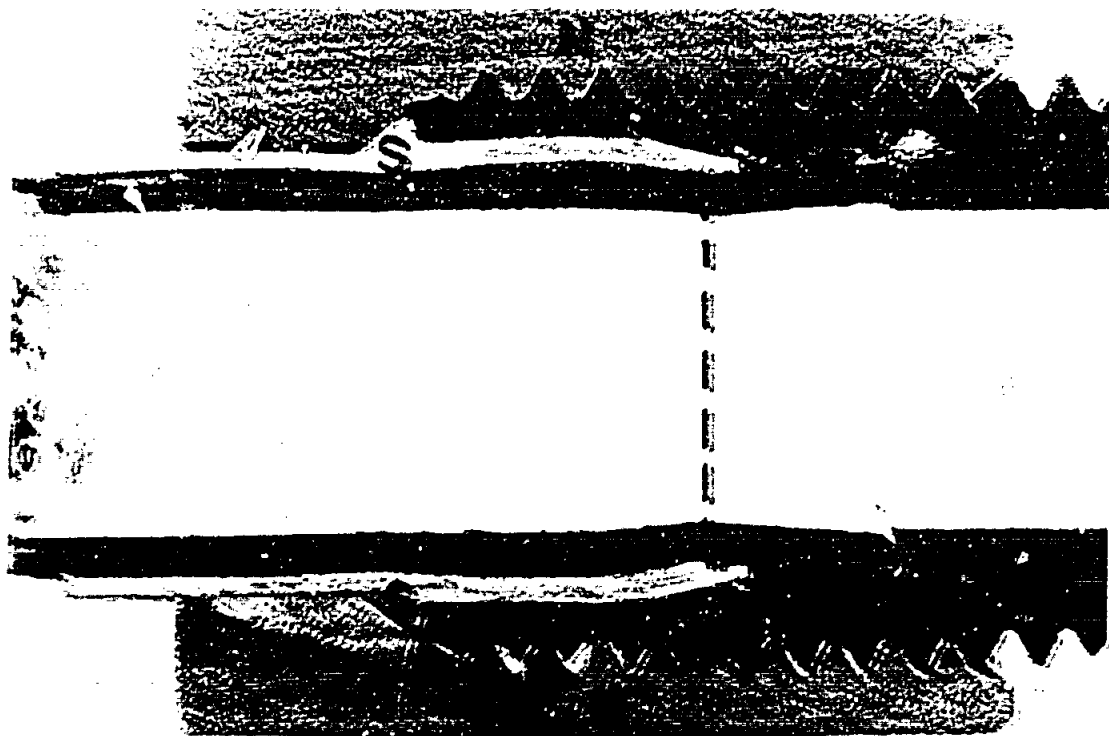
The hydraulic pressure line to the downside of the left outboard spoiler actuator had failed at the bottom of the sharp notch cut in the outside surface of the tube by the edge of the flareless coupling sleeve. Metallurgical examination of the break indicated that the failure was due to metal fatigue. (See Appendix D.)

Longitudinal section through an assembled flareless coupling, illustrating the location of the fracture (dashed line) indicated by arrow "a", Fig. 1. X 4

J. Swivel joint fitting	S. Coupling sleeve
M. Coupling nut	T. Hydraulic tube
