AIRCRAFT ACCIDENT REPORT

CESSNA 310N, N4111Q

NEAR UPLAND CALIFORNIA

APRIL 12, 1969

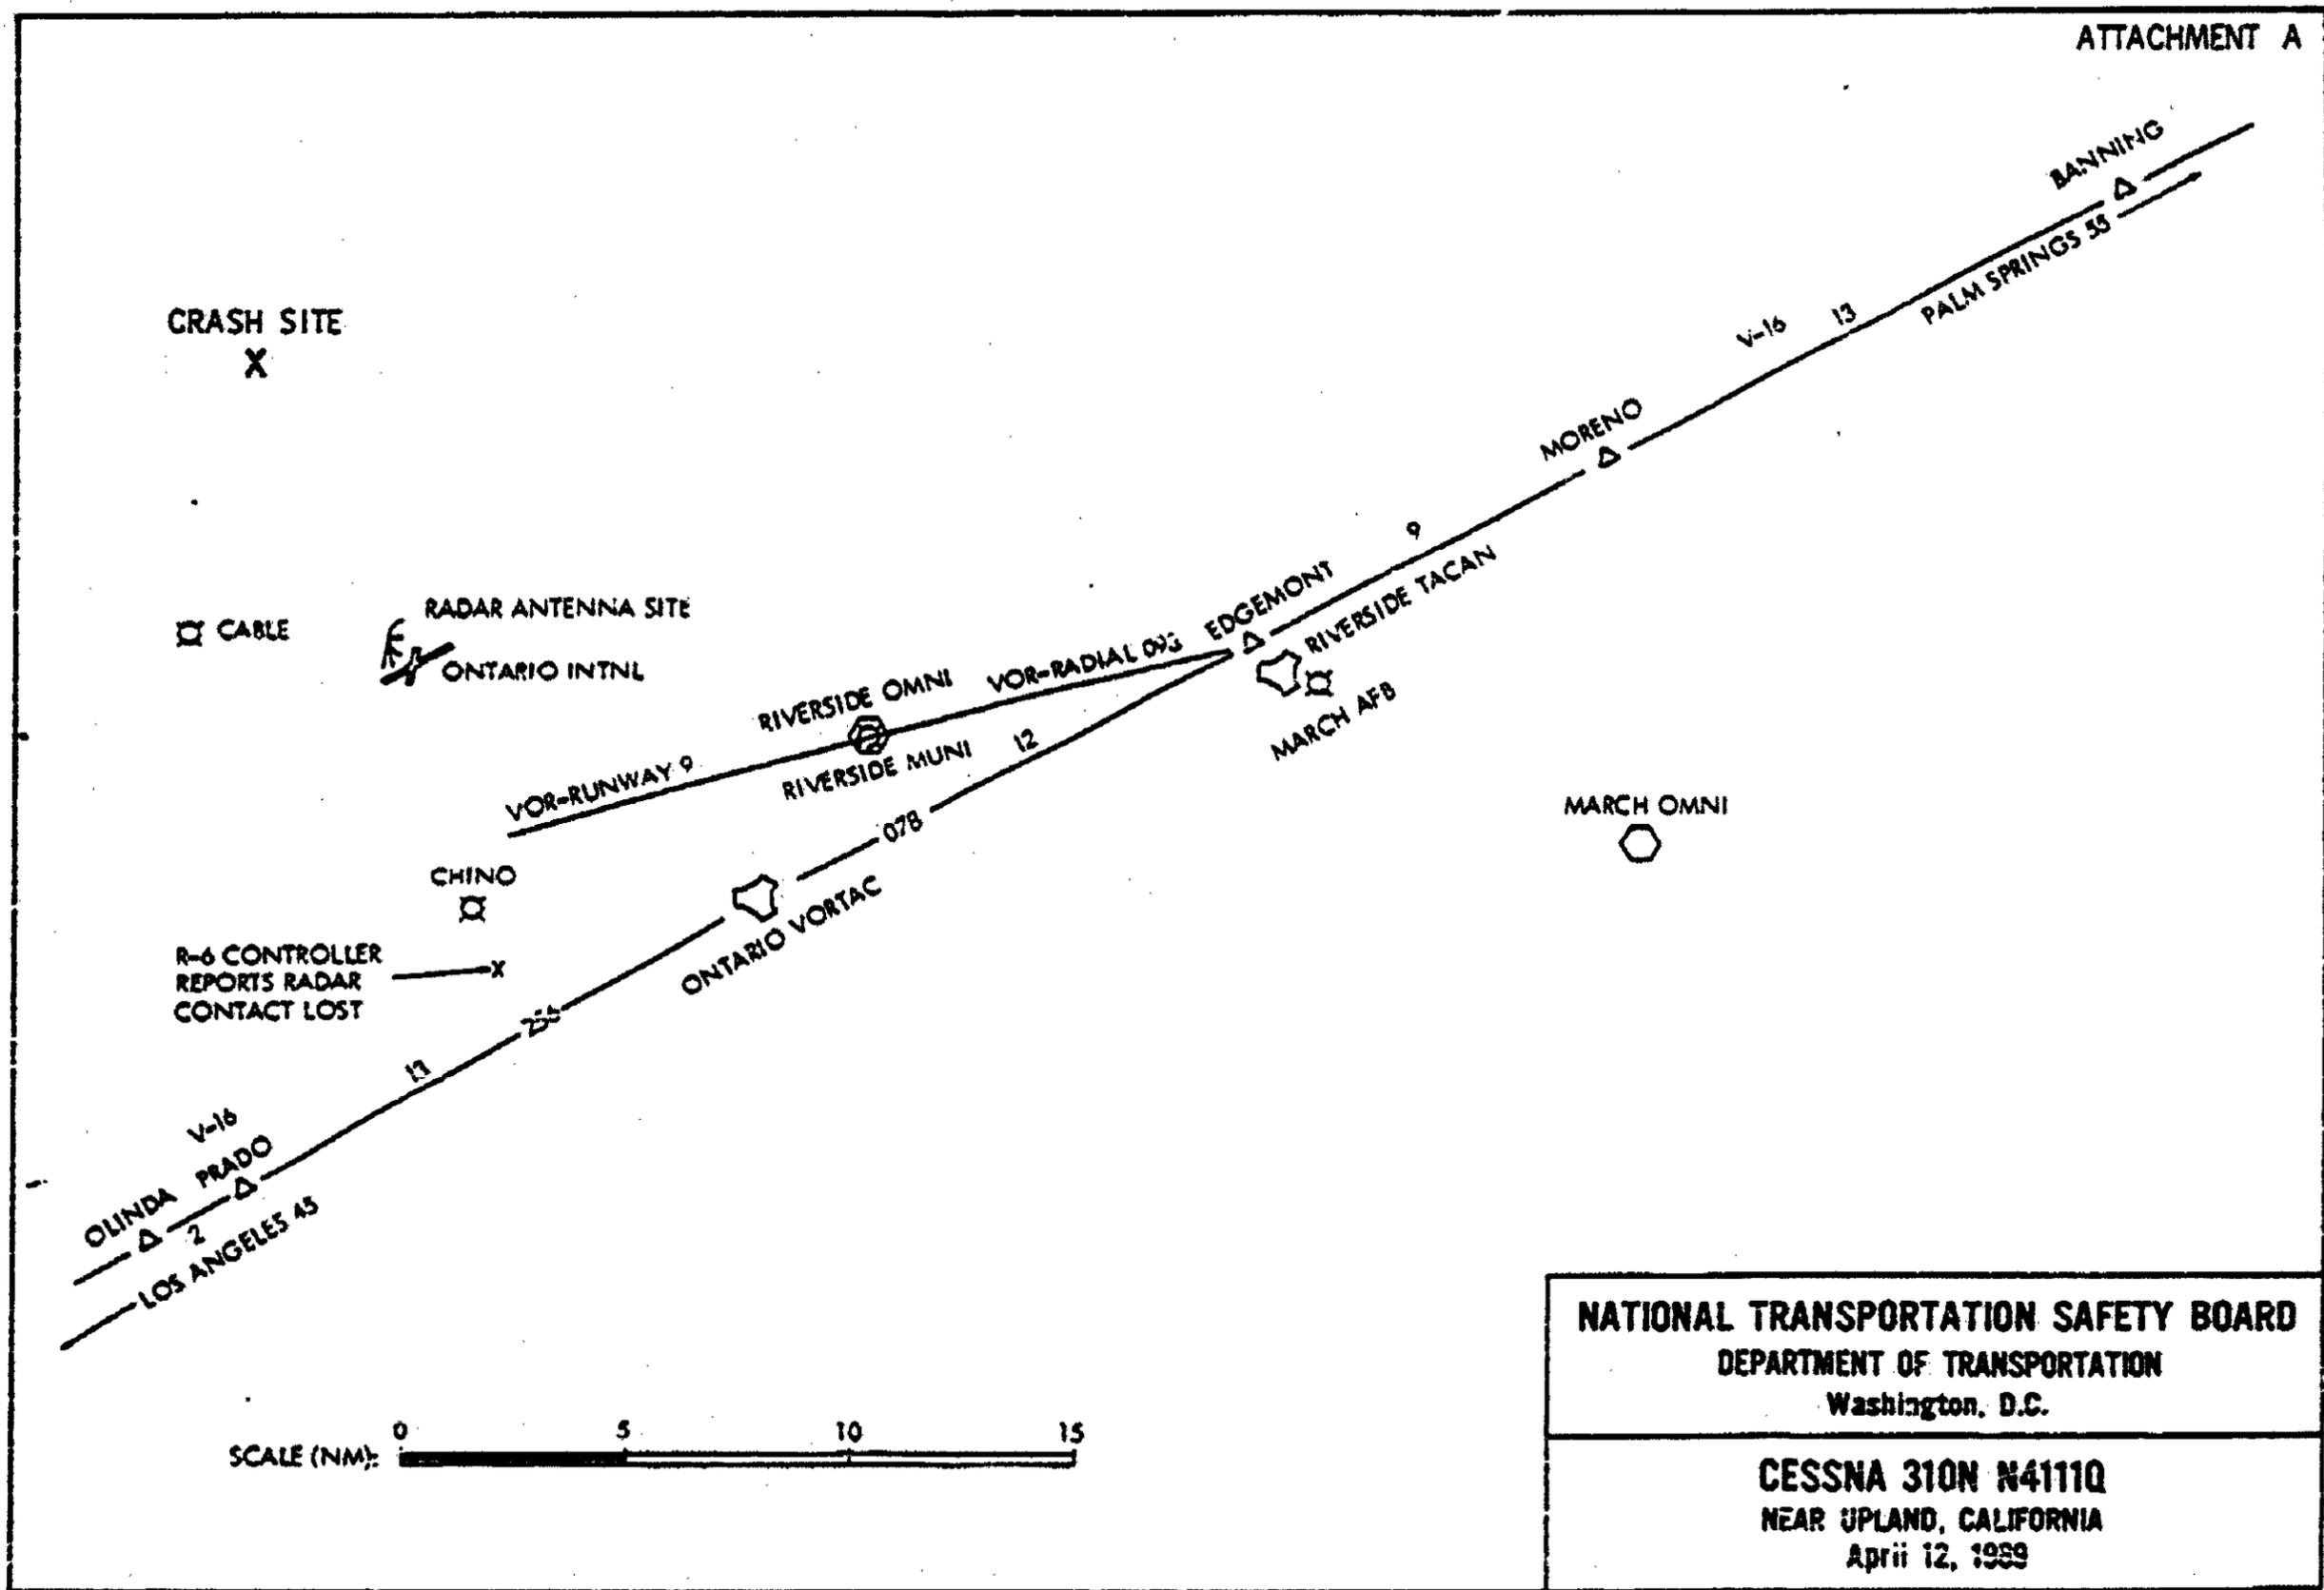
The flight, N4111Q, a privately owned Cessna 310N, was the return portion of a round trip from Riverside, California, to Albuquerque, New Mexico. An Instrument Flight Rules (IFR) flight plan was filed at the Albuquerque Flight Service Station (FSS) indicating that the transponder-equipped aircraft would be flown at 180 knots true airspeed, with an initial cruising altitude of 10,000 feet. The specialist receiving the flight plan at the FSS briefed the pilot on pertinent weather and then forwarded the proposed flight plan to the Albuquerque Air Route Traffic Control Center (ARTCC). The flight was cleared via Victor Airway 12 (V-12), flight-planned route, to maintain 12,000 feet, with a climb on course approved. Communication with Albuquerque ARTCC was established at 0936:30 P.s.t. 1/ and a transponder code of 1100 was assigned. Radar contact was established by means of the "ident" feature of the transponder. At 0940:25, the pilot of N4111Q reported level at 12,000 feet. During the next 1-1/2 hours, the pilot twice requested descent clearance to 10,000 feet and was finally cleared to that altitude at 1116. The pilot reported level at 10,000 feet at 1119:50, and the flight continued routinely. At approximately 1138, Los Angeles ARTCC instructed the pilot to "ident" and radar contact was established 50 miles northeast of Parker, California. When the flight was cleared to cross Palm Springs at 13,000 feet, the pilot initially acknowledged, but then at 1209, he advised Los Angeles ARTCC that he would proceed in accordance with Visual Flight Rules (VFR) at 10,500 feet until Banning Intersection, 21 miles west-southwest of Palm Springs. (See Attachment A.)
