NTSB-AAR-70-15

# AIRCRAFT ACCIDENT REPORT

ALLEGHENY AIRLINES, INC., DC-9, N988VI

SEPTEMBER 9, 1969

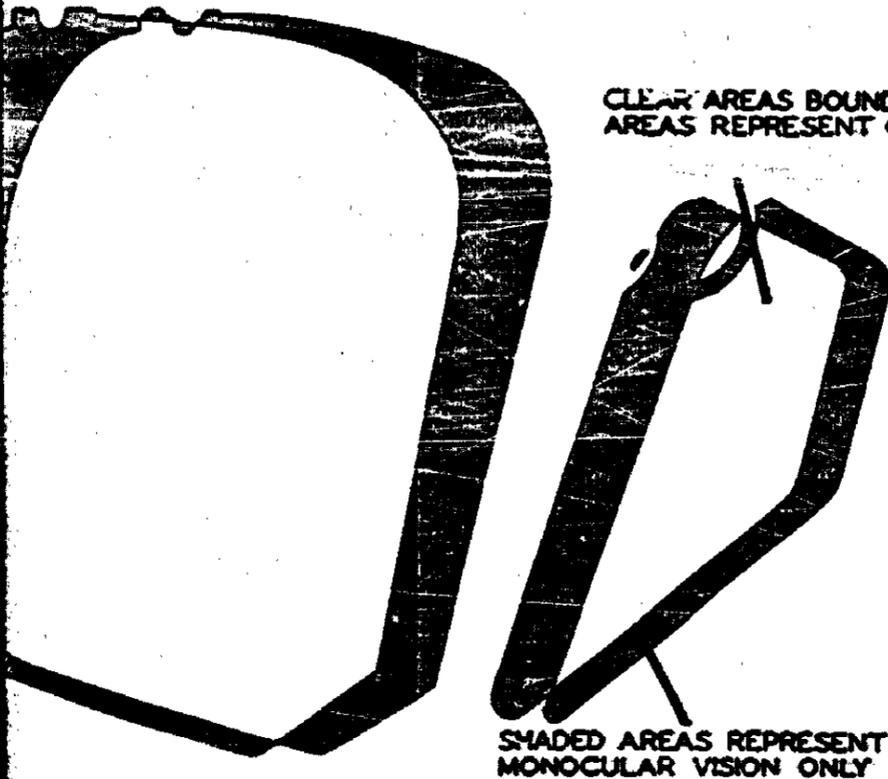
CALCULATED  
DC-9 PILOT'S VIEW-NORMAL POSITION  
DOUGLAS DESIGN EYE POSITION

INDICATES AREAS OF POSSIBLE  
SIGHTING FROM 22.8 SECONDS  
UNTIL 2.4 SECONDS PRIOR TO COLLISION.

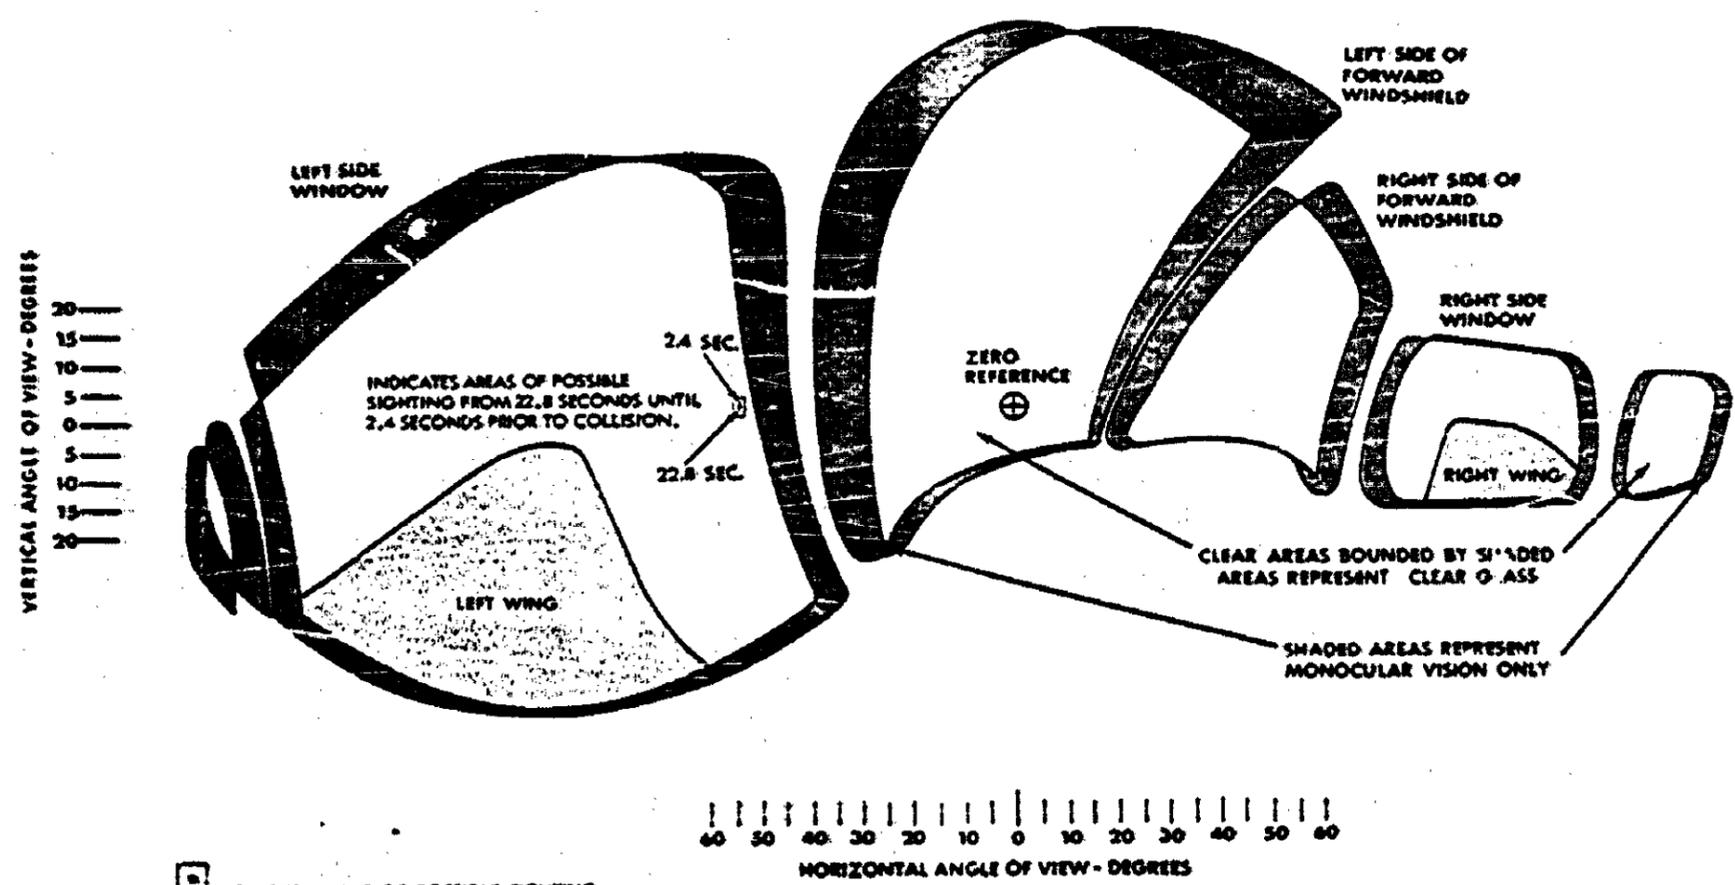
CALCULATED  
PIPER CHEROKEE (PA-28-140B)  
PILOT'S VIEW  
NORMAL POSITION

INCLUDES AREAS OF POSSIBLE SIGHTING FROM 22.8 SECONDS UNTIL 2.4 SECONDS PRIOR TO COLLISION

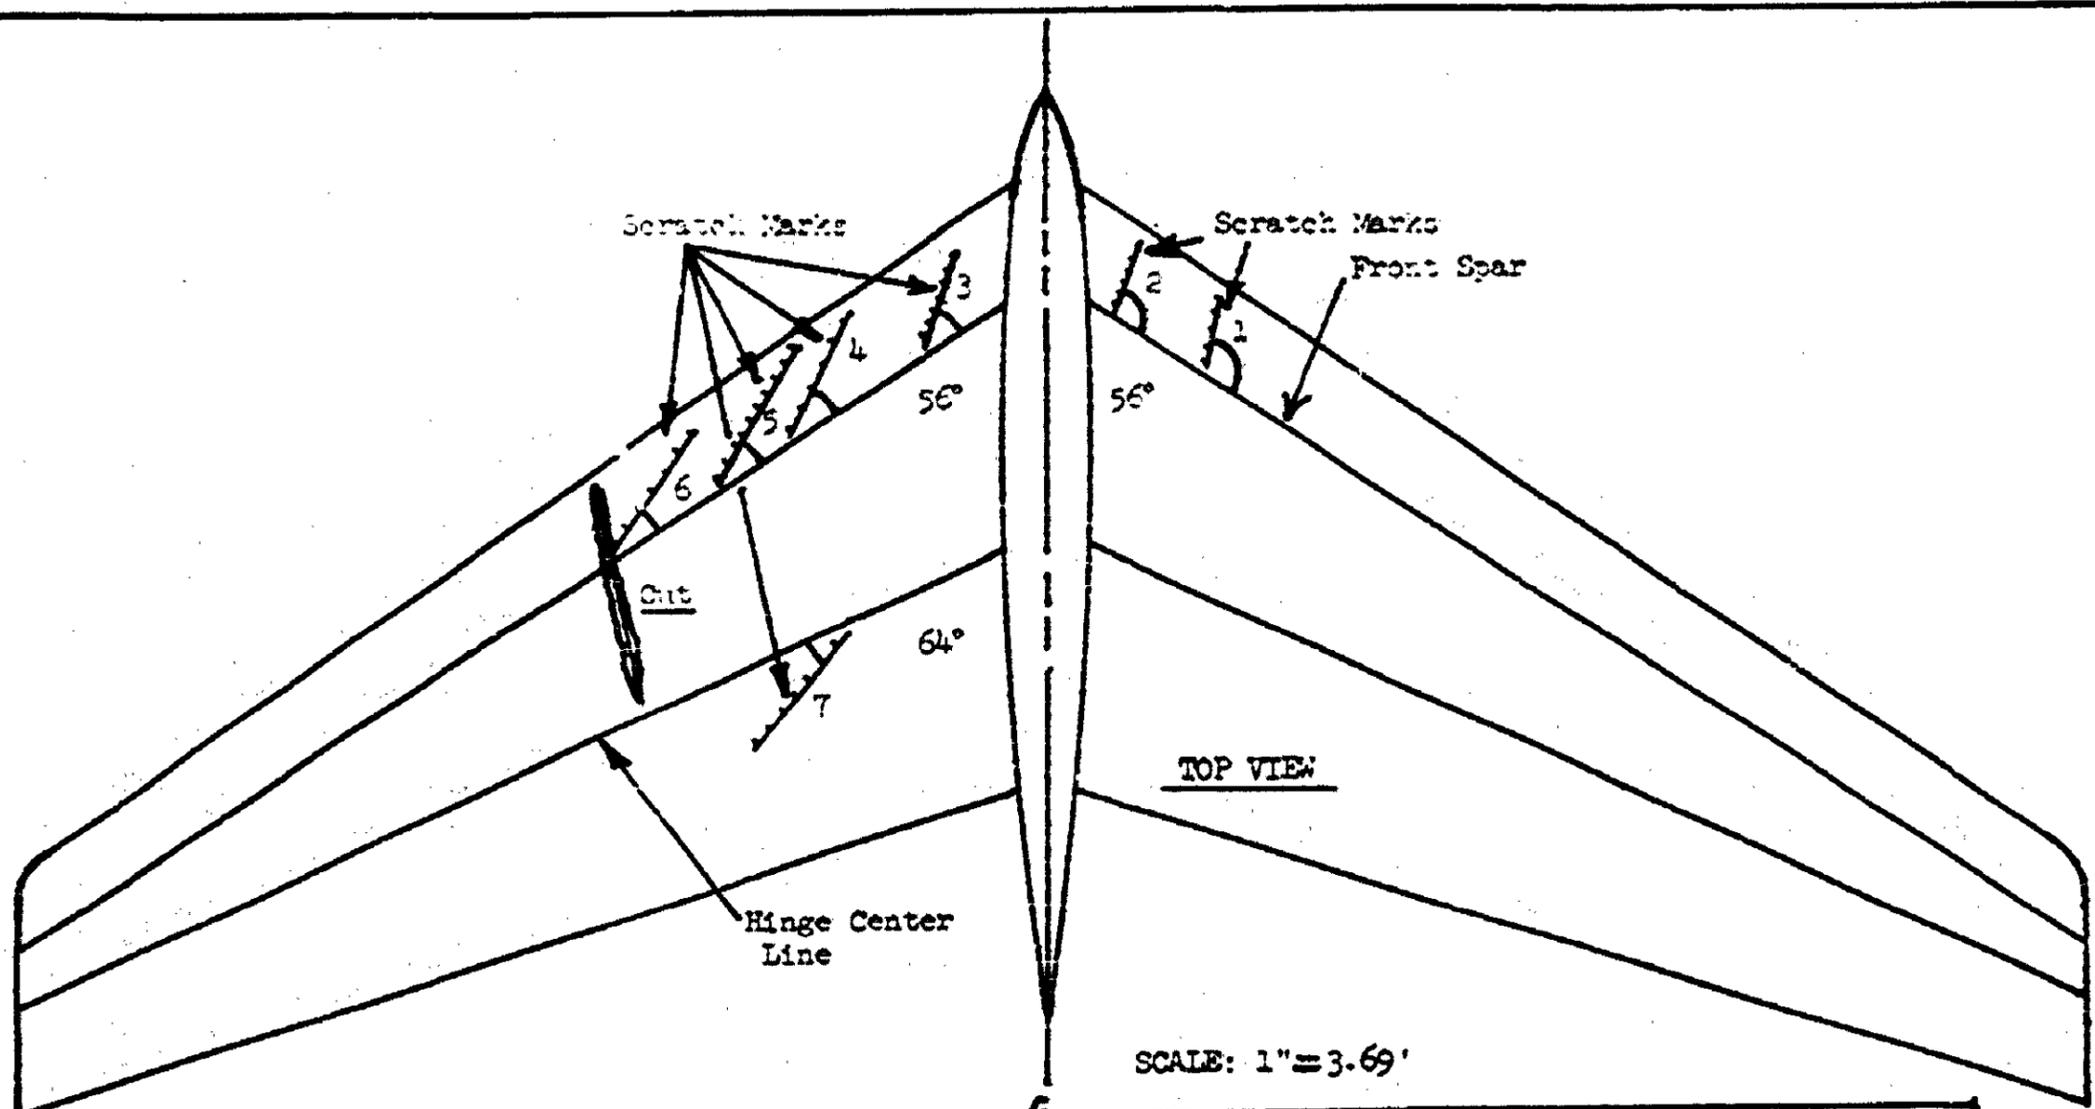
DCA 70-A-4  
 Allegheny Airlines, Inc.  
 DC-9 N988VJ  
 SCRATCH MARKS ON HOR. STABILIZER

The wreckage of both aircraft was moved to Bakalar AFB where a two-dimensional layout was made to study the scratch and scuff marks and determine the principal points of impact and the impact geometry. The initial contact between the two aircraft occurred at the forward upper right side of the vertical fin, just below the horizontal stabilizer, of the DC-9, and the left forward side of the PA-28, just forward of the left wing root. The representative scratch and scuff marks on the DC-9 horizontal stabilizer (Attachment D), nearest the initial point of contact, were aligned at an angle of 22° to the longitudinal axis of the aircraft on the right stabilizer and 16° on the left stabilizer. The scratch and scuff marks on the right wing of the PA-28 (Attachment E) were generally aligned 50° to 60° with the longitudinal axis of the aircraft. A line of sight along the damage through the PA-28 fuselage was approximately 60° to the longitudinal axis of the aircraft. There was no indication of relative motion between the two aircraft in the vertical plane.
