NTSB AAR-70-26

# AIRCRAFT INCIDENT REPORT

ROEING 747-128, F-BPVD

ST. JEAN, P.Q., CANADA

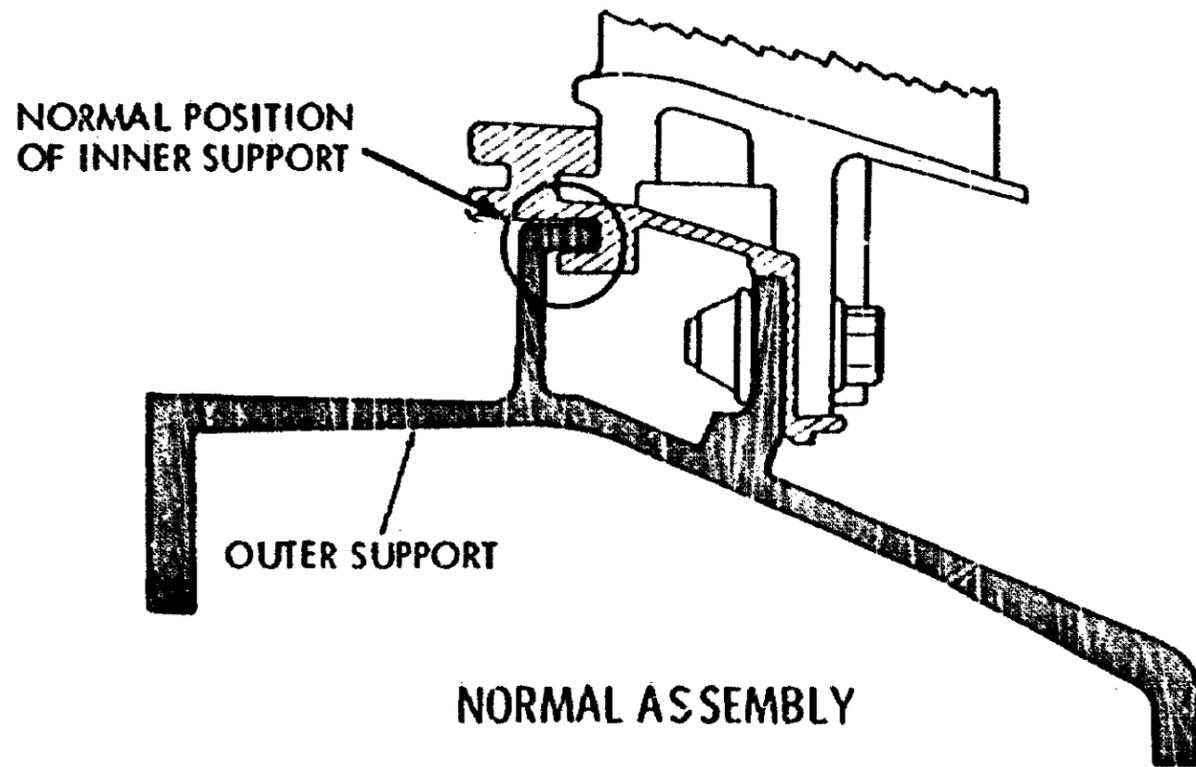
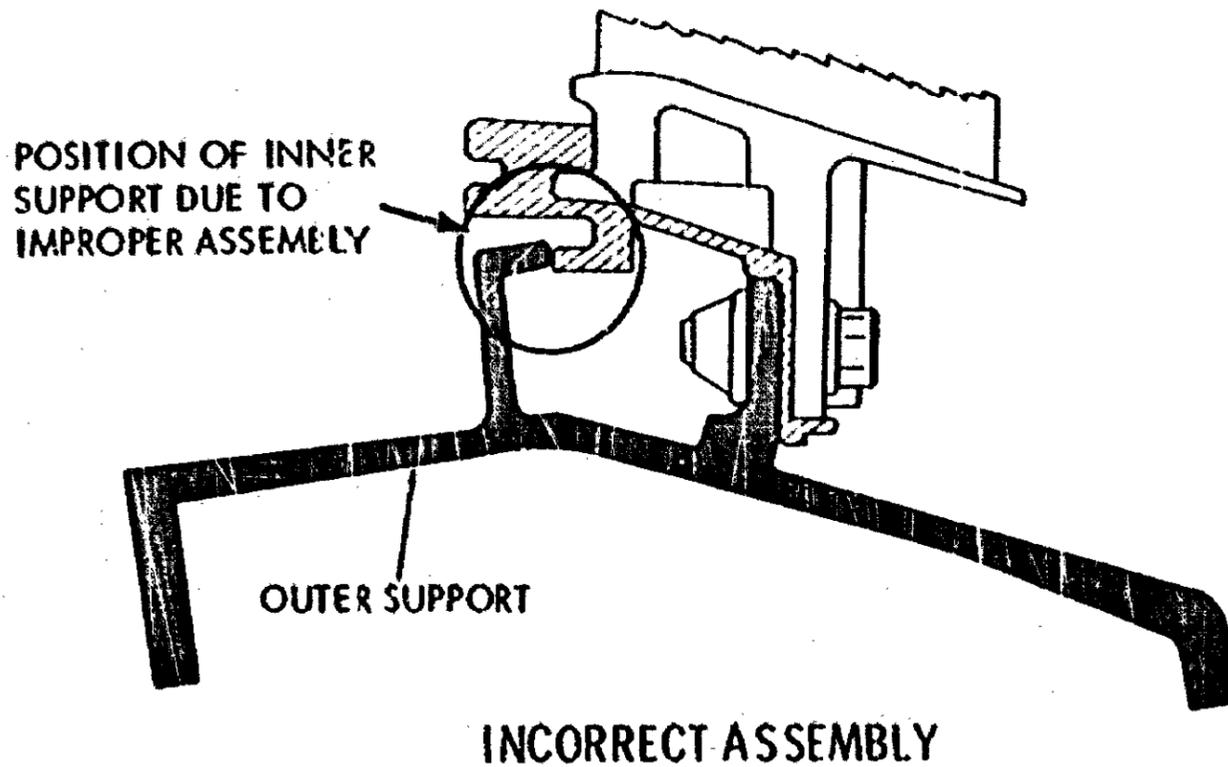
Review of assembly and inspection procedures disclosed that there were written and pictorial instructions for torqueing the 90 bolts securing the 30 vane segments. These instructions, however, did not provide for any specific sequence for accomplishing this operation. Also at the time the HPT module underwent final assembly, there were no provisions for making dimensional checks which could have detected improper positioning of mating parts.

5/ See Attachment 1 for illustration of proper and improper engagement.

installed in this engine, was not correctly assembled. The result was a transient condition of second-stage turbine disk rub against the second-stage turbine vanes, causing grooving of the disk in the rim area. This occurred during application of takeoff thrust when maximum gas velocities in a rearward direction existed. Progressive weakening of the disk around its periphery resulted in separation of the disk rim, and fragments of the rim penetrated the high-pressure turbine case and caused varied degrees of secondary damage and localized fire.

As a result of this incident and identification of the failure mechanism, the manufacturer's assembly and inspection procedures were revised to provide for sequence torquing of the 90 bolts securing the second-stage nozzle guide vanes and a measurement of critical axial dimension to ascertain correct assembly and fits
