# AIRCRAFT INCIDENT REPORT

AMERICAN AIRLINES, INC.,  
BOEING 747-121, N743PA  
SAN FRANCISCO, CALIFORNIA  
SEPTEMBER 18, 1970

NATIONAL TRANSPORTATION SAFETY BOARD  
Washington, D. C. 20591  
REPORT NUMBER NTSB-AAR-71-7

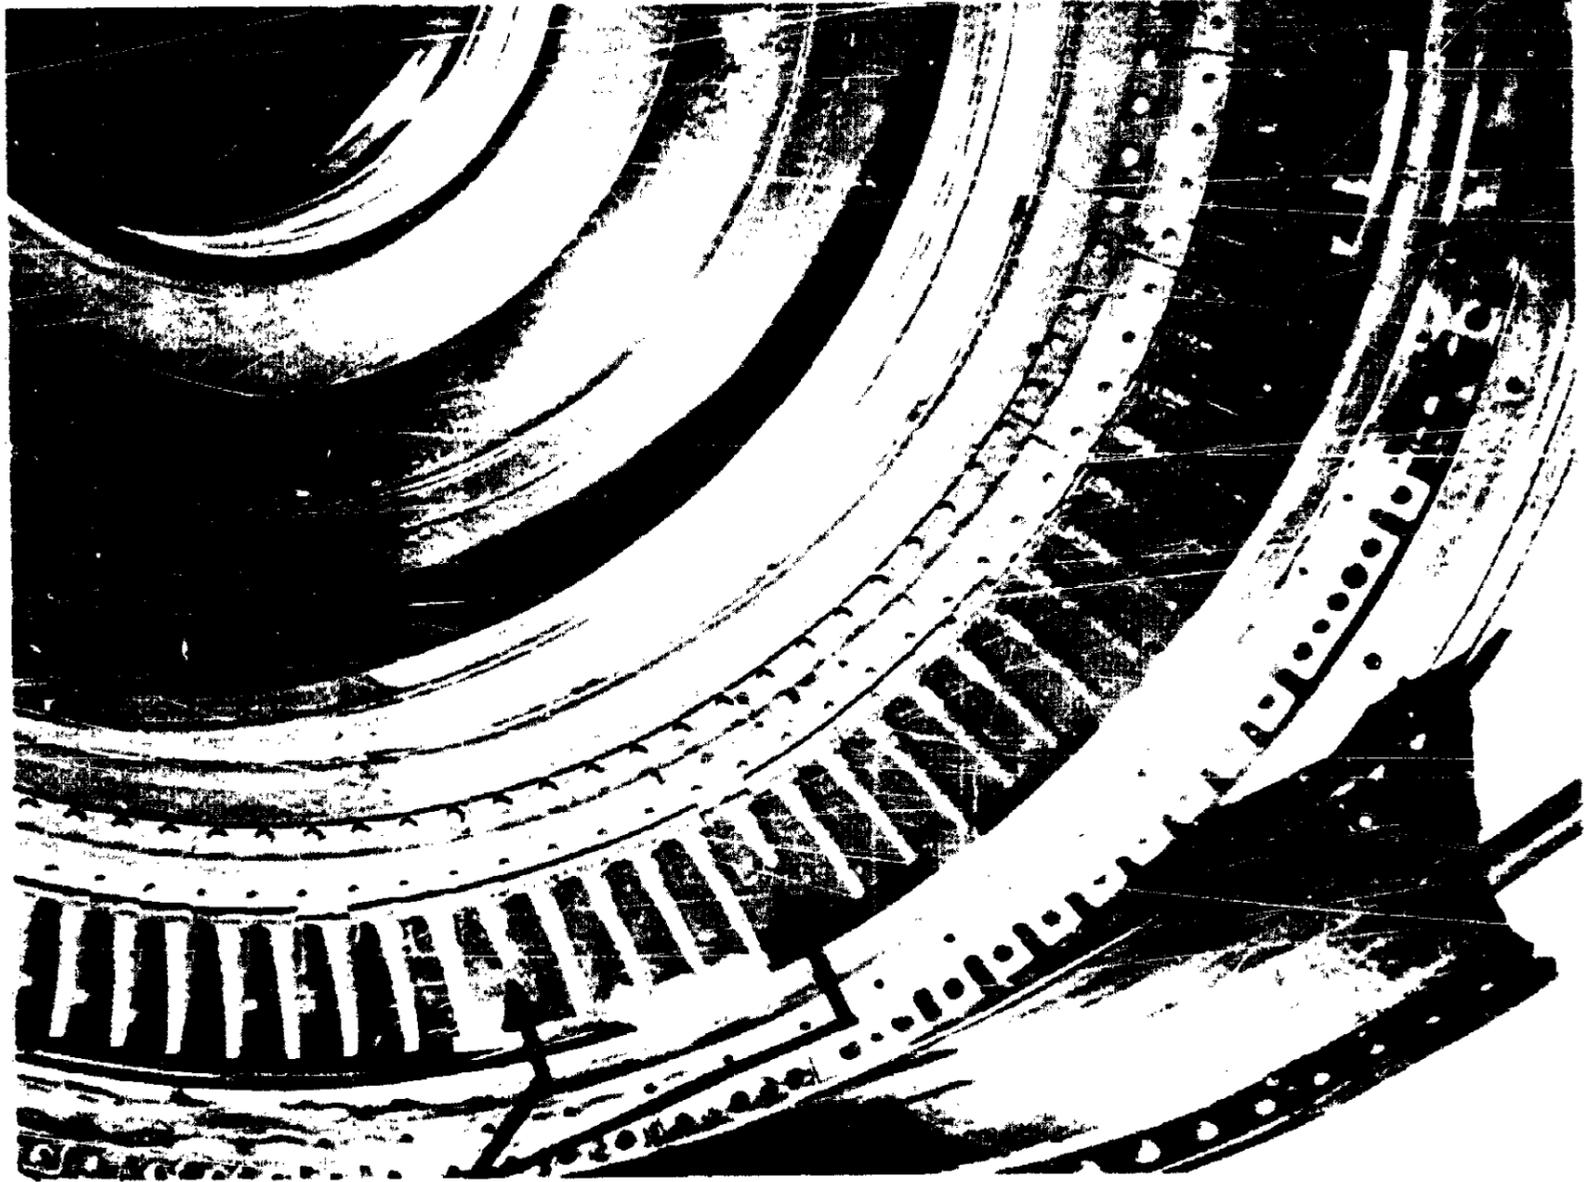
Detailed laboratory examination of seven P/N 674331 first-stage turbine blades disclosed transverse fractures through the airfoil sections approximately 1 inch above the blade root platforms. Thirty additional P/N 674331 first-stage blades exhibited cracks in the leading edges at locations similar to those found in the fractured blades (Photograph No. 5). The complete fractures, as well as the fractures seen through the cracks, exhibited oxide discolored dendritic surfaces. There was no evidence of fatigue. Spectrographic analysis of the turbine blade material disclosed that the material fully conformed to required specifications. None of the failed blades, nor 16 additional blades sectioned at random, showed any evidence of blocked cooling passages.

Photograph No. 5    Quarter of first-stage turbine wheel No. 1 engine W-30A showing  
two of the fractured turbine blades. (See arrows at top of photo).

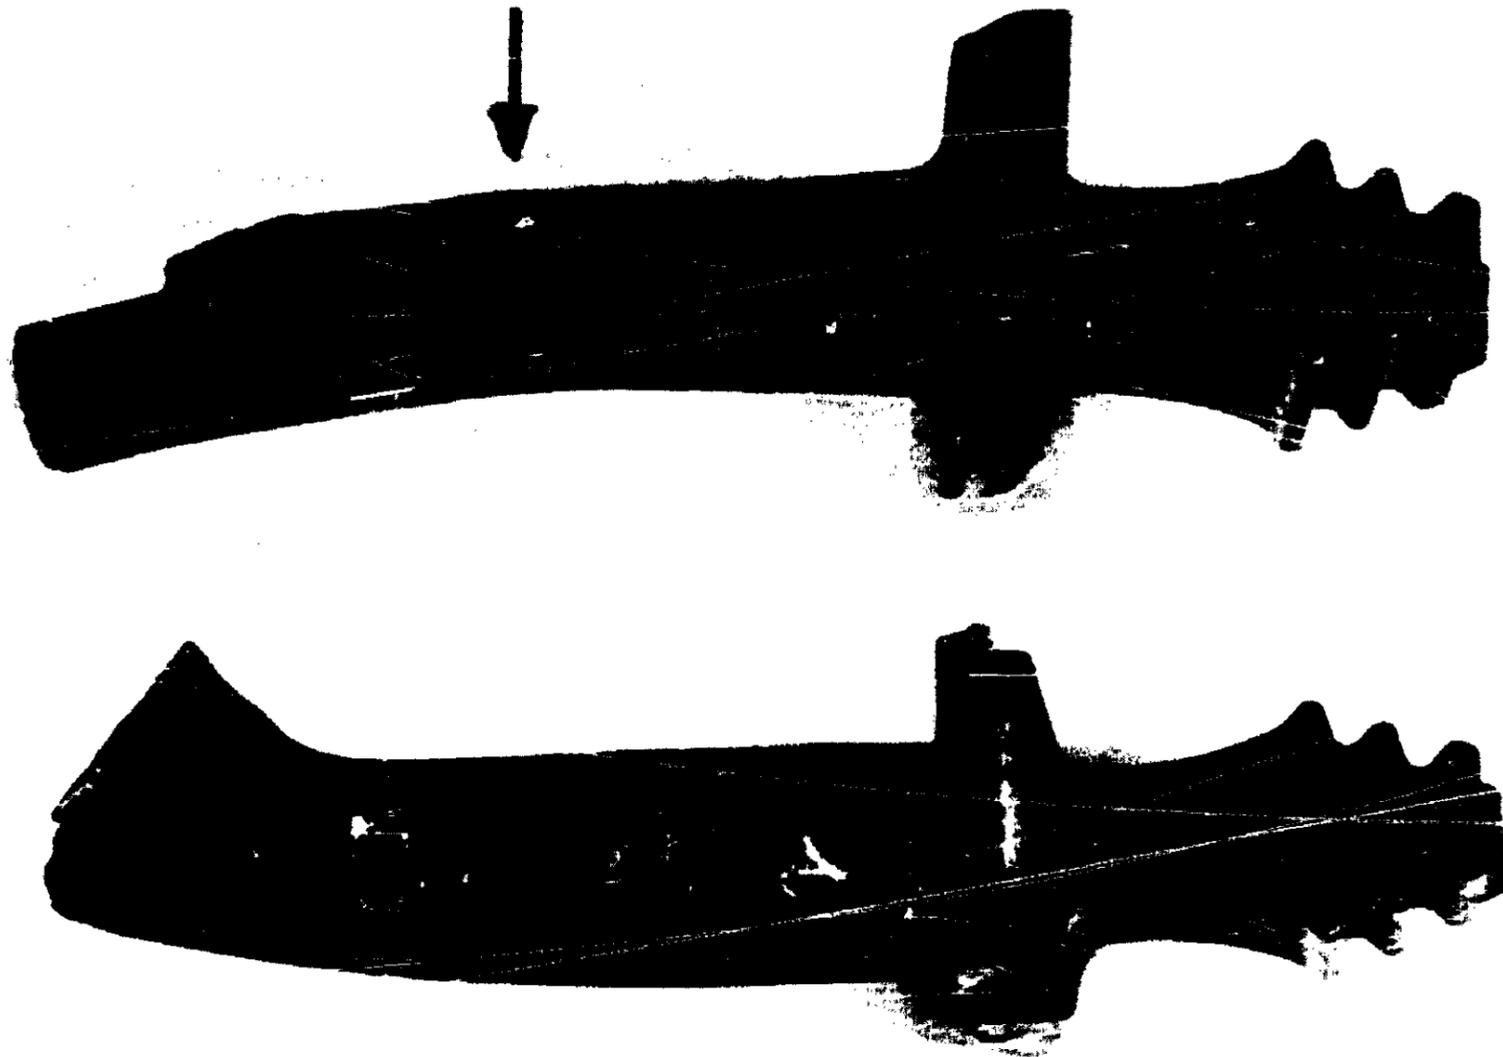
Metallographic examination of the fractured blades disclosed intergranular, oxidized fracture surfaces with associated alloy depletion. Evidence of sulfidation attack was also present along the fracture surfaces. This examination also provided evidence of metal temperatures of approximately 2,050° F. to 2,200° F. at the first-stage blade leading edges, and 2,000° F. to 2,050° F. at the blade trailing edges. Normal leading edge temperature of first-stage blades at takeoff thrust, operating on a standard 80° F. day, average 1,970° F. Under the same conditions, the maximum permissible temperatures at this point are between 2,025° F. and 2,050° F.

Photograph No. 6 Two first-stage turbine blades showing airfoil bending and stress rupture crack of one blade. Blade on top of photograph shows partial crack in the same general area where complete fractures occurred.
