AIRCRAFT ACCIDENT REPORT

MISSISSIPPI VALLEY AIRWAYS, INC.

DeHAVILLAND DHC-6, N956SM

LA CROSSE, WISCONSIN

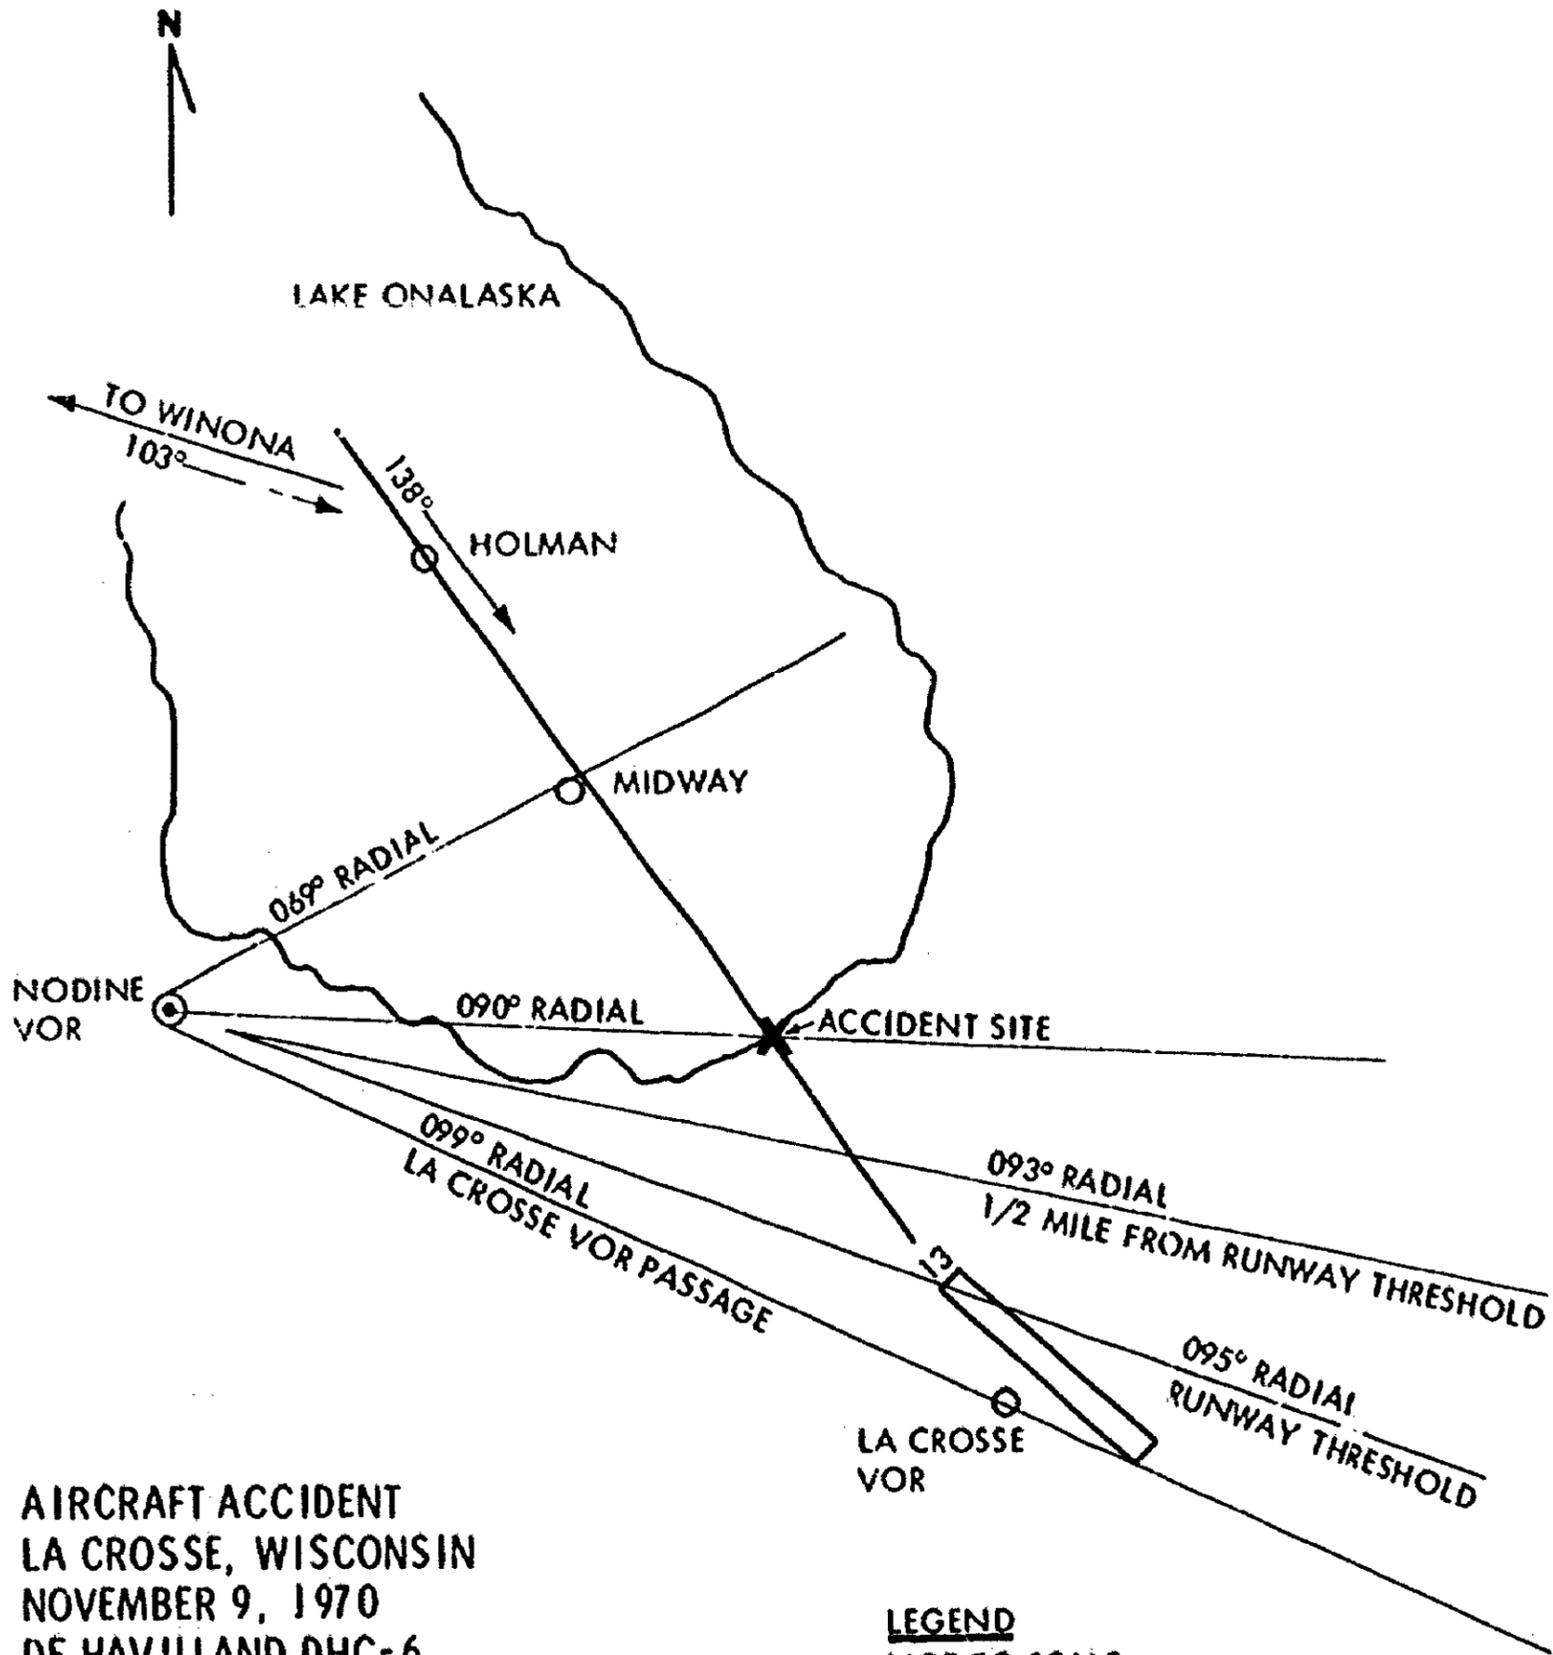
AIRCRAFT ACCIDENT
LA CROSSE, WISCONSIN
NOVEMBER 9, 1970
DE HAVILLAND DHC-6
N 95S SM

The Midway Intersection, the final descent fix for Runway 13, is positioned 5.1 nautical miles from the touchdown zone of that runway. This fix is shown as the intersection of the 069° radial of the Nodine VOR and the 138° inbound radial, to the La Crosse VOR. ^{1/} Pilots are authorized to descend to the minimum descent altitude of 1,040 feet m.s.l., or 383 feet above the touchdown zone elevation of Runway 13, for a straight-in approach, after they cross the VOR at La Crosse.

The pilots of VALAIR 106 stated that they normally monitor the aircraft's progress along a 5.1 nautical-mile track from the Midway final descent fix to the La Crosse VOR by utilizing an arbitrary radial from the Nodine VOR. The captain stated that the 090° Nodine VOR radial was selected for reference on this particular approach. This radial is selected to intercept the inbound course at a position that will indicate to the pilot that the aircraft is passing over a point about one-half mile from the threshold of the approach to Runway 13. This point coincides with a ground position where the approach course line and the shoreline intersect.
