AIRCRAFT ACCIDENT REPORT

COMMUTER AIRLINES, INC.

BEECHCRAFT C-45H (INFINITE II), N497DM

MARCH 22, 1970

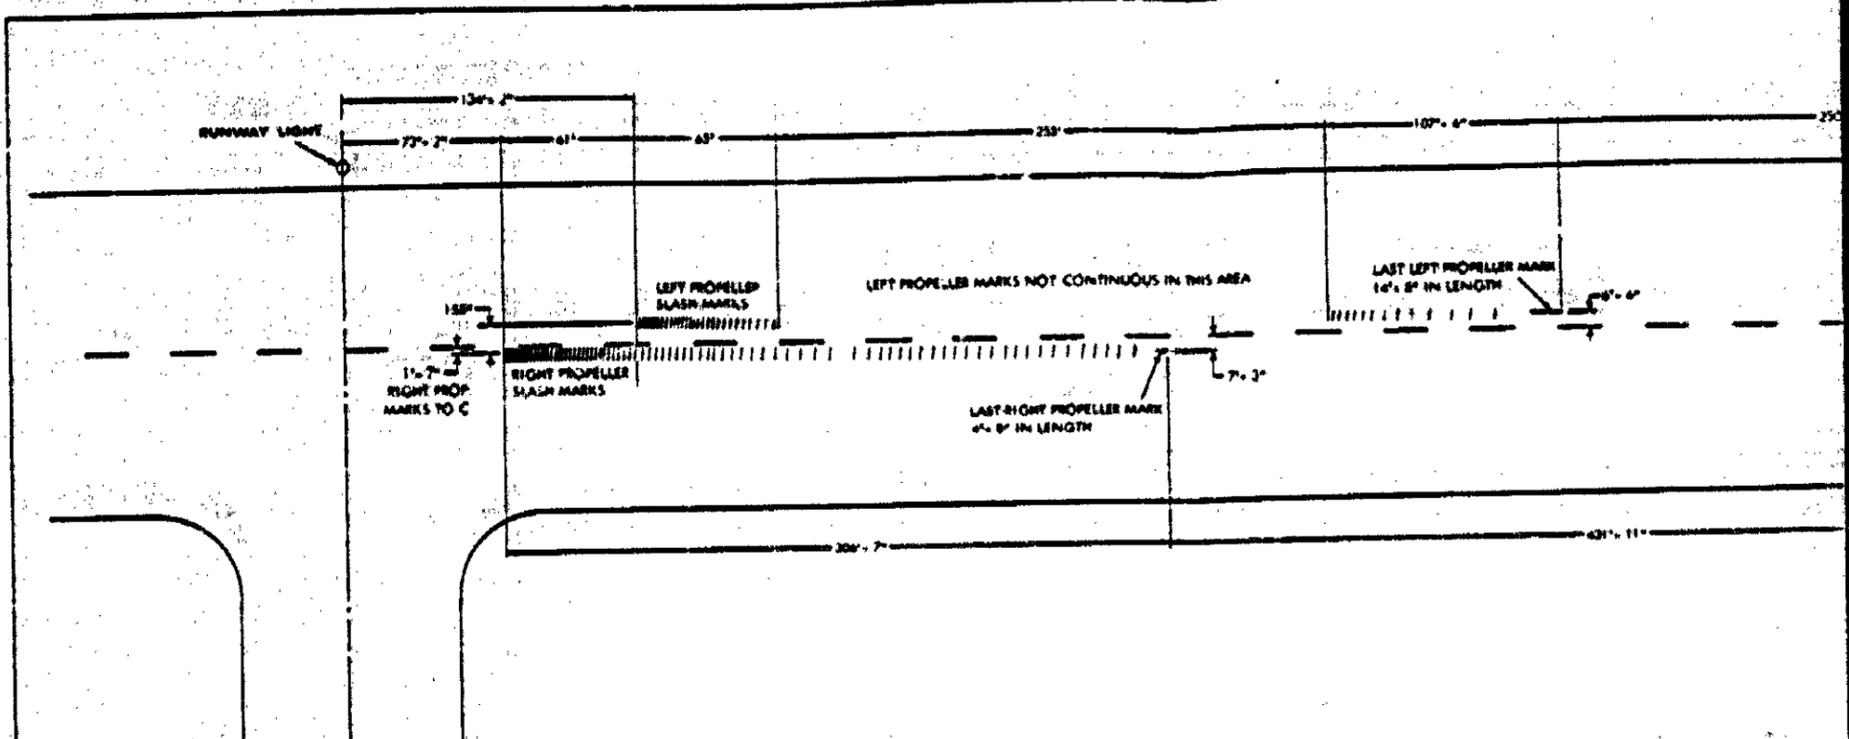
Propeller slash marks were found on the surface of the runway, starting at a point approximately 738 feet from the departure end and continuing for about 490 feet along the approximate center of the runway. One tip of the left engine propeller was recovered near the end of the runway.

RIGHT PROPELLER MARKS
MEASURED DISTANCE BETWEEN MARKS - APPROXIMATE

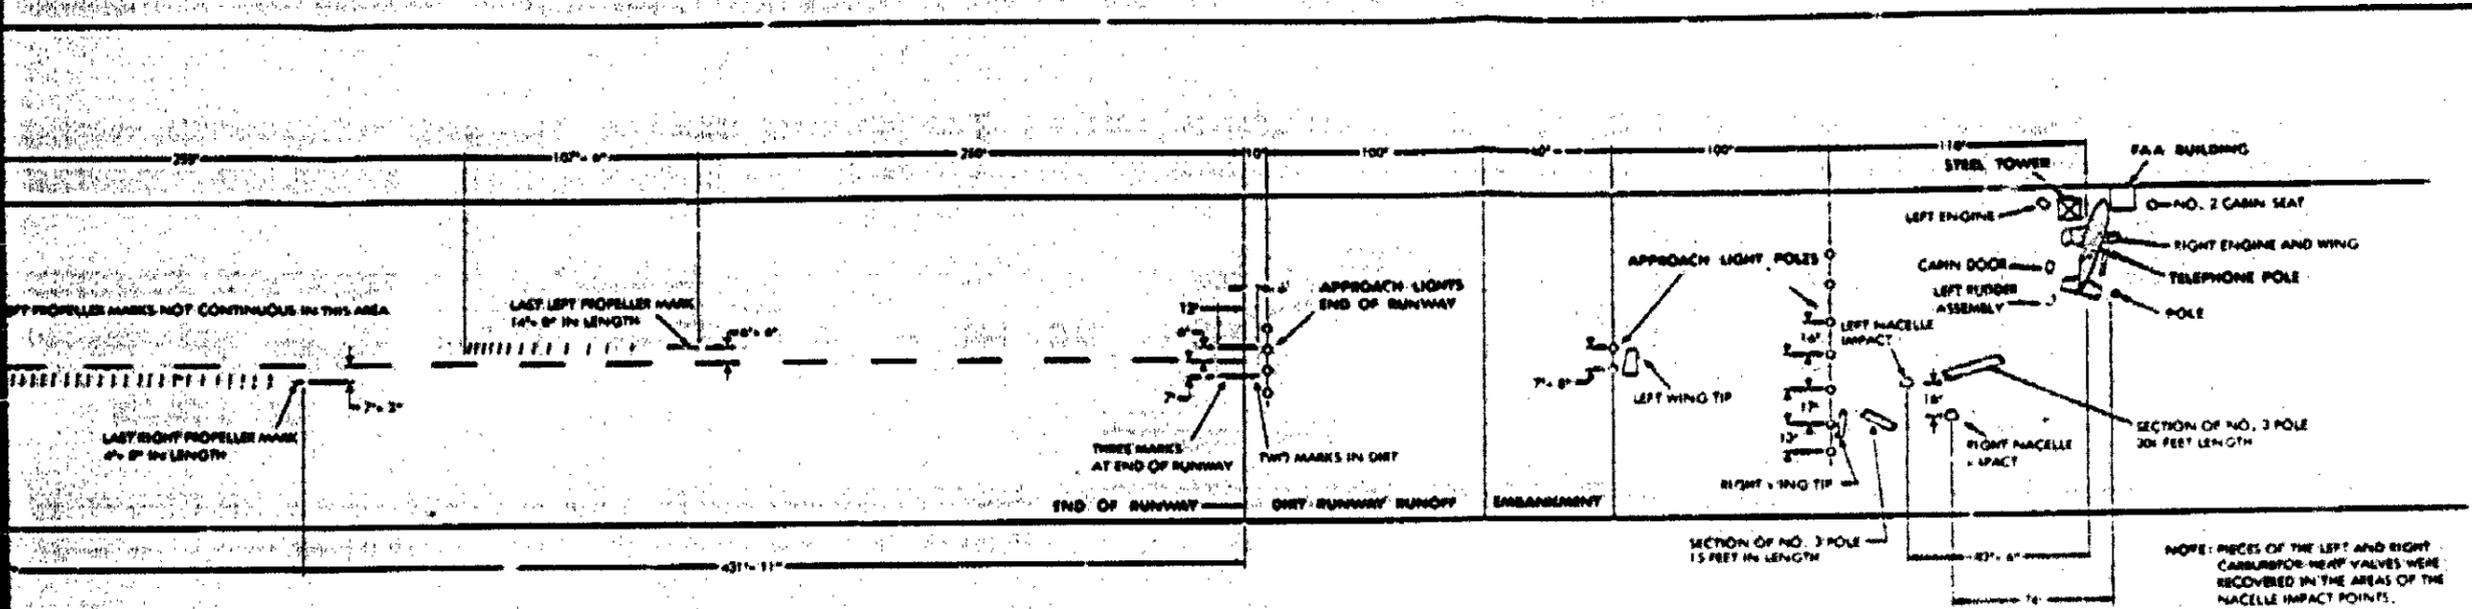
NOTE: PIECES OF THE LEFT AND RIGHT CARBURATOR-NEAR VALVES WERE RECOVERED IN THE AREAS OF THE MACELLE IMPACT POINTS.

LEFT PROPELLER MARKS MEASURED DISTANCE BETWEEN MARKS (APPROXIMATE)
