AIRCRAFT ACCIDENT REPORT

Delta Air Lines, Inc.
Douglas DC-9-32, N3329L
Louisville, Kentucky
September 8, 1970

REPORT NUMBER NTSB-AAR-71-15

DELTA AIR LINES, INC.
DOUGLAS DC 9-32, N3329L
LOUISVILLE, KENTUCKY
SEPTEMBER 8, 1970

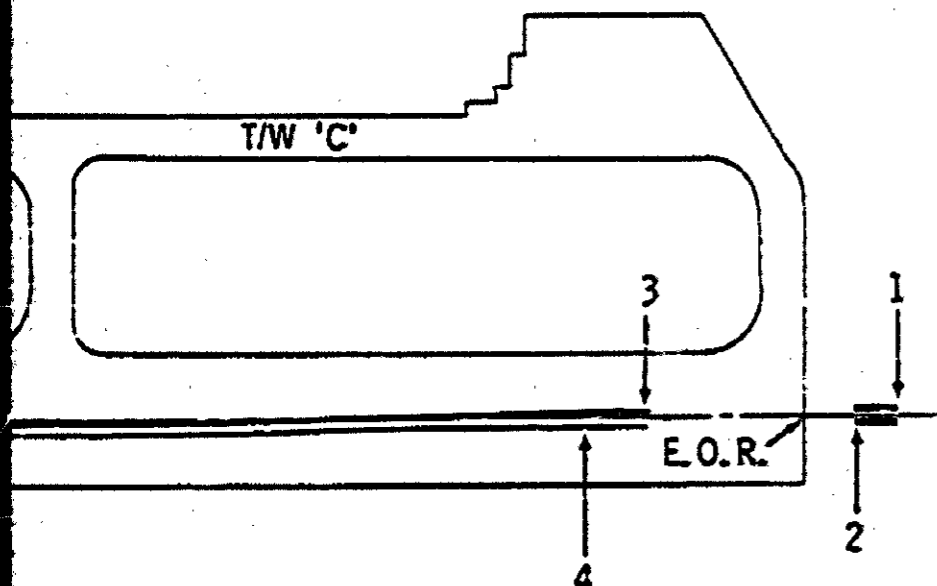
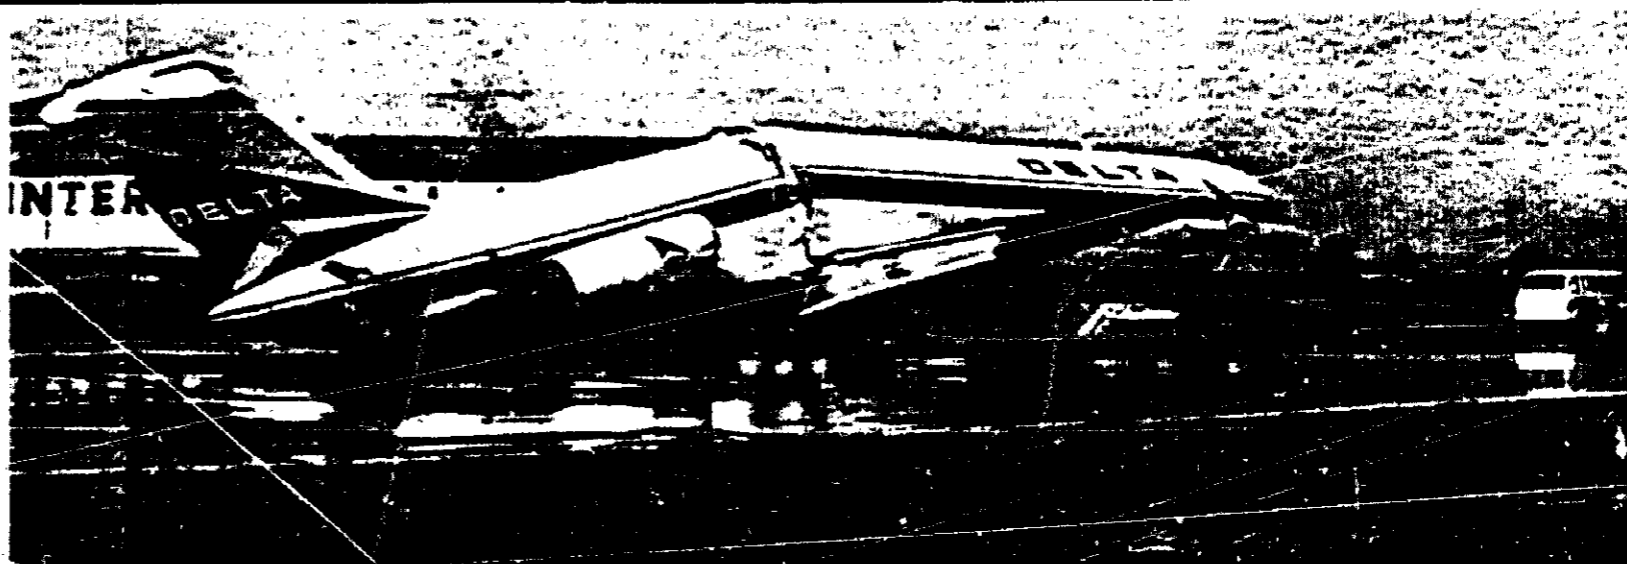
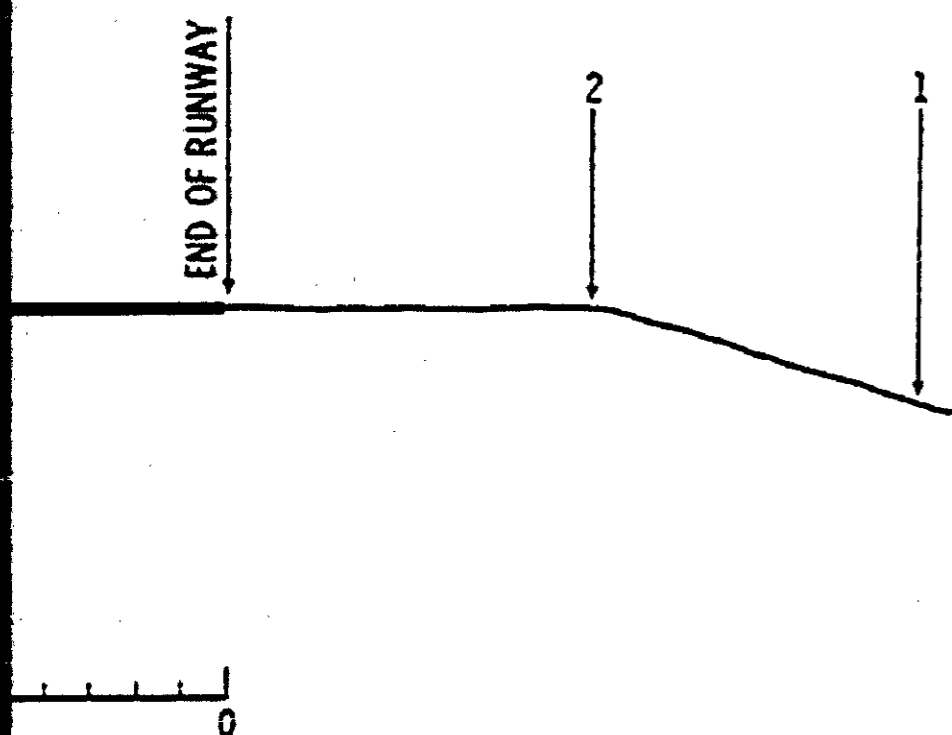
**PLAN AND PROFILE VIEW OF
RUNWAY 29**

Flight 439 made initial ground contact on this incline 156 feet short of the threshold of the runway, rolled forward 73 feet, and became airborne. The aircraft then contacted the runway 262 feet beyond the threshold and continued to roll/skid on the runway before it came to rest 4,457 feet beyond the threshold. (See Attachment 2.)

1. TOUCHDOWN POINTS OF THE LEFT AND RIGHT MAIN LANDING GEAR TIRES 156 FEET BEFORE THE RUNWAY THRESHOLD.
2. TRACKS OF THE LEFT AND RIGHT MAIN LANDING GEAR TIRES END 83 FEET BEFORE THE RUNWAY THRESHOLD.
3. INDICATIONS OF REAR FUSELAGE CONTACT ON THE RUNWAY 262 FEET FROM THE THRESHOLD.
4. INDICATIONS OF THE LEFT MAIN LANDING GEAR TIRES SKIDDING ON THE RUNWAY SURFACE 385 FEET FROM THE THRESHOLD AND 8 FEET TO THE LEFT OF THE RUNWAY CENTERLINE.
5. INDICATIONS THAT THE LEFT MAIN LANDING GEAR TIRES HAD BLOWN-OUT 1,488 FEET FROM THE RUNWAY THRESHOLD AND 16 FEET TO THE LEFT OF THE RUNWAY CENTERLINE.
6. STOPPING POINT OF THE AIRCRAFT ON THE RUNWAY 4,457 FEET FROM THE THRESHOLD.
