AIRCRAFT ACCIDENT REPORT

MONMOUTH AIRLINES, INC.

Scheduled Air Taxi
Beech 99, N-986MA
Allentown-Bethlehem-
Easton Airport
Allentown, Pennsylvania
October 24, 1971

REPORT NUMBER: NTSB-AAR-72-3

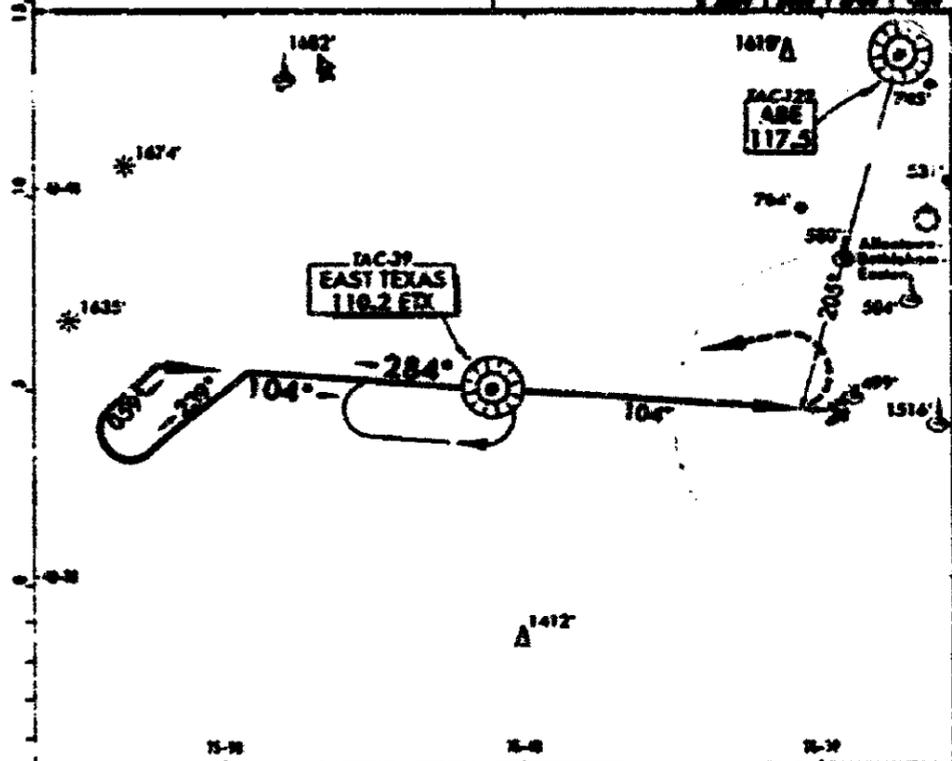
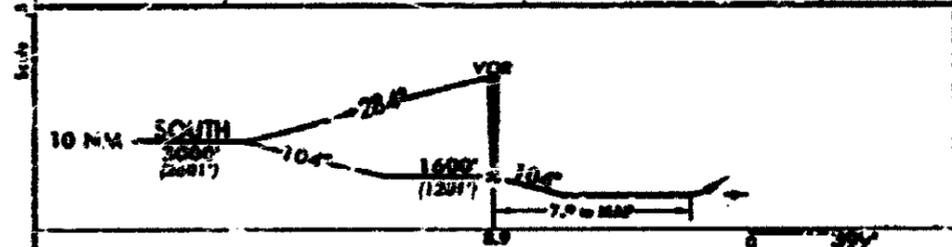
Jeppesen Approach Chart SEP 24/71 (23.1) ALLENTOWN, PA. - QUEEN CITY MUNI VOR-1
 Apt. Elev 399' VOR 118.2 ETX
 Use Altimeter FSS altimeter setting.
 Vcr 10°W Class B VOR/TAC
 ALLENTOWN Approach 118.2

The Queen City Municipal Airport is close to the ABE Airport, and has a VOR-1 approach plate with peculiar similarity to the ABE VOR-1 approach plate. The Queen City VOR-1 approach utilizes the East Texas VOR facility

for the approach to Queen City Airport. The ABE VOR-1 approach utilizes the Allentown VOR facility for the approach to ABE. However, the minimum altitude over the final approach fix for the Queen City approach is 1,600 feet, whereas the minimum altitude over the final approach fix for the ABE approach is 2,200 feet. Both of these approach plates were filed together in the same approach plate binder utilized by Monmouth Airlines. (See Attachment B for approach details and minima for each facility.)

Since the flight had been cleared from Wilkes-Barre direct to ABE, the pilot likely would have established course on the Allentown 360° radial utilizing the Allentown VORTAC. Hence, in referring to the approach plate, his main concern might have been the minimum altitude over the final approach fix. According to the Allentown Approach Control communications transcript, the pilot used the 030° radial of the East Texas VOR to establish a 12-mile position north of the Allentown VORTAC because of the erratic operation of his DME. That the 12-mile fix was established is shown by the pilot's computation of the 6-minute estimate from the station. It is possible that at this point, as a result of fatigue and the previous flight delays, the pilot elected to make a straight-in approach to the ABE Airport without proceeding to the VOR station at the minimum en route altitude, or executing the procedure turn as required. If, in this circumstance, the Allentown Queen City VOR-1 approach chart was used mistakenly to determine the minimum altitude for crossing the final approach fix, the aircraft would have been descended to 1,600 feet instead of the correct altitude of 2,200 feet as shown on the Allentown-Bethlehem-Easton chart. (See Attachment B.) The result would be a descent below terrain elevation in the Blue Mountain area.

Since both instrument approach plates are entitled "VOR-1" and have the word Allentown twice in proximity thereto, it is entirely possible that haste, poor lighting, or other factors might have caused the pilots to select the wrong approach plate for the approach they were conducting. Thus, when the aircraft was cleared for the approach and erroneously descended to 1,600 feet m.s.l., there was inadequate terrain clearance, and the ensuing accident was inevitable.

- (1) Require some conspicuous and distinctive marking to be affixed to the Allentown approach plates to enable pilots to identify the proper plate quickly and positively. The words "CAUTION -- VERIFY PROPER APPROACH" or similar phraseology may be appropriate.
- (2) Promptly review all instrument approach plates to determine instances of potential approach plate misidentifications in other locations, and if found, institute the same remedial action.
- (3) As an interim measure, notify the public of this potential hazard by whatever means you deem most expeditious and effective.

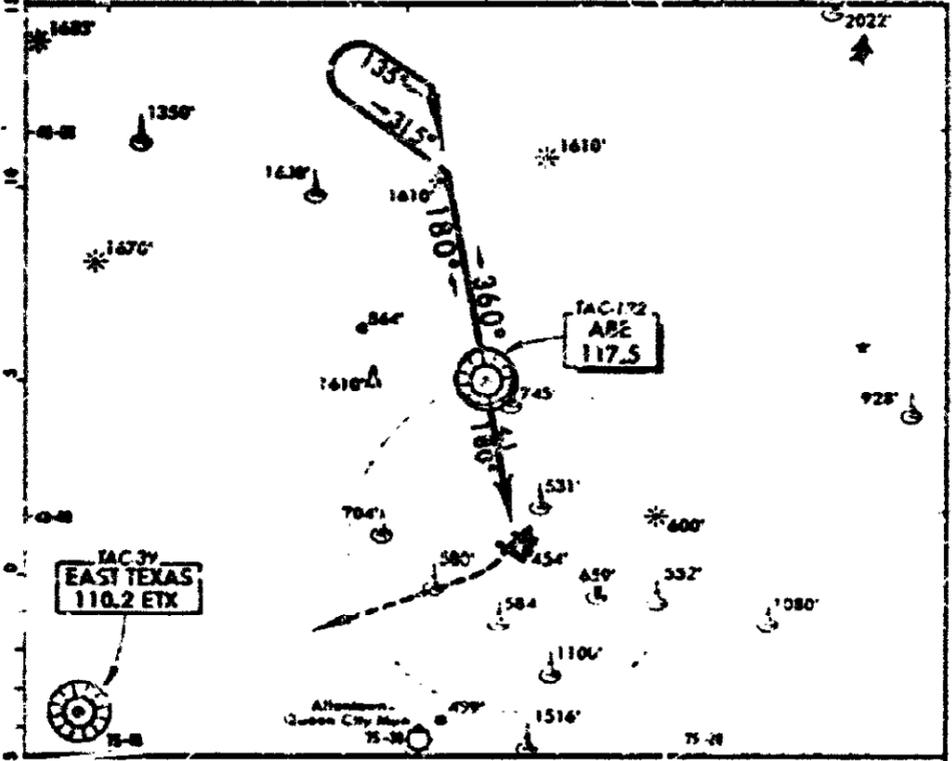
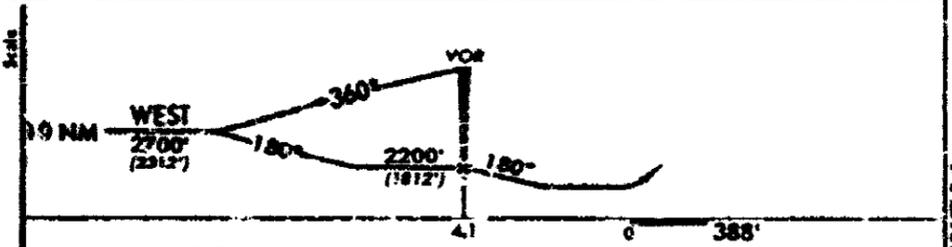
Jeppesen Approach Chart OCT 1/71 (23.1) ALLENTOWN PA. - BETHLEHEM-EASTON VOR-1
 APT. Elev 388' VOR 117.5 ABE
 Use Altimeter FSS altimeter setting.
 Vcr 10°W Class B VOR/TAC
 ALLENTOWN Approach 118.2

The aircraft crashed 10 miles north of the airport and 5 miles north of the Allentown VOR at an altitude of 1,600 feet mean sea level (m.s.l.). In an attempt to ascertain why the aircraft was at that altitude, at that point, the VOR approach plates were reviewed closely. It was noted that 1,600 feet m.s.l. is the low station altitude for the Allentown VOR approach to the Queen City Municipal Airport, utilizing the East Texas VOR. The VOR approach to the Bethlehem-Easton Airport, using the Allentown VOR, has a low station altitude of 2,200 feet m.s.l.
