AIRCRAFT ACCIDENT REPORT

TRANS CARIBBEAN AIRWAYS, INC.

Boeing 727-200, N8790R

REPORT NUMBER: NTSB-AAR-72-8

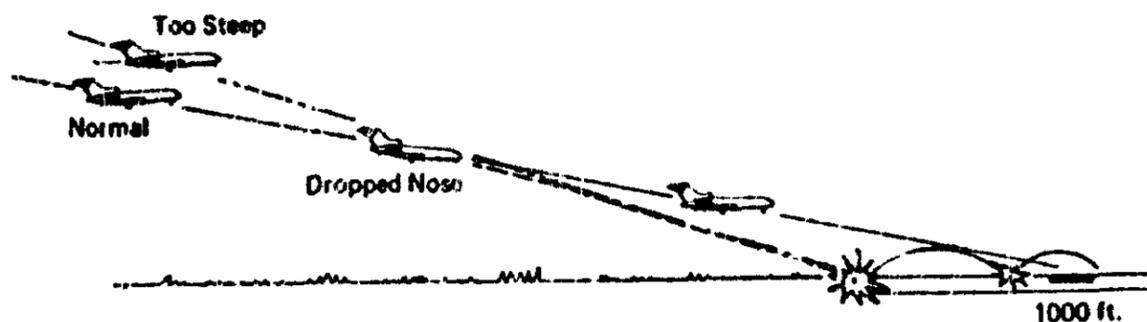
Figure 1. Bounce Landing

A normal approach aimed at the 1000 foot mark can result in a hard landing when the pilot unintentionally moves his eyes to the approach end of the runway as he nears the runway or "breaks out" on an instrument approach. Thus, the nose is dropped and the rate of descent increases--unnoticed--until too late. See Figure 1.

If a high hard bounce occurs, the thrust must be increased to control the rate of descent for the second touchdown, or to perform a go-around if excessive runway has been used.

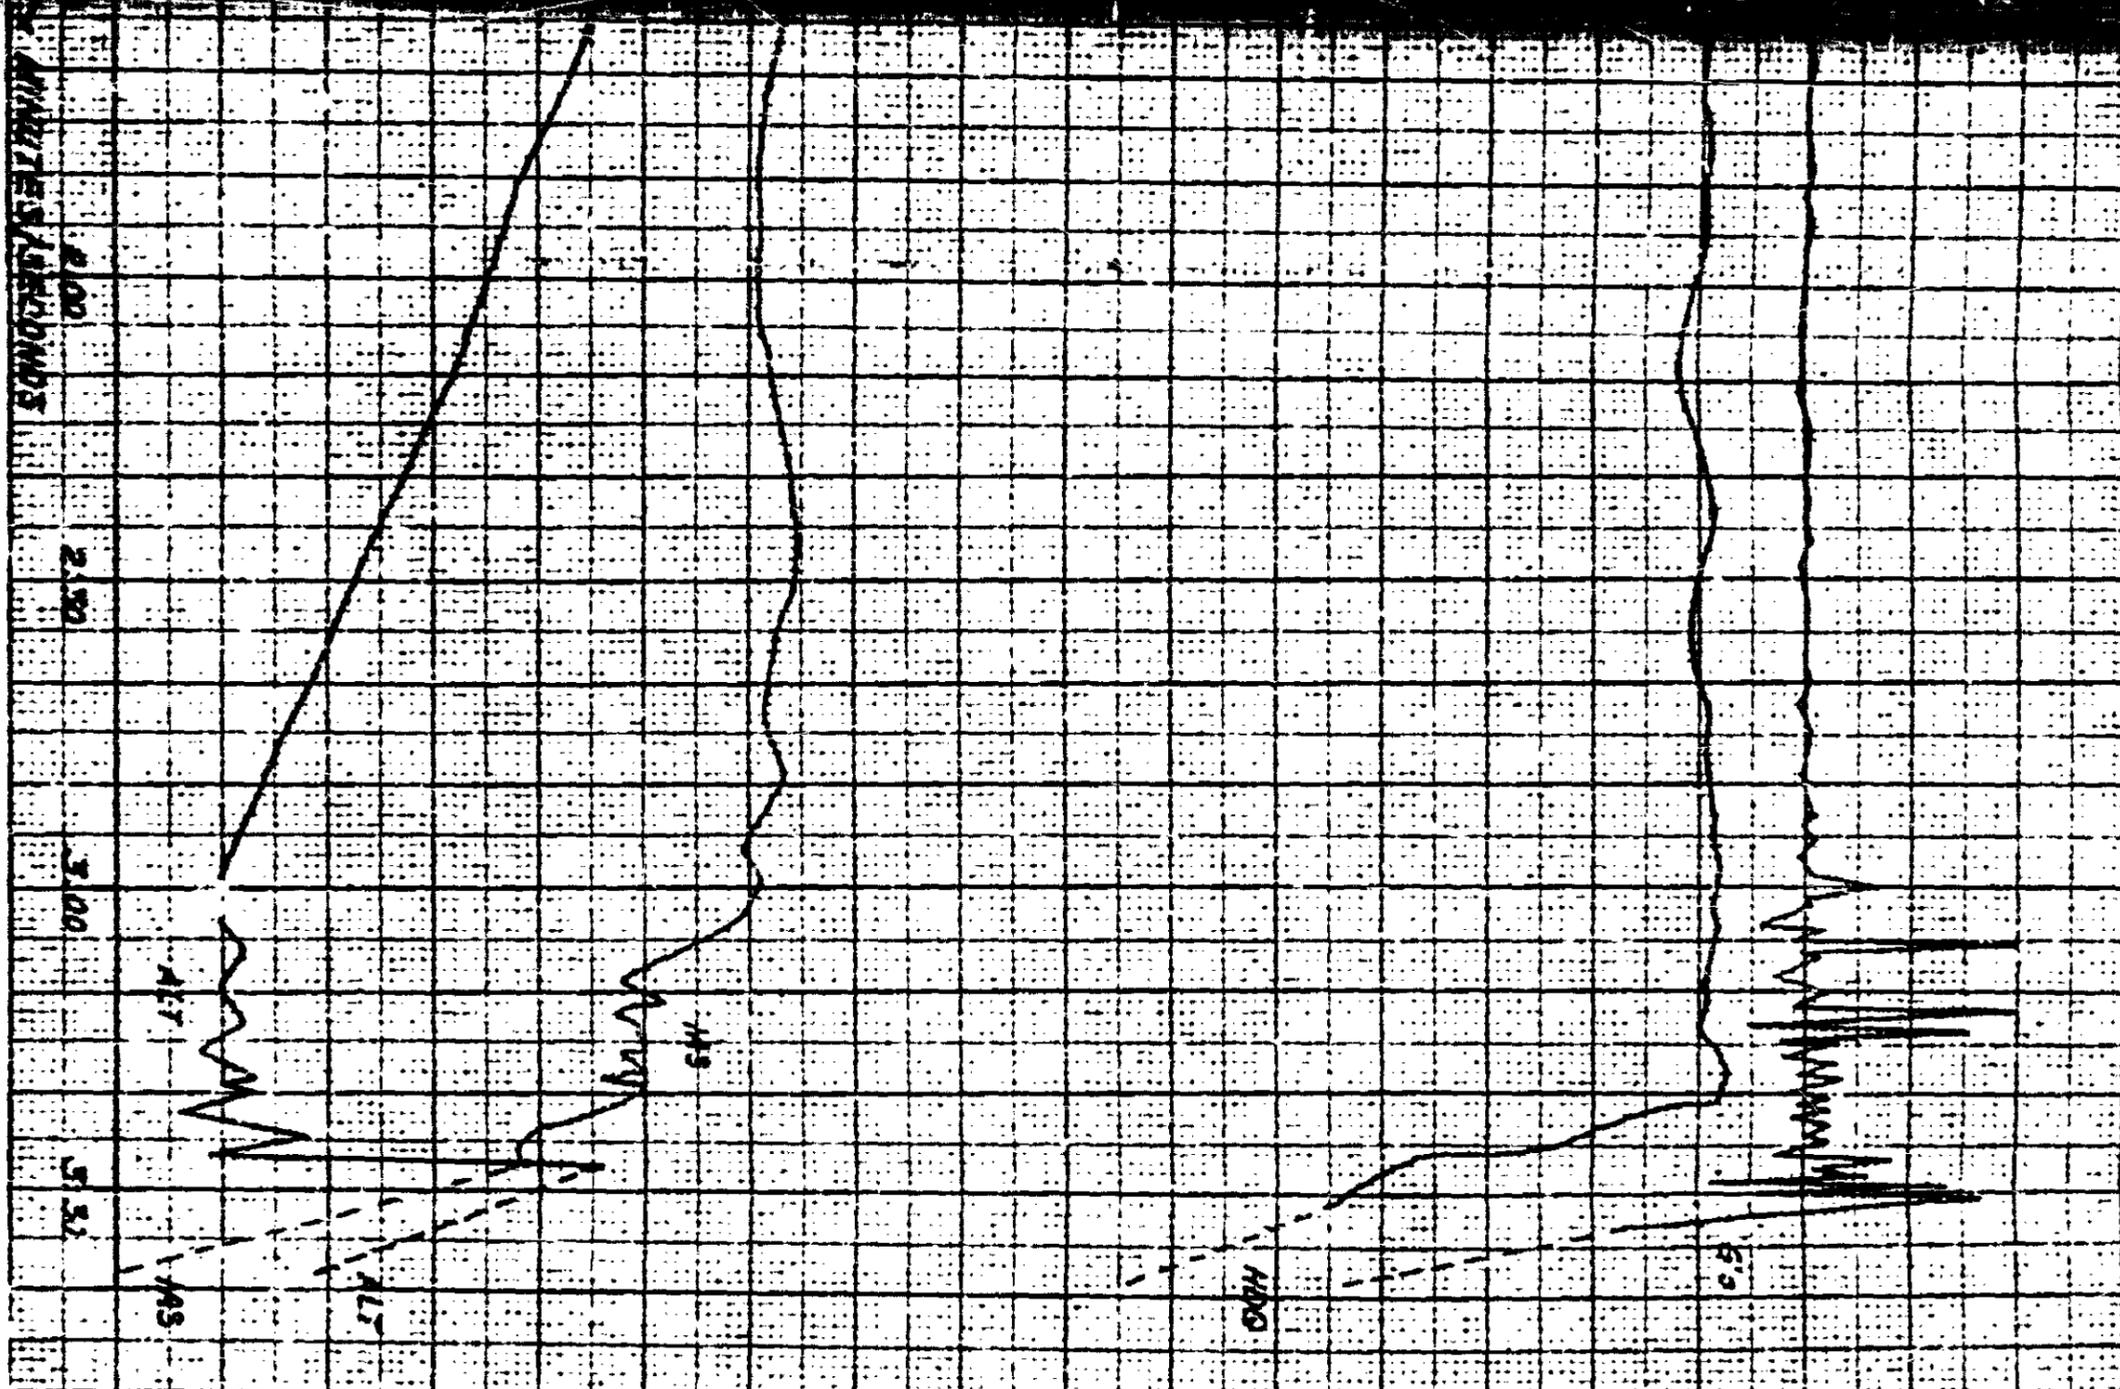
ATTACHMENT 1

Several witnesses verified that the third touchdown occurred about 2,700 feet from the threshold, and that the right wing tip settled and began to drag on the runway immediately after the touchdown. The local controller said that the fire department was called just after this bounce. It was about this time that the captain called for a go-around, according to the other crewmembers, and the flight engineer advised him not to. The captain advanced the thrust lever, and he called for the flaps to be raised to 25°. The flight engineer noted that he tried, first with his left hand and then with both hands, before he succeeded in raising the flap lever to the 25° setting. The aircraft veered off the runway 3,800 feet beyond the threshold, and the first officer helped the captain regain directional control.

At a point 1,490 feet from the threshold, a 17-foot long groove was cut into the surface of the runway parallel to the centerline. The tailskid scuff block from the aircraft, which was worn flat, was removed from the wreckage and found to match the width of this groove.

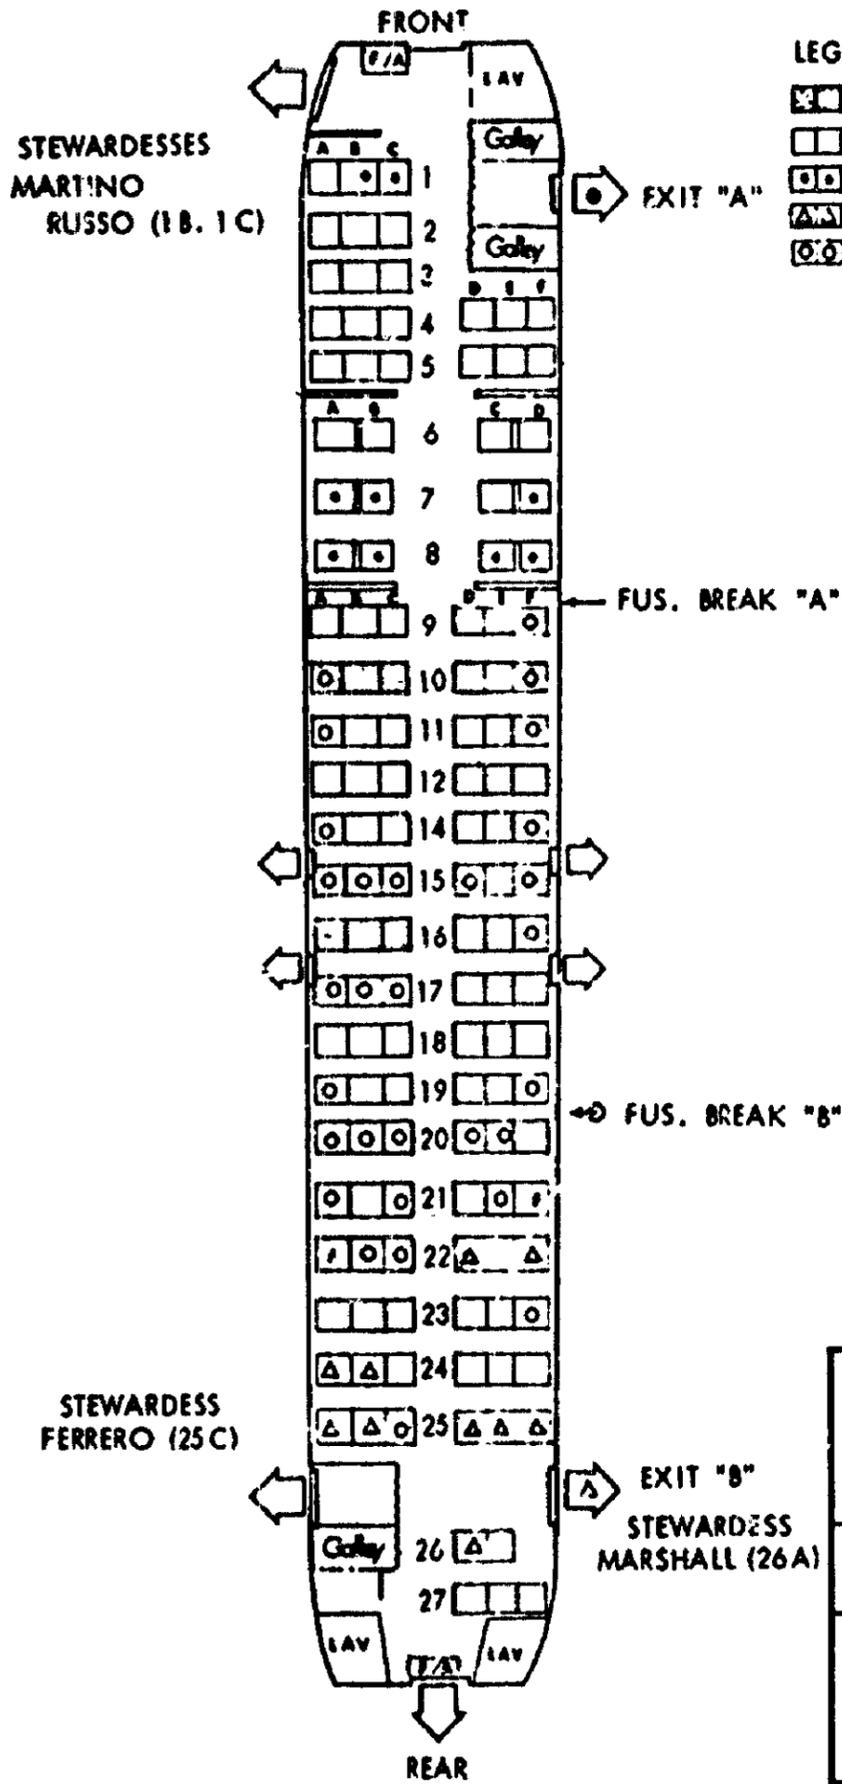
ATTACHMENT 2
 NATIONAL TRANSPORTATION
 SAFETY BOARD
 Washington, D. C.

This was a survivable accident. Of the 55 persons aboard, all seven crewmembers and 46 of the 48 passengers survived. The cause of the two fatalities was attributed to burns. One fatality reportedly was trapped by debris between two seats in Row 22. The body of the other fatality was recovered, free from its seat, on the ground in the area of the aft break in the fuselage.

There were eight known passenger seat failures in the aircraft. However, the frame of only one seat unit was found, the others having been consumed by the fire. The seat frame, which was that of a right-hand triple unit, was found near the break at FS 940. All of the legs of the seat were fractured, and the entire seat showed a lateral deformation to the left.
