**AIRCRAFT ACCIDENT REPORT**

UNITED AIR LINES, INC.  
Boeing 737-222, N9005U  
PHILADELPHIA INTERNATIONAL AIRPORT  
Philadelphia, Pennsylvania  
July 19, 1970

REPORT NUMBER: NTSB-AAR-72-9

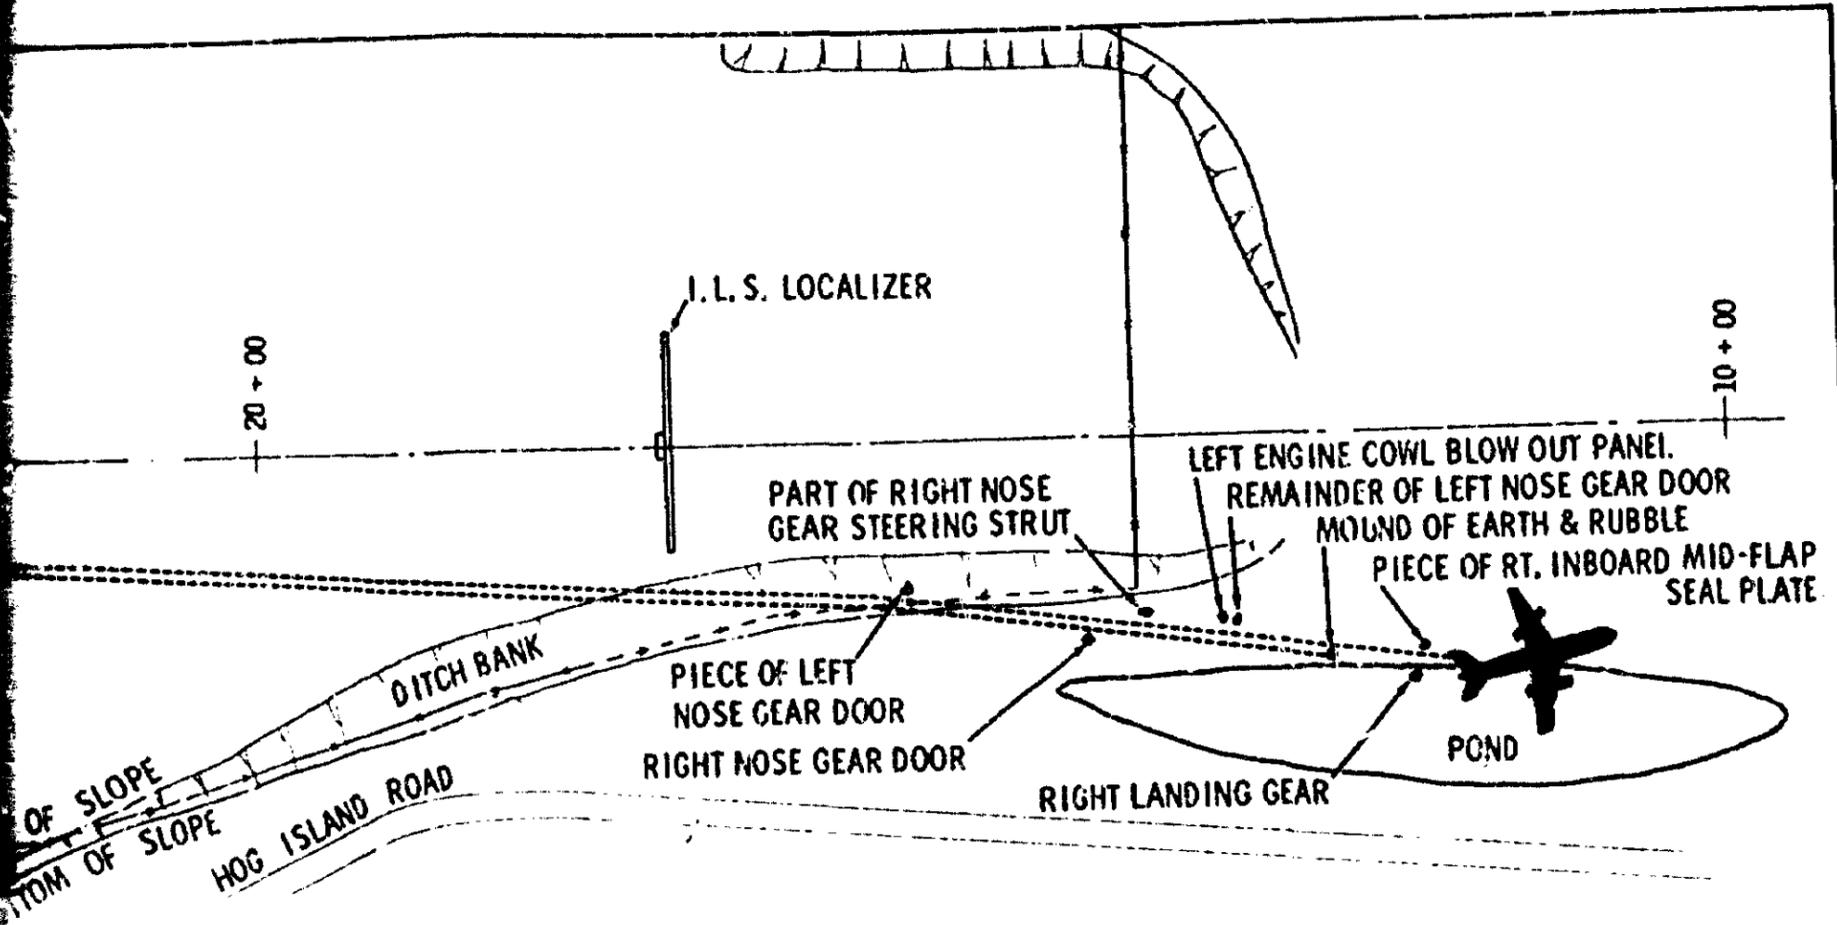
**PLAN VIEW OF WRECKAGE DISTRIBUTION**

The aircraft's right main landing gear touched down approximately 1,075 feet from the end of the runway and approximately 46 feet to the right of the centerline. The nose landing gear touched down approximately 776 feet from the end of the runway and 44 feet to the right of the centerline. The blackened condition of the runway prevented the determination of the touchdown point of the left main landing gear. However, the track of the left main landing gear was visible after it came out of the blackened area. It was also evident that the nose gear wheels tracked toward the right main gearwheel tracks throughout the landing and overrun. The aircraft came to rest 1,634 feet beyond the end of the runway beside a pond on a heading of 070° magnetic. During the overrun, the aircraft had passed over three runway threshold lights, through a chain link fence topped with barbed wire, and then impacted two mounds of earth and rubble before it came to rest. (See Appendix C.)
