AIRCRAFT ACCIDENT REPORT

**CHICAGO & SOUTHERN AIRLINES, INC.
Beech E18S (ATECO WESTWIND II) N51CS**

**Peoria, Illinois
October 21, 1971**

**NATIONAL TRANSPORTATION SAFETY BOARD
Washington, D. C. 20591
REPORT NUMBER: NTSB-AAR-72-15**

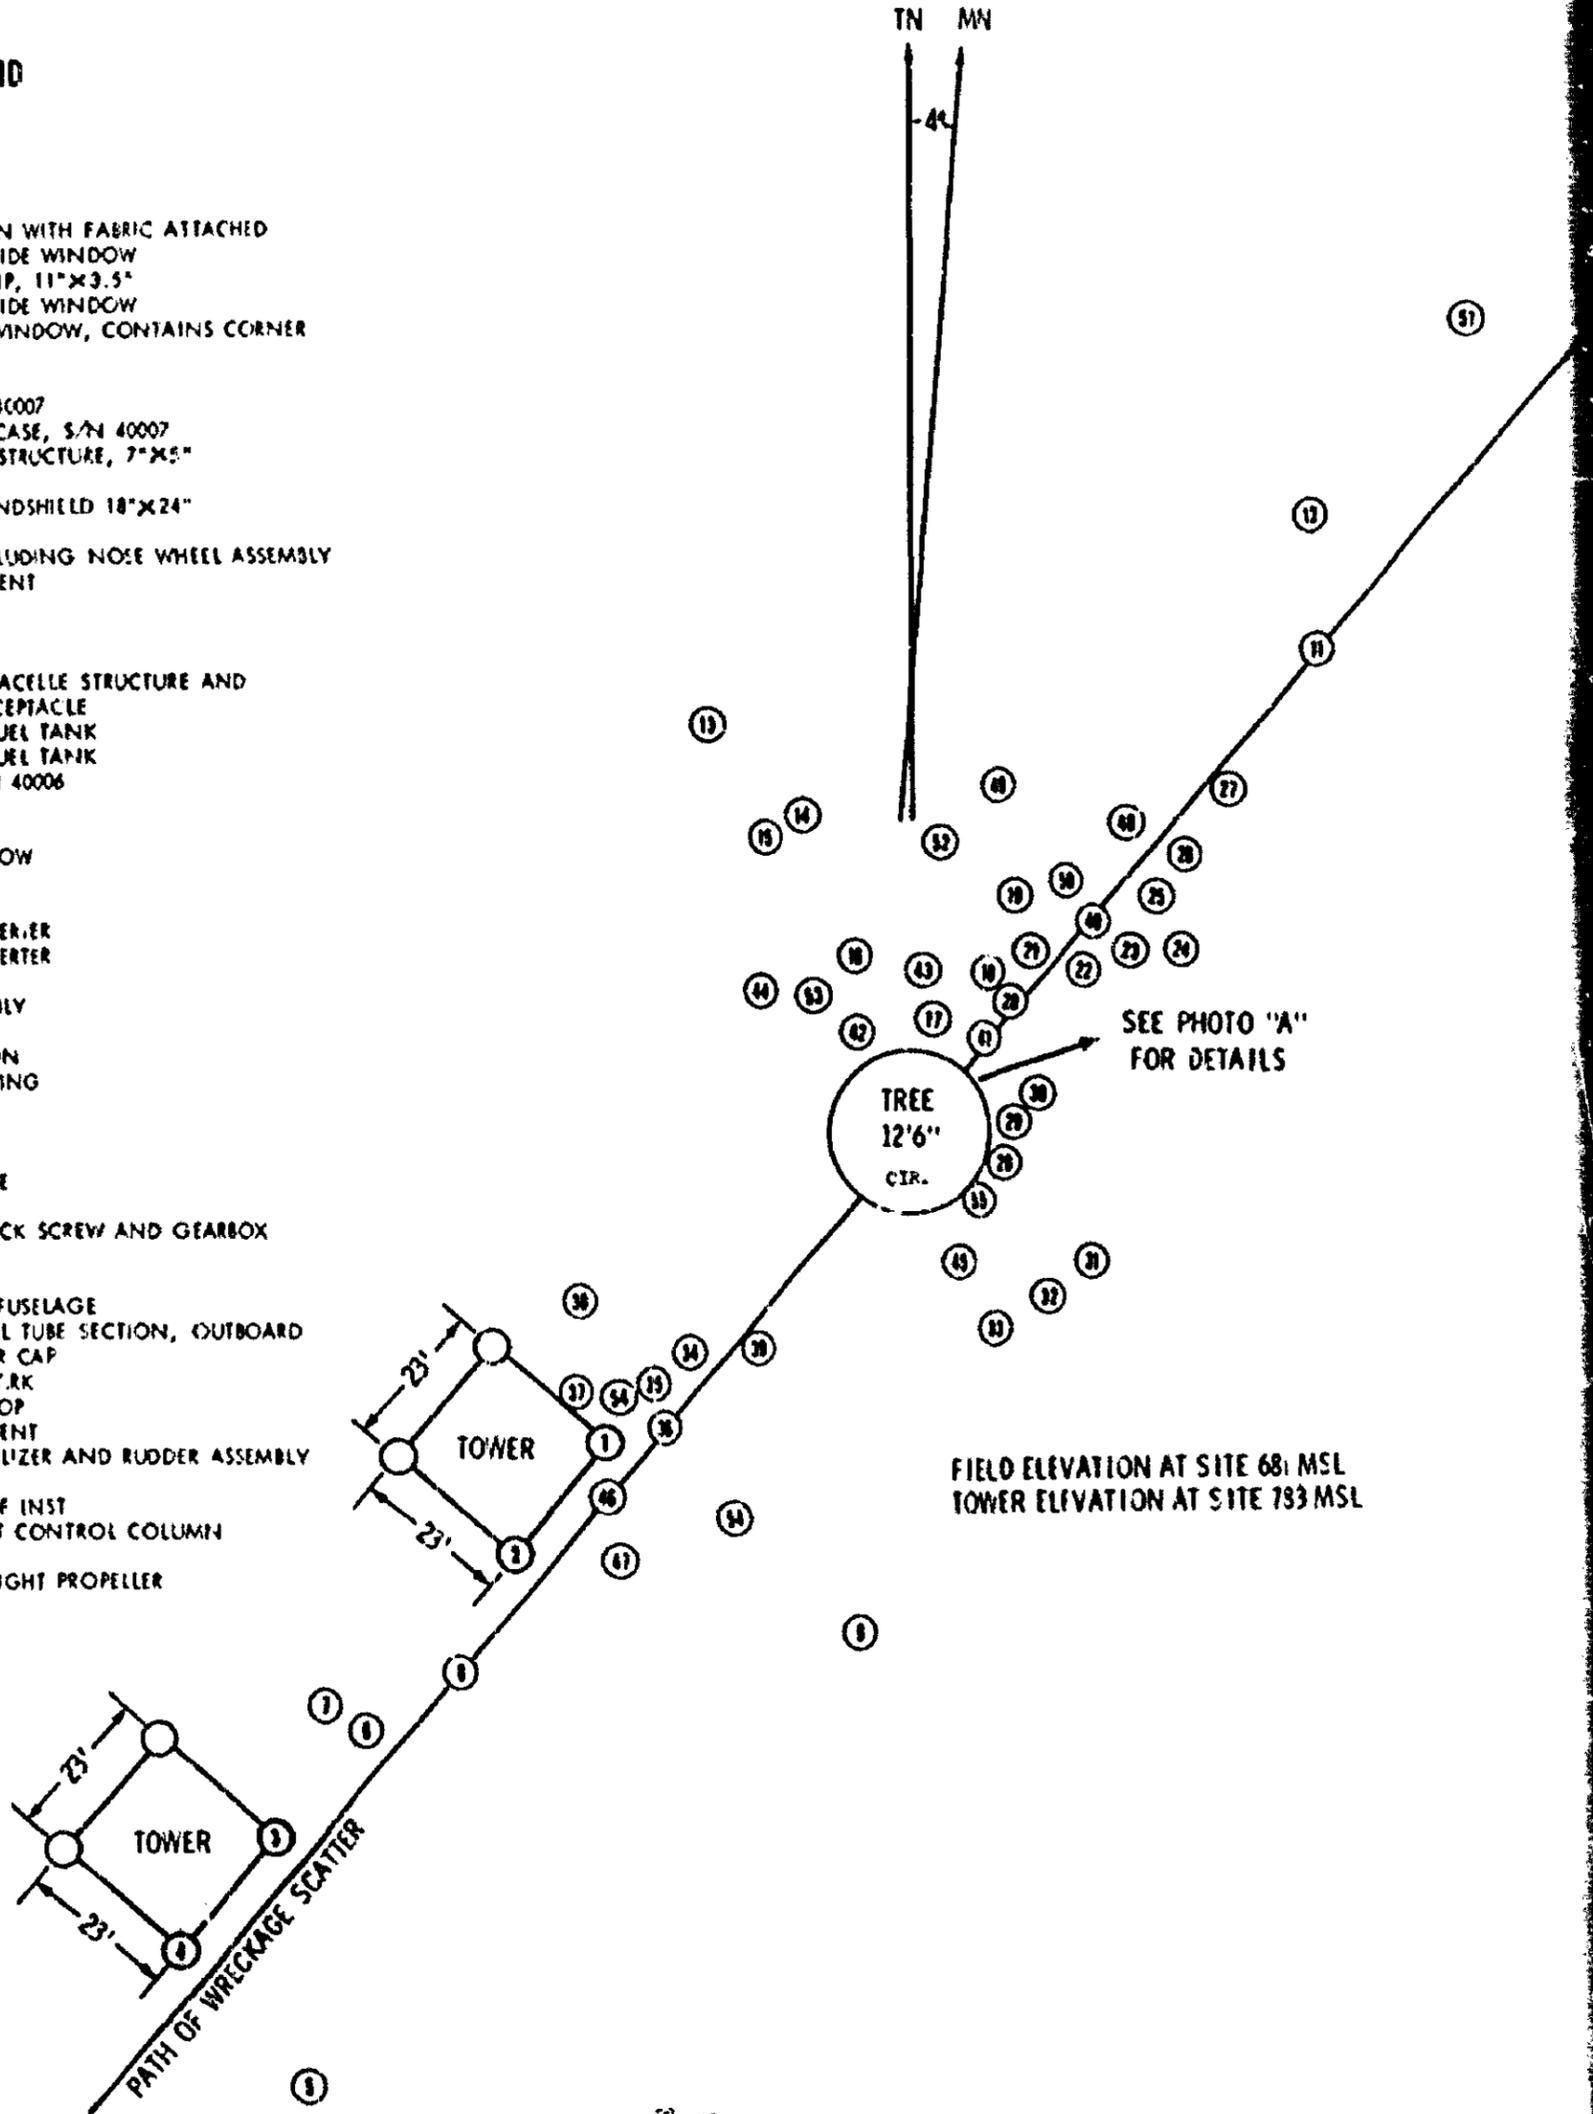
SEE PHOTO "A" FOR DETAILS

FIELD ELEVATION AT SITE 68: MSL
TOWER ELEVATION AT SITE 73: MSL

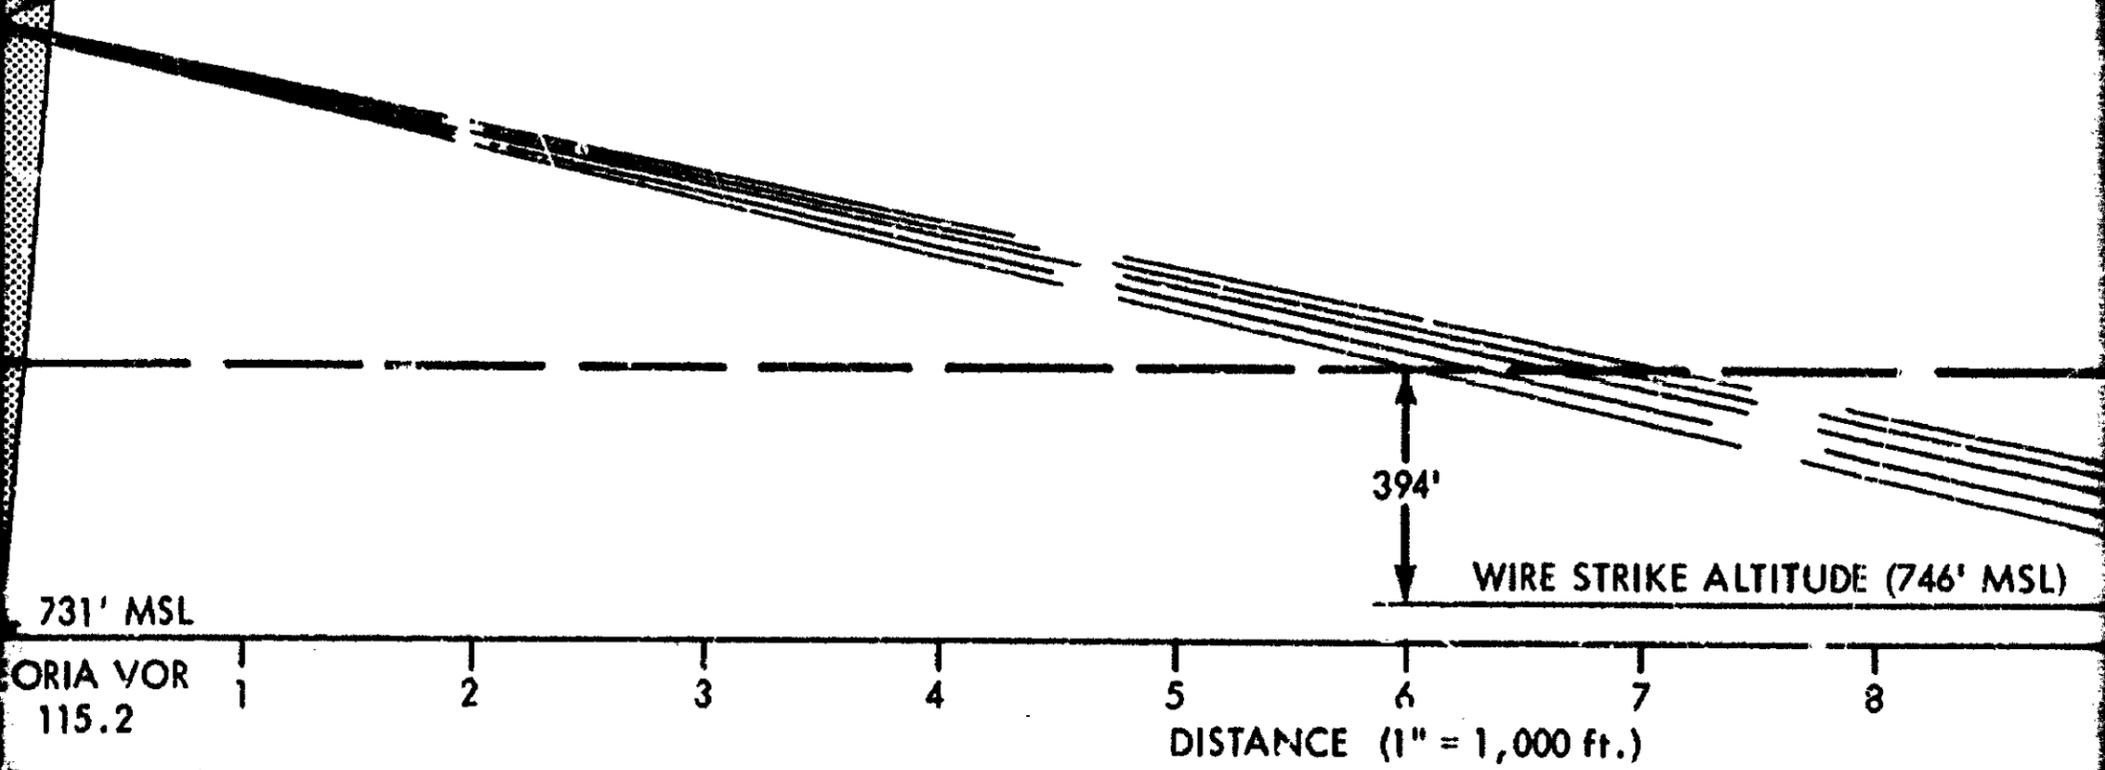
PROFILE VIEW

The aircraft had struck electrical transmission lines⁸ which cross the Peoria VOR Runway 12 instrument approach path 2.0 nautical miles from the approach end of Runway 12. These powerlines are supported at regular intervals by pairs of steel towers. Each tower supports eight cables in four sets of two lines. The two towers immediately to the left of the aircraft's flight-path were oriented northeast-southwest. The lowest cables on the westerly tower were severed, and one line of the next higher pair was damaged. The elevations of the wires on this tower were:

1800' MSL (1069' above ground level).
