AIRCRAFT ACCIDENT REPORT
WESTERN AIR LINES, INC.
BOEING 720-047B, N3166
ONTARIO INTERNATIONAL AIRPORT
ONTARIO, CALIFORNIA
MARCH 31, 1971

ADOPTED: JUNE 7, 1972

NATIONAL TRANSPORTATION SAFETY BOARD
Washington, D. C. 20591
REPORT NUMBER: NTSB-AAR-72-18

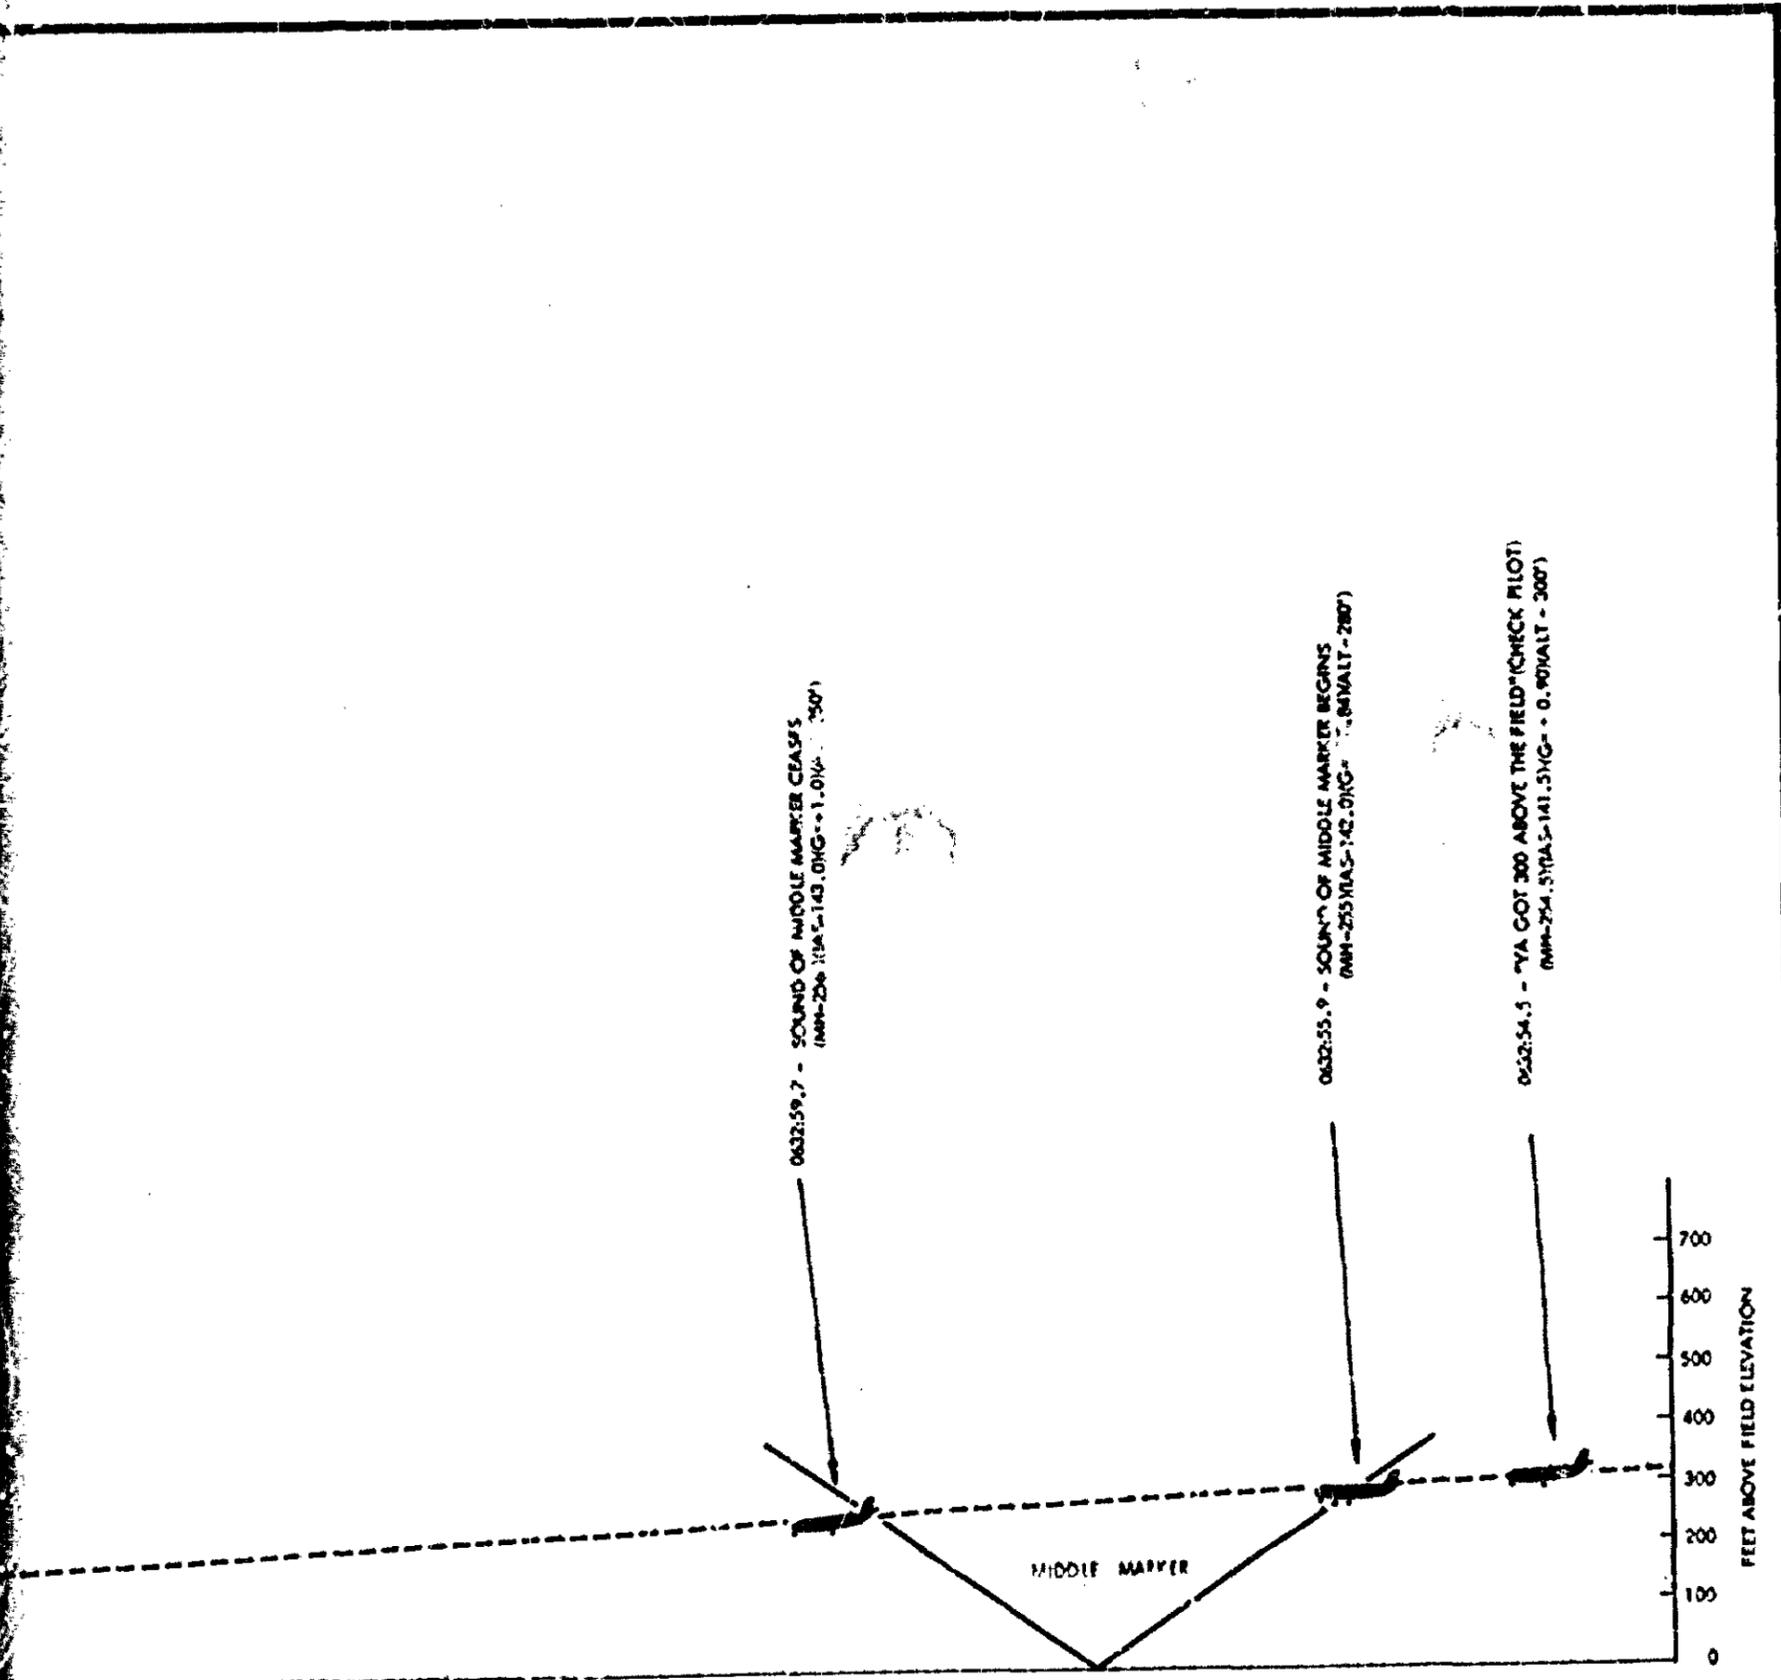
ATTACHMENT 2

PROBABLE FLIGHT PATH
WESTERN AIRLINES, INC.
BOEING 720-047B, N3168
ONTARIO, CALIFORNIA
March 31, 1971
