AIRCRAFT INCIDENT REPORT

EASTERN AIR LINES, INC.

BOEING 727-100, N8168G,

REPORT NUMBER: NTSB-AAR-72-27

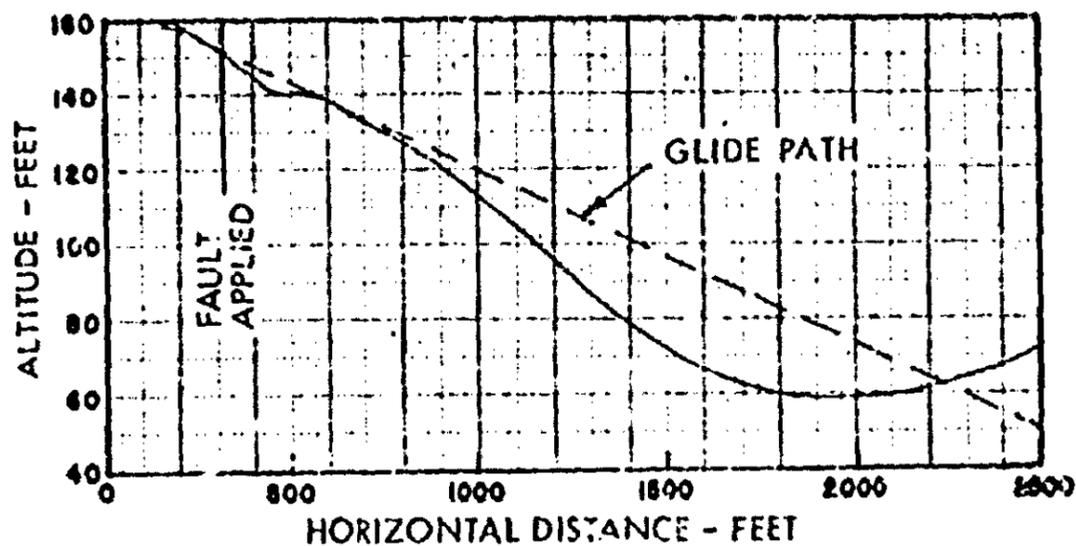
- (a) Altitude loss above 100 feet 24 feet below glide slope when recovery was initiated one second after pilot recognition. (See profile chart.)

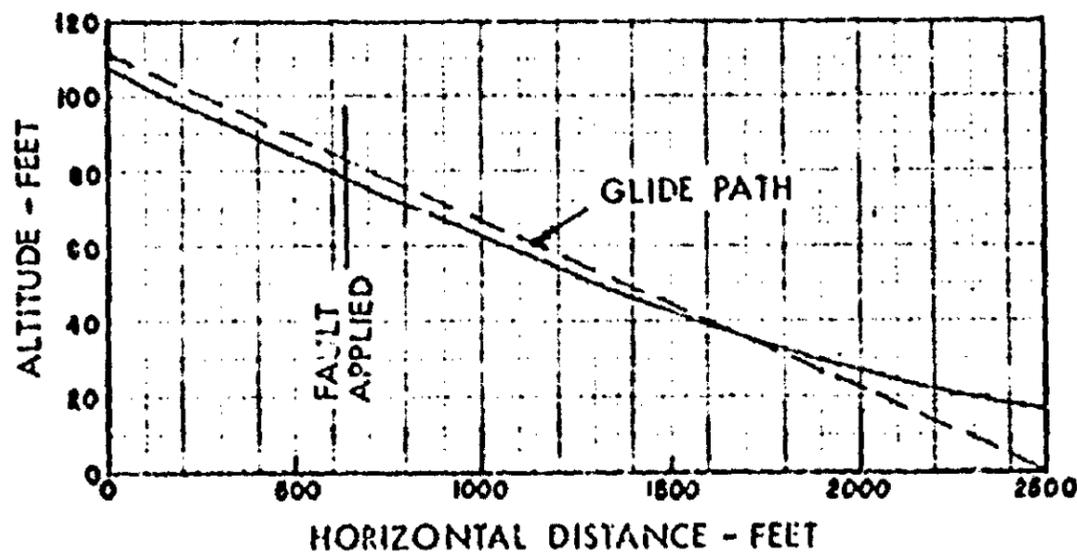
- (b) Altitude loss below 100 feet Negligible when recovery was initiated without delay after pilot recognition. (See profile chart.)
