AIRCRAFT ACCIDENT REPORT

ALII AIR HAWAII, INC.

BEECH D18S, N5642V, KALOHI CHANNEL

REPORT NUMBER: NTSB-AAR-72-23

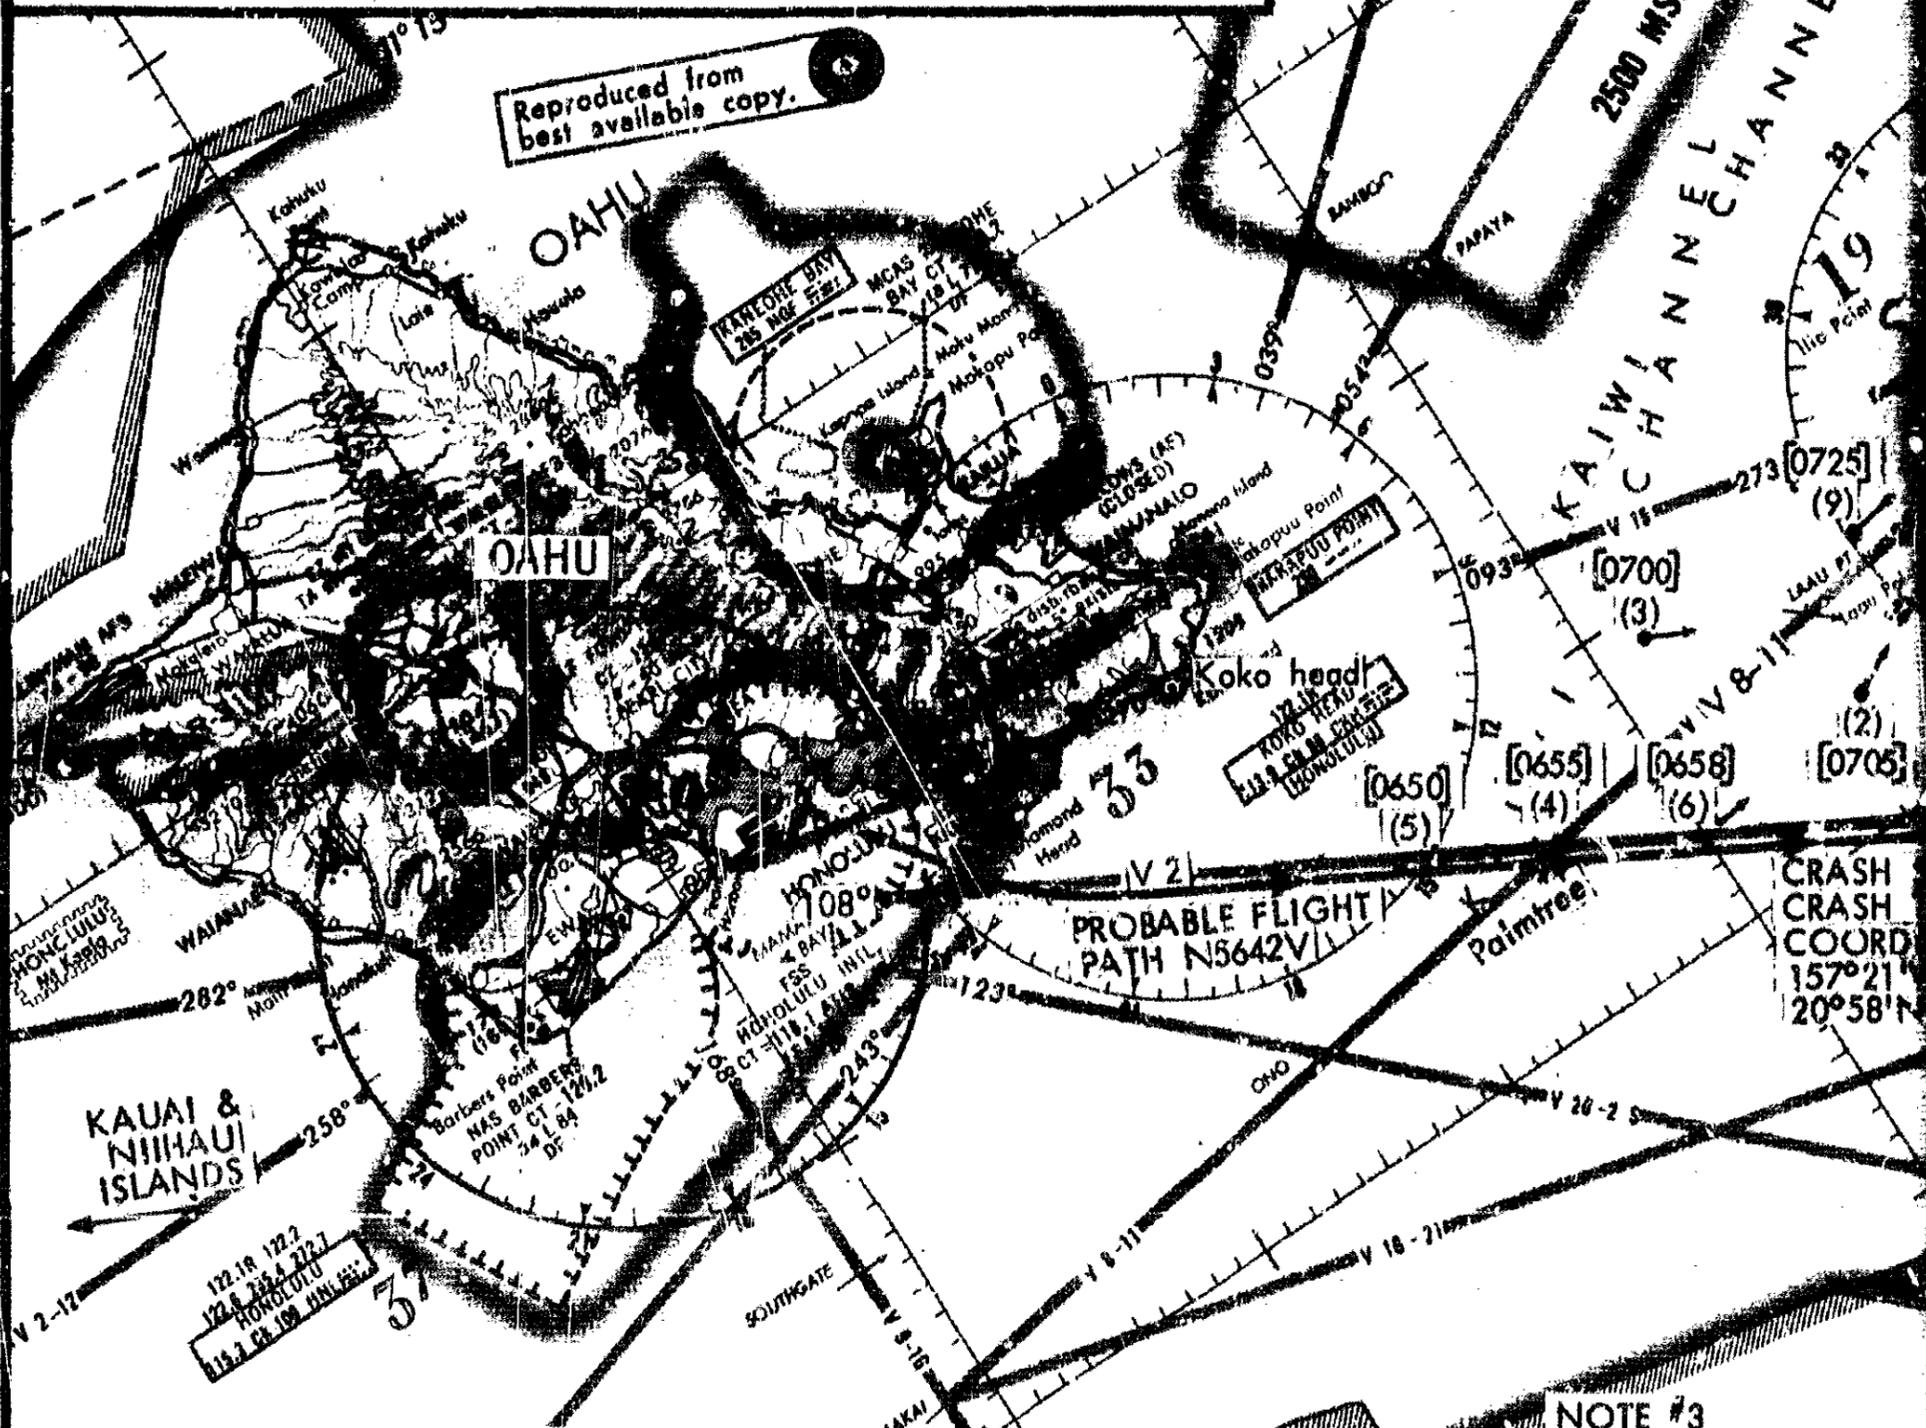
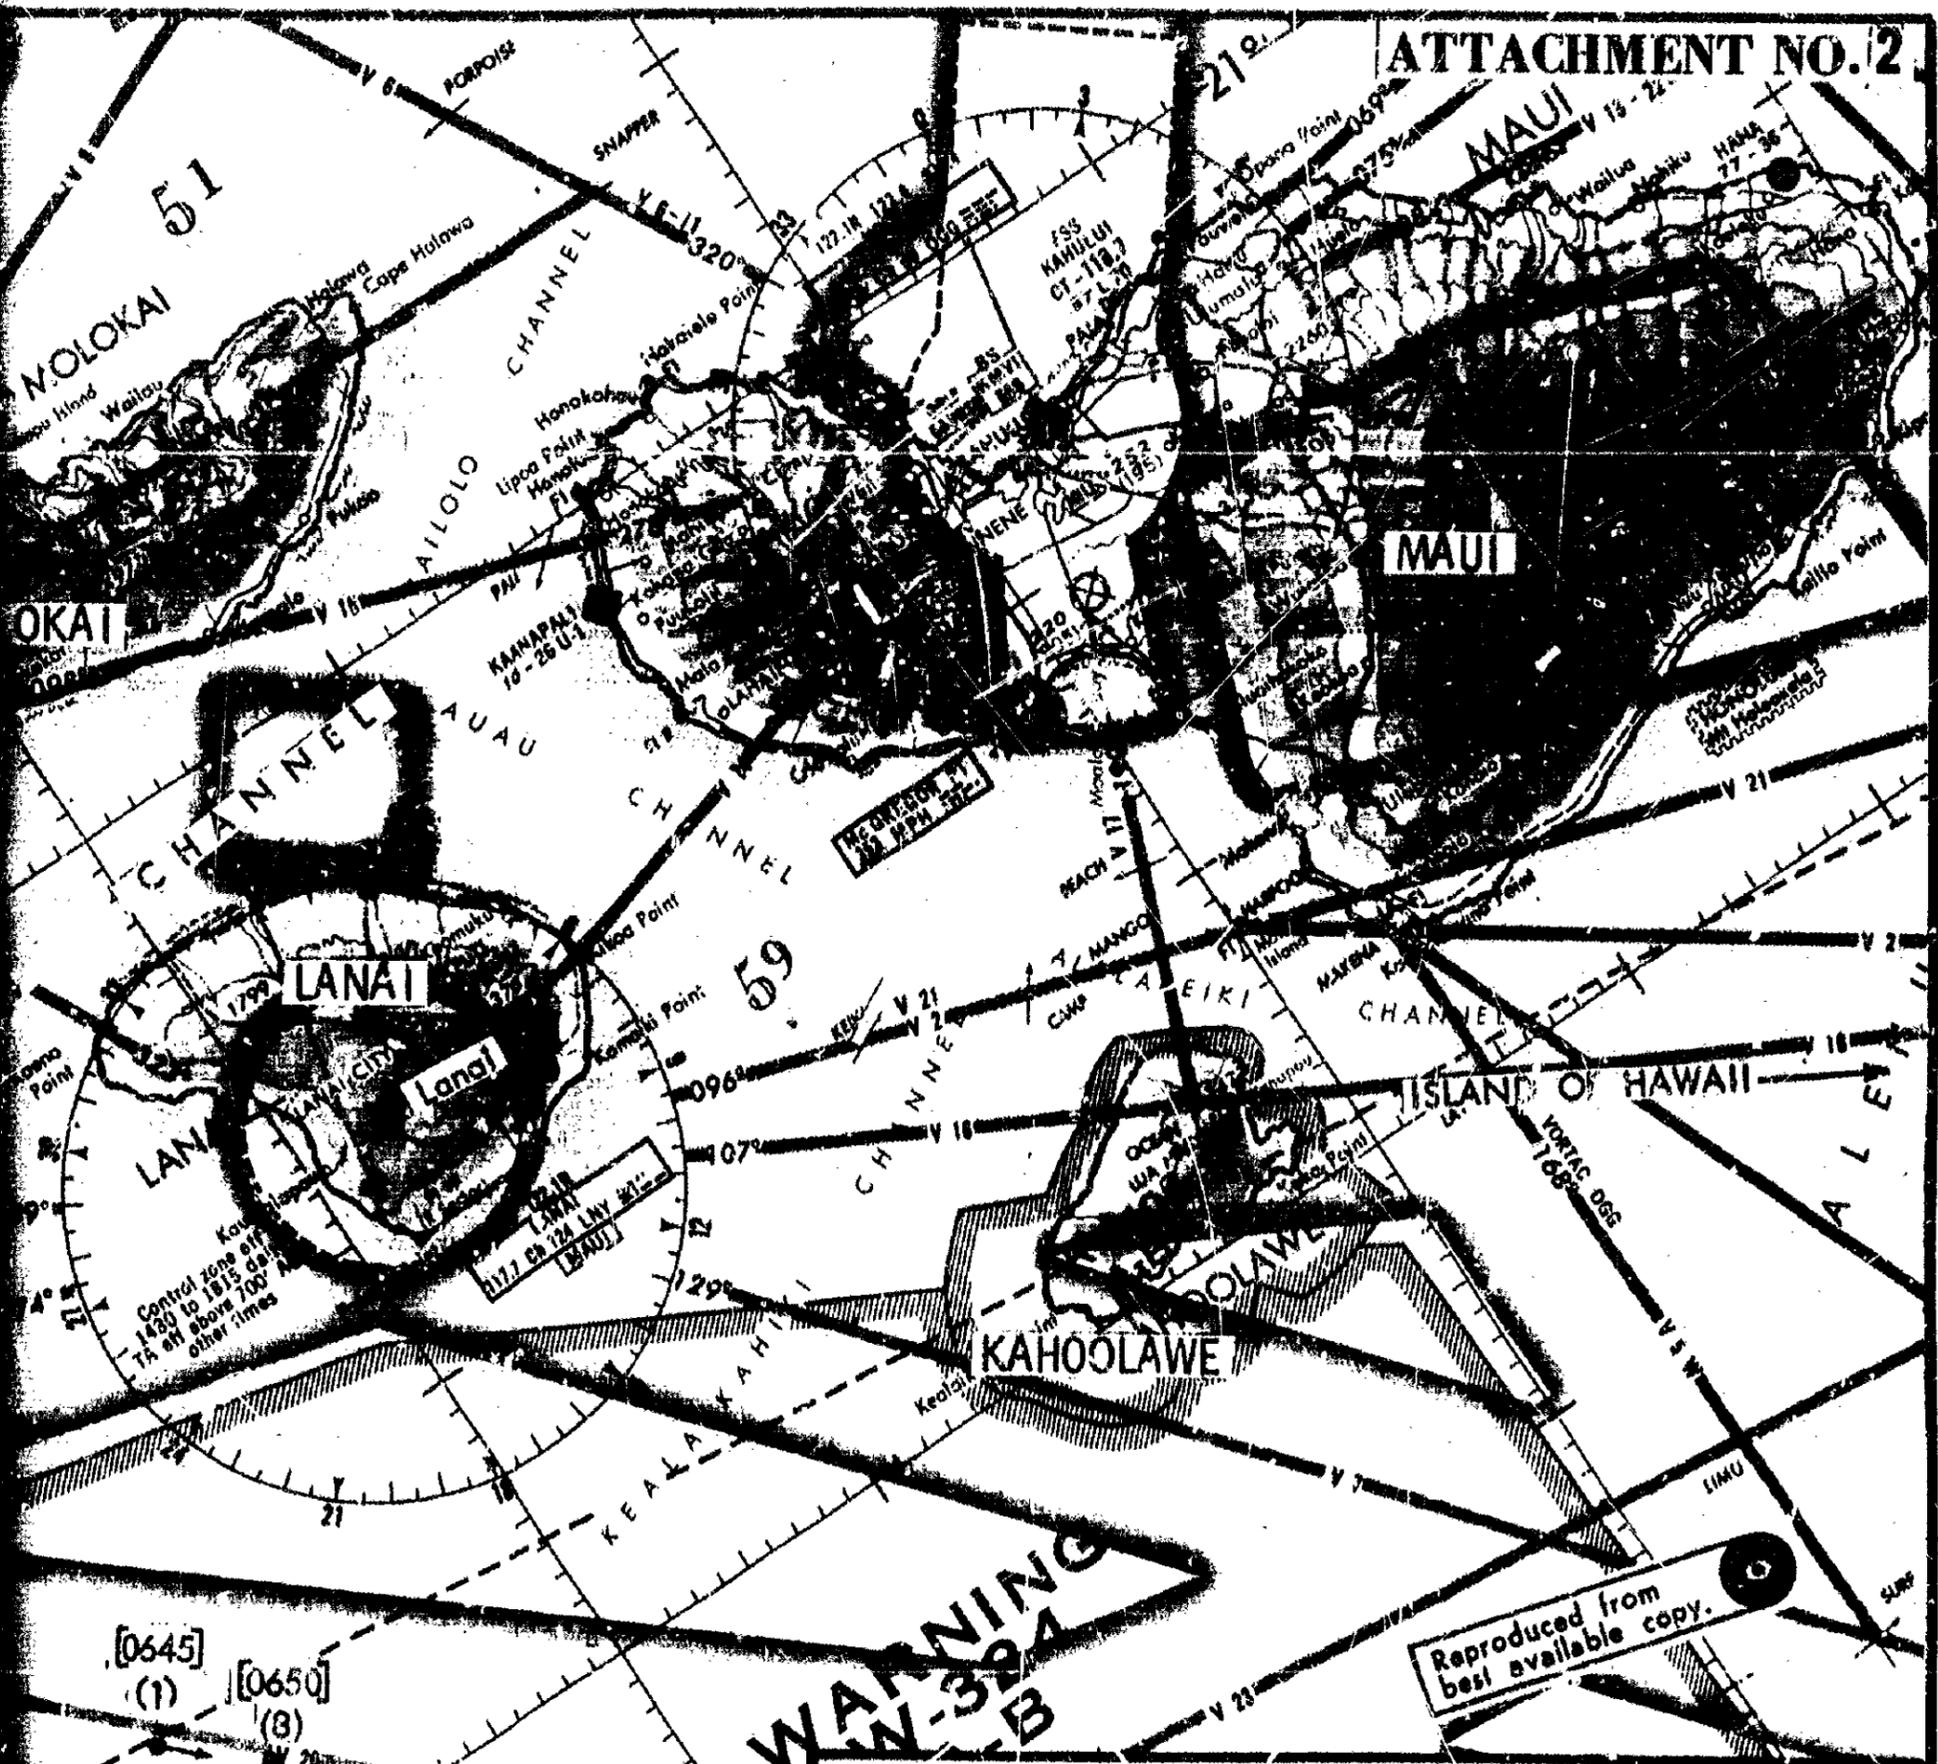
**WEATHER OBSERVATIONS
IN AREA OF CRASH SITE
ALL AIR HAWAII, INC
BEECH D18S, N5642V**

NO.	AIRLINE	FLIGHT	EXTRACTS FROM OBSERVATIONS	ALTITUDE IN FEET
(1)	ROYAL HAWAIIAN AIR SERVICE		LIGHT RAIN AND TURBULENCE	3,000
(2)	AIR MOLOKAI, LTD.		ENCOUNTERED RAIN AND SEVERE TURBULENCE, DARK CLOUDS SOUTH	5 TO 100

(3)	ALII AIR HAWAII, INC.	141	HEAVY RAIN AND DARK CLOUDS TO SOUTH	500 TO 700
(4)	HAWAIIAN AIRLINES	100	ENCOUNTERED RAIN WITH LIGHT TO MODERATE TURBULENCE	7,000

(5)	ALOHA AIRLINES, INC.	304	FREZZED RAIN, HAIL, WINDSHIELD ICING, TURBULENCE	9,000
(6)	ALOHA AIRLINES, INC.	904	MODERATE TURBULENCE, HEAVY RAIN SHOWERS, LIGHTNING	14,000

(7)	ROYAL HAWAIIAN AIR SERVICE	206	THUNDER, RAIN AND LIGHTNING IN LANAI - MOLOKAI CHANNEL	500 TO 1,000
(8)	ALOHA AIRLINES, INC.	380	ENCOUNTERED LIGHT TO MODERATE TURBULENCE, HEAVY RAIN	19,000

(9)	ROYAL HAWAIIAN AIR SERVICE	105	OBSERVED RAIN SHOWER APPROACHING MOLOKAI AIRPORT	500 TO 1000
(10)	HAWAIIAN AIRLINES	308	LARGE AREAS OF HEAVY RAIN TO LEFT	19,000
