# AIRCRAFT ACCIDENT REPORT

TANDY CORPORATION  
GATES LEARJET MODEL 25, N658TC  
NEAR THE  
VICTORIA COUNTY-FOSTER AIRPORT  
VICTORIA, TEXAS  
JANUARY 18, 1972

NATIONAL TRANSPORTATION SAFETY BOARD  
Washington, D. C. 20591  
REPORT NUMBER: NTSB-AAR-72-24

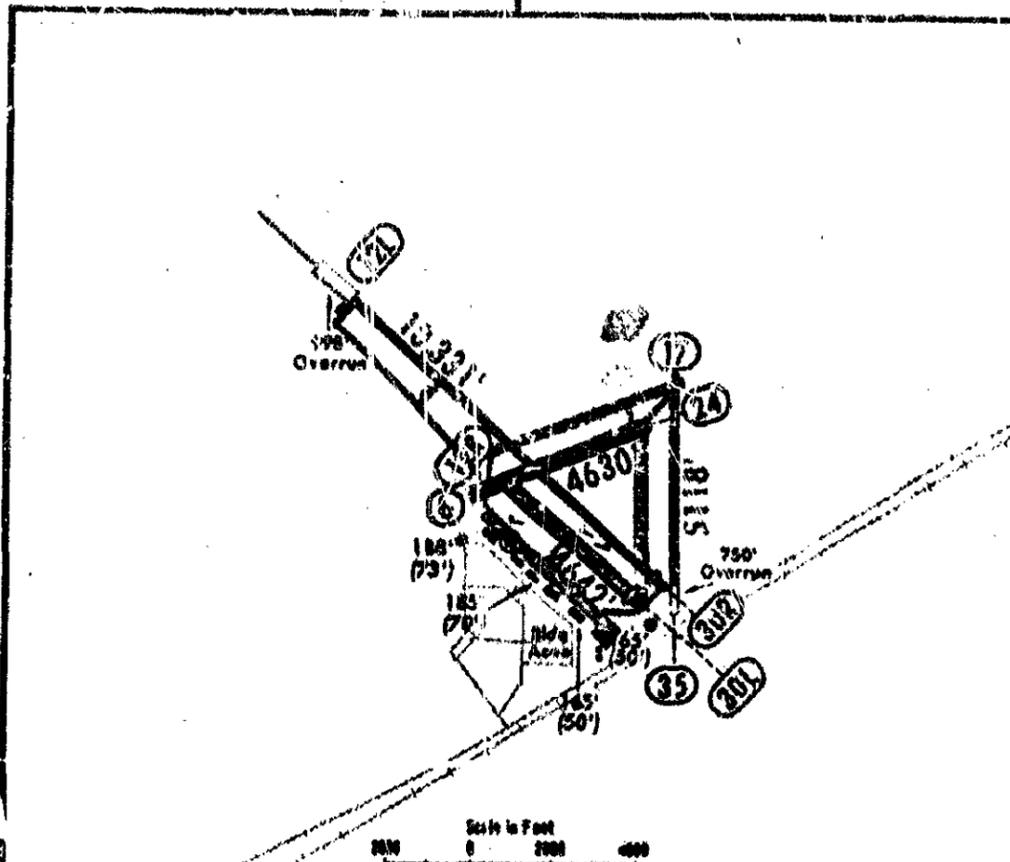
APPENDIX B

1,800 feet left of the centerline projected from the VOR<sup>4</sup> facility toward the runway. (For details see Appendix B.) The aircraft was almost completely demolished by the surface impact and subsequent ground fire. All occupants in the aircraft were fatally injured.
