# AIRCRAFT ACCIDENT REPORT

Sun Valley Airlines, Inc.

Beech 65B-80, N1027C

Report Number: NTSB-AAR-72-25

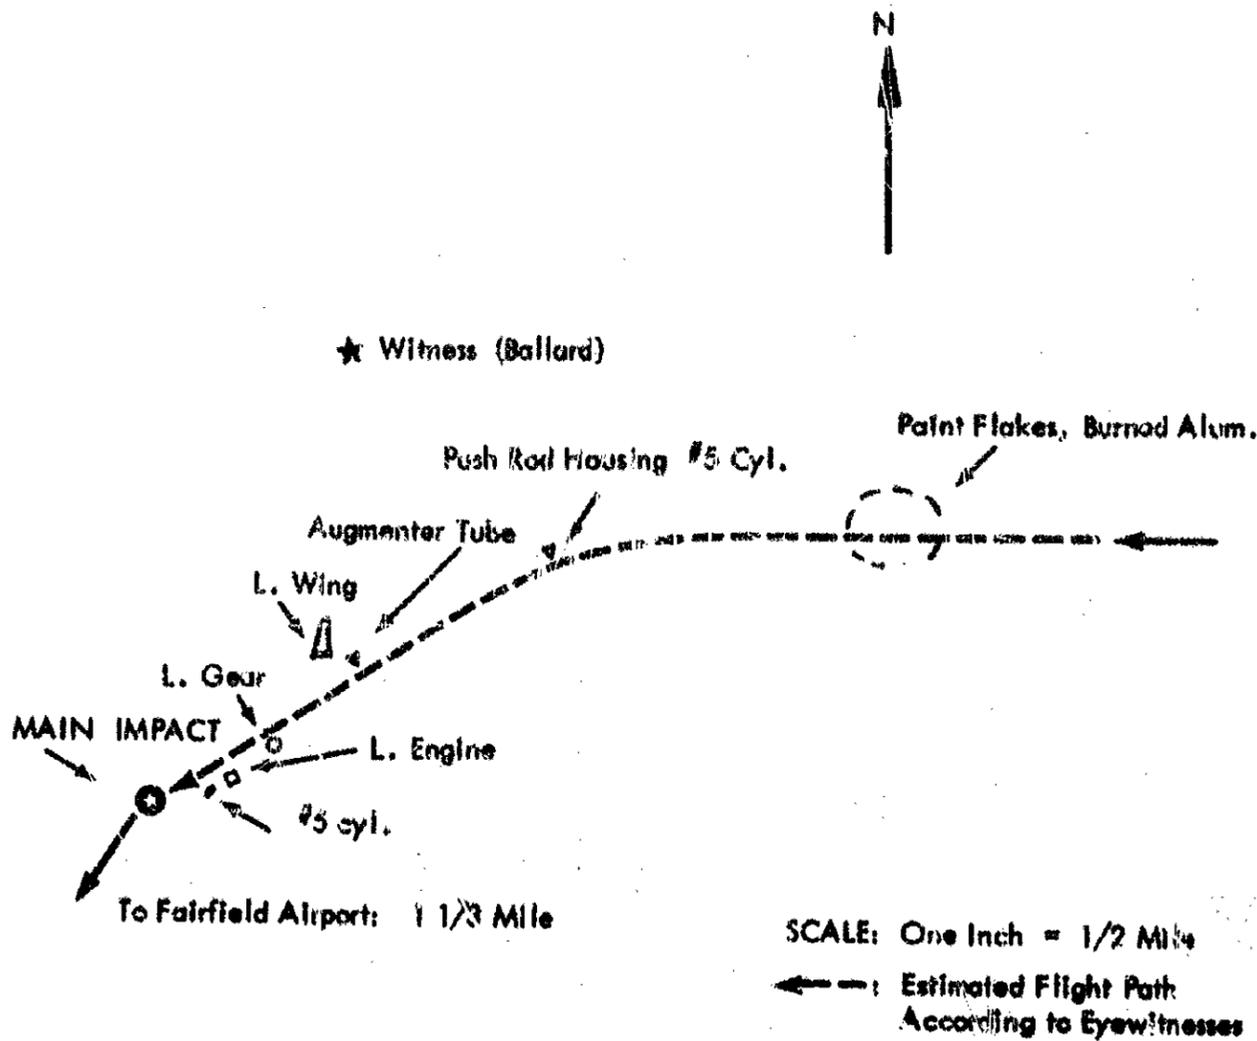
WRECKAGE DISTRIBUTION CHART  
SUN VALLEY AIRLINES, INC.  
BEECH AIRCRAFT MODEL 95B-80, N1027C

The centerline of the in-flight wreckage scatter was oriented along a heading of 210° magnetic. (See wreckage distribution diagram, Appendix D.) The estimated distance from the main crash site to the separated components was as follows: left wing - 750 yards, left landing gear - 500 yards, left engine - 250 yards. Farther back along the debris path, the undamaged pushrod housing of the No. 5 cylinder of the left engine was found. About 2 miles east-northeast of the main impact area, flakes of burned paint and aluminum were found in the snow.
