AIRCRAFT ACCIDENT REPORT

EASTERN AIR LINES INC.

DC-9-31, N8961E

Fort Lauderdale, Florida

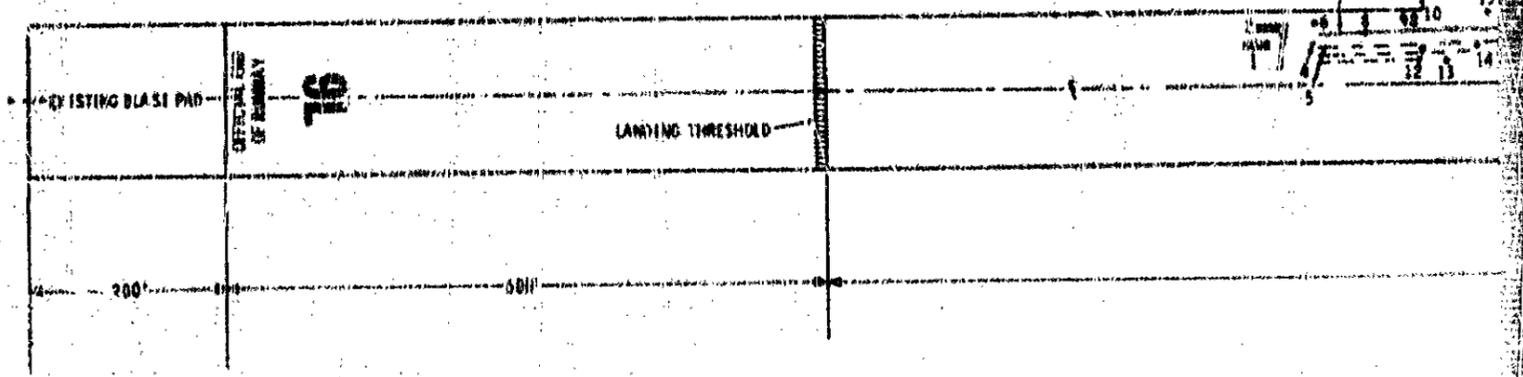
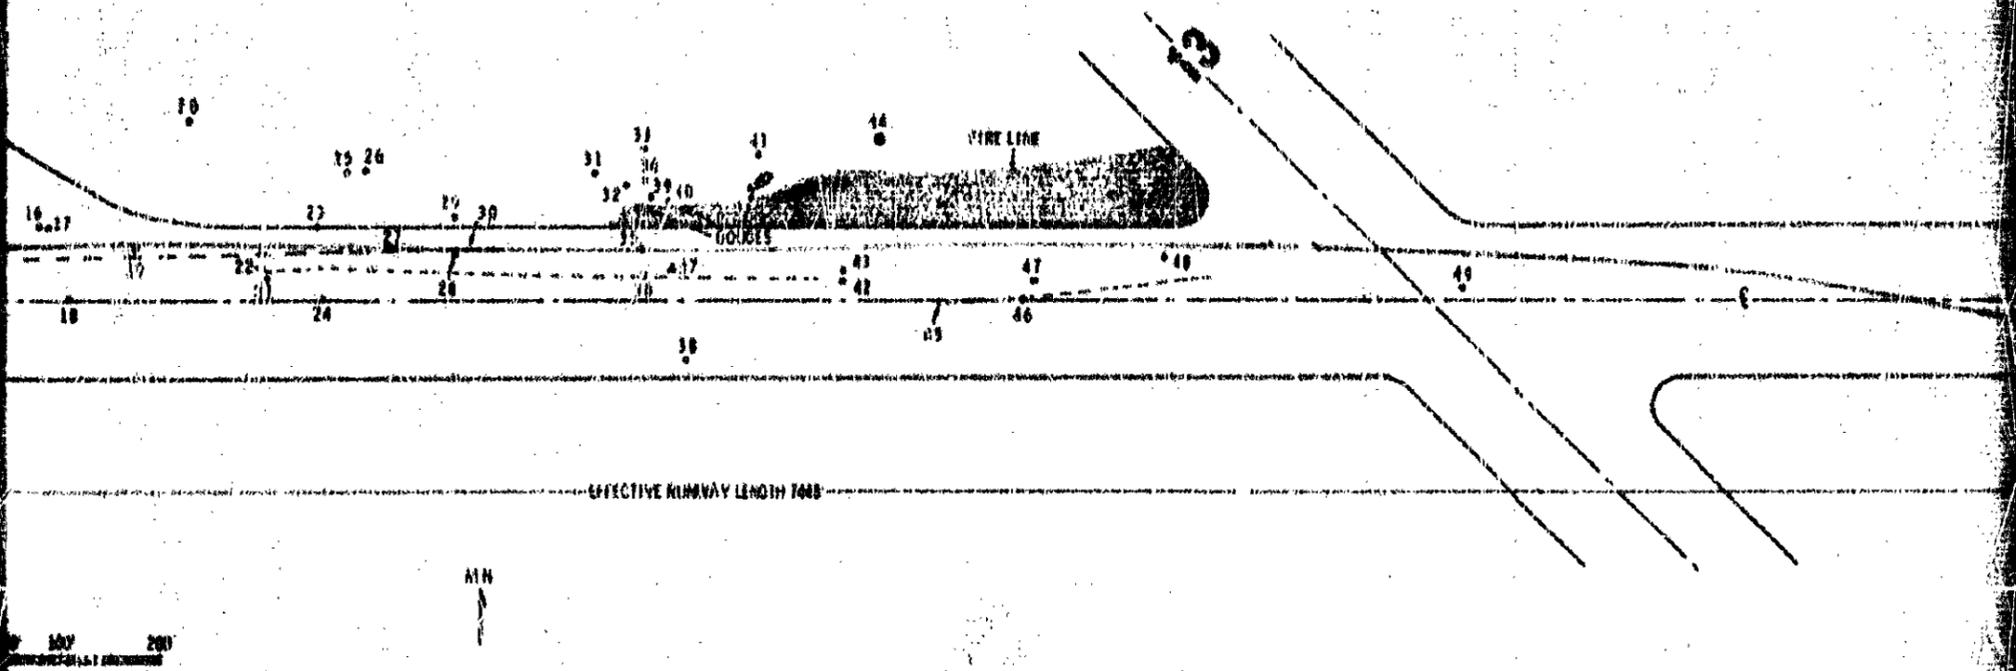
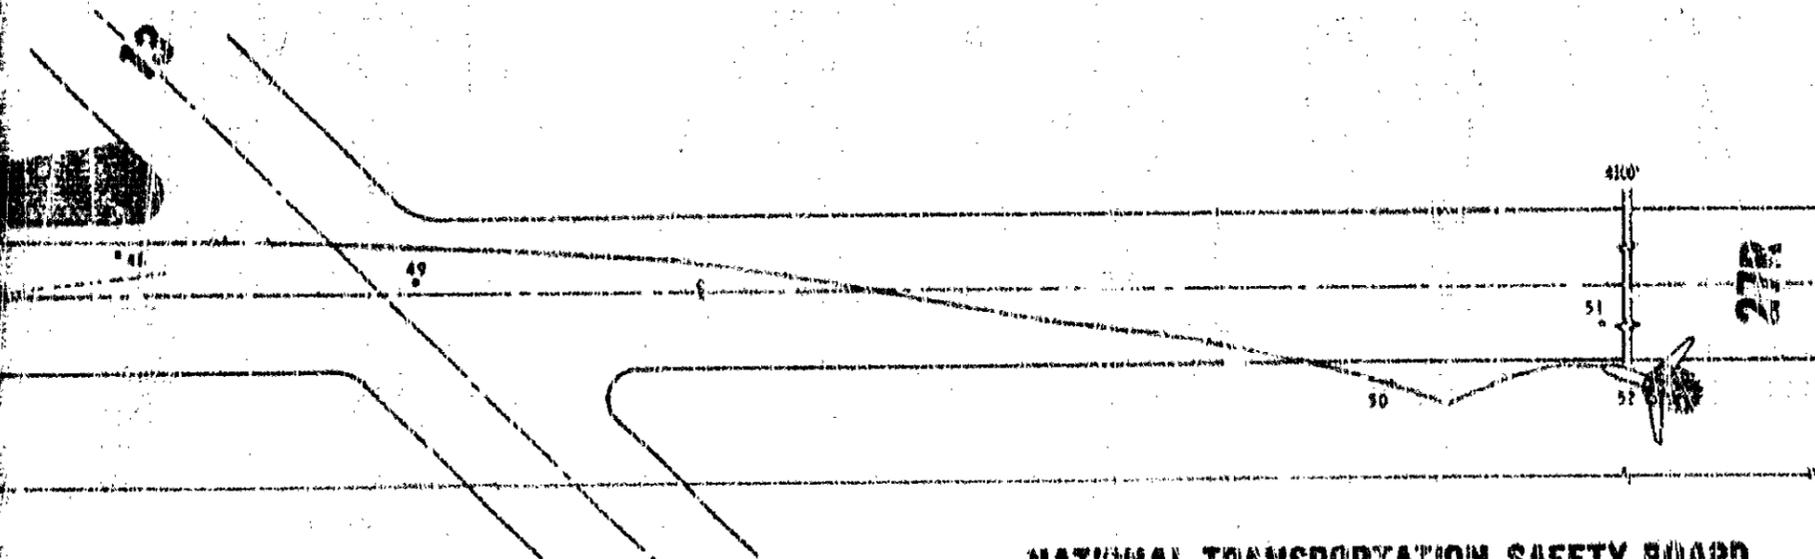
WRECKAGE DISTRIBUTION CHART
EASTERN AIRLINES, INC. DOUGLAS DC-9-31, N896IE
FORT LAUDERDALE - HOLLYWOOD INTERNATIONAL AIRPORT
Fort Lauderdale, Florida
May 18, 1972

The right main landing gear with a section of the rear spar web separated from the aircraft at impact. The left main landing gear was pushed up and to the rear but remained attached to the left wing. The nose gear was found in the down and locked position. The wing leading edge slats were fully extended. The exact position of the trailing edge flaps could not be determined because of the damage caused by the collapse of the main landing gear. All spoiler panels were found in the retracted position. All flight control surfaces were accounted for, and no discrepancies were found in any flight control system. The stabilizer was positioned at 2.5°, aircraft nose up.
