AIRCRAFT ACCIDENT REPORT

DELTA AIR LINES, INC.

MCDONNELL DOUGLAS DC-9-14, N3305L

MAY 30, 1972

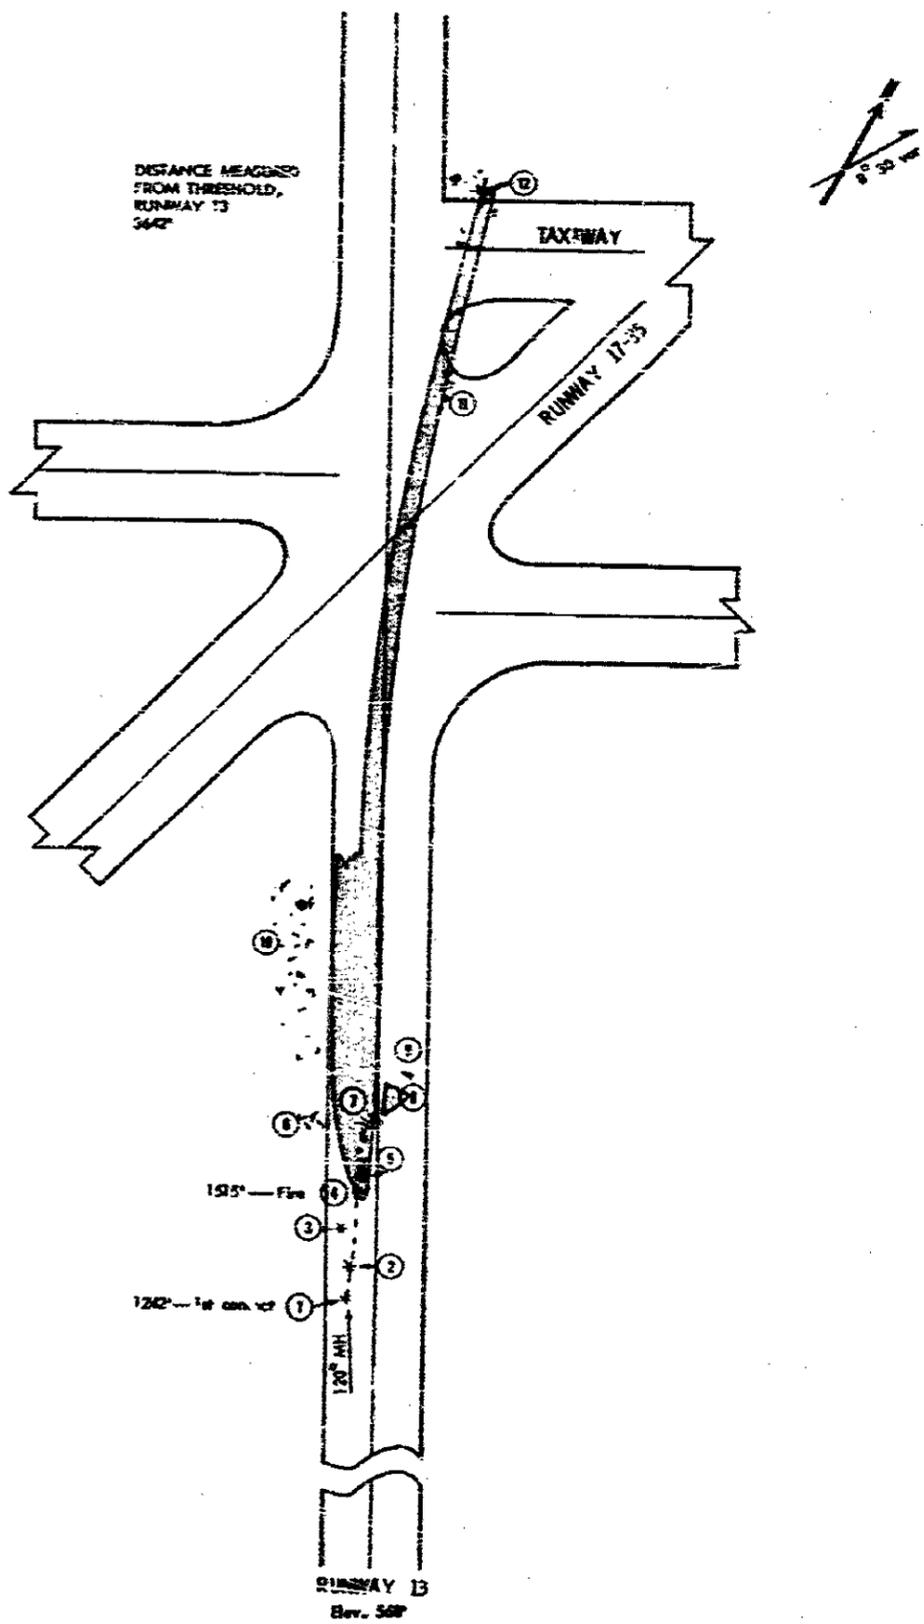
The initial marks on the runway continued in a slight curve to the right for approximately 340 feet down the left side of the runway. A fuel stain on the runway originated 84 feet from the initial impact mark, and ground fire originated 273 feet beyond the point of initial contact.

A continuous trail, made by fire, extended from that point to the main wreckage site. The parts of the airplane, including right wing fuel system components, outside of this trail were neither burned nor sooted. (See Wreckage Distribution Chart, Appendix F.)

1. First contact - score in runway surface.
2. Unburned fuel on runway surface.
3. Green material from right navigation light.
4. Ground fire area.
5. Mark on runway with paint smears similar to paint scheme on the sides on the fuselage nose section.
6. Pieces of right wing tip and adjacent structure.
7. Gouges and scores in runway surface which approximate the geometry of the inverted empennage.
8. Spray of red and clear material from left navigation light.
9. Window trim panel from cabin interior.
10. Scattered parts from outer portion of right wing.
11. Pieces of radome, cabin interior trim and fuselage structure.
12. Main wreckage.
