AIRCRAFT ACCIDENT REPORT

SPECTRUM AIR, INC.
Sabre Mark 5, N275X
Sacramento, California
September 24, 1972
Adopted: March 28, 1973

NATIONAL TRANSPORTATION SAFETY BOARD
Washington, D.C. 20591
Report Number: NTSB-AAR-73-6

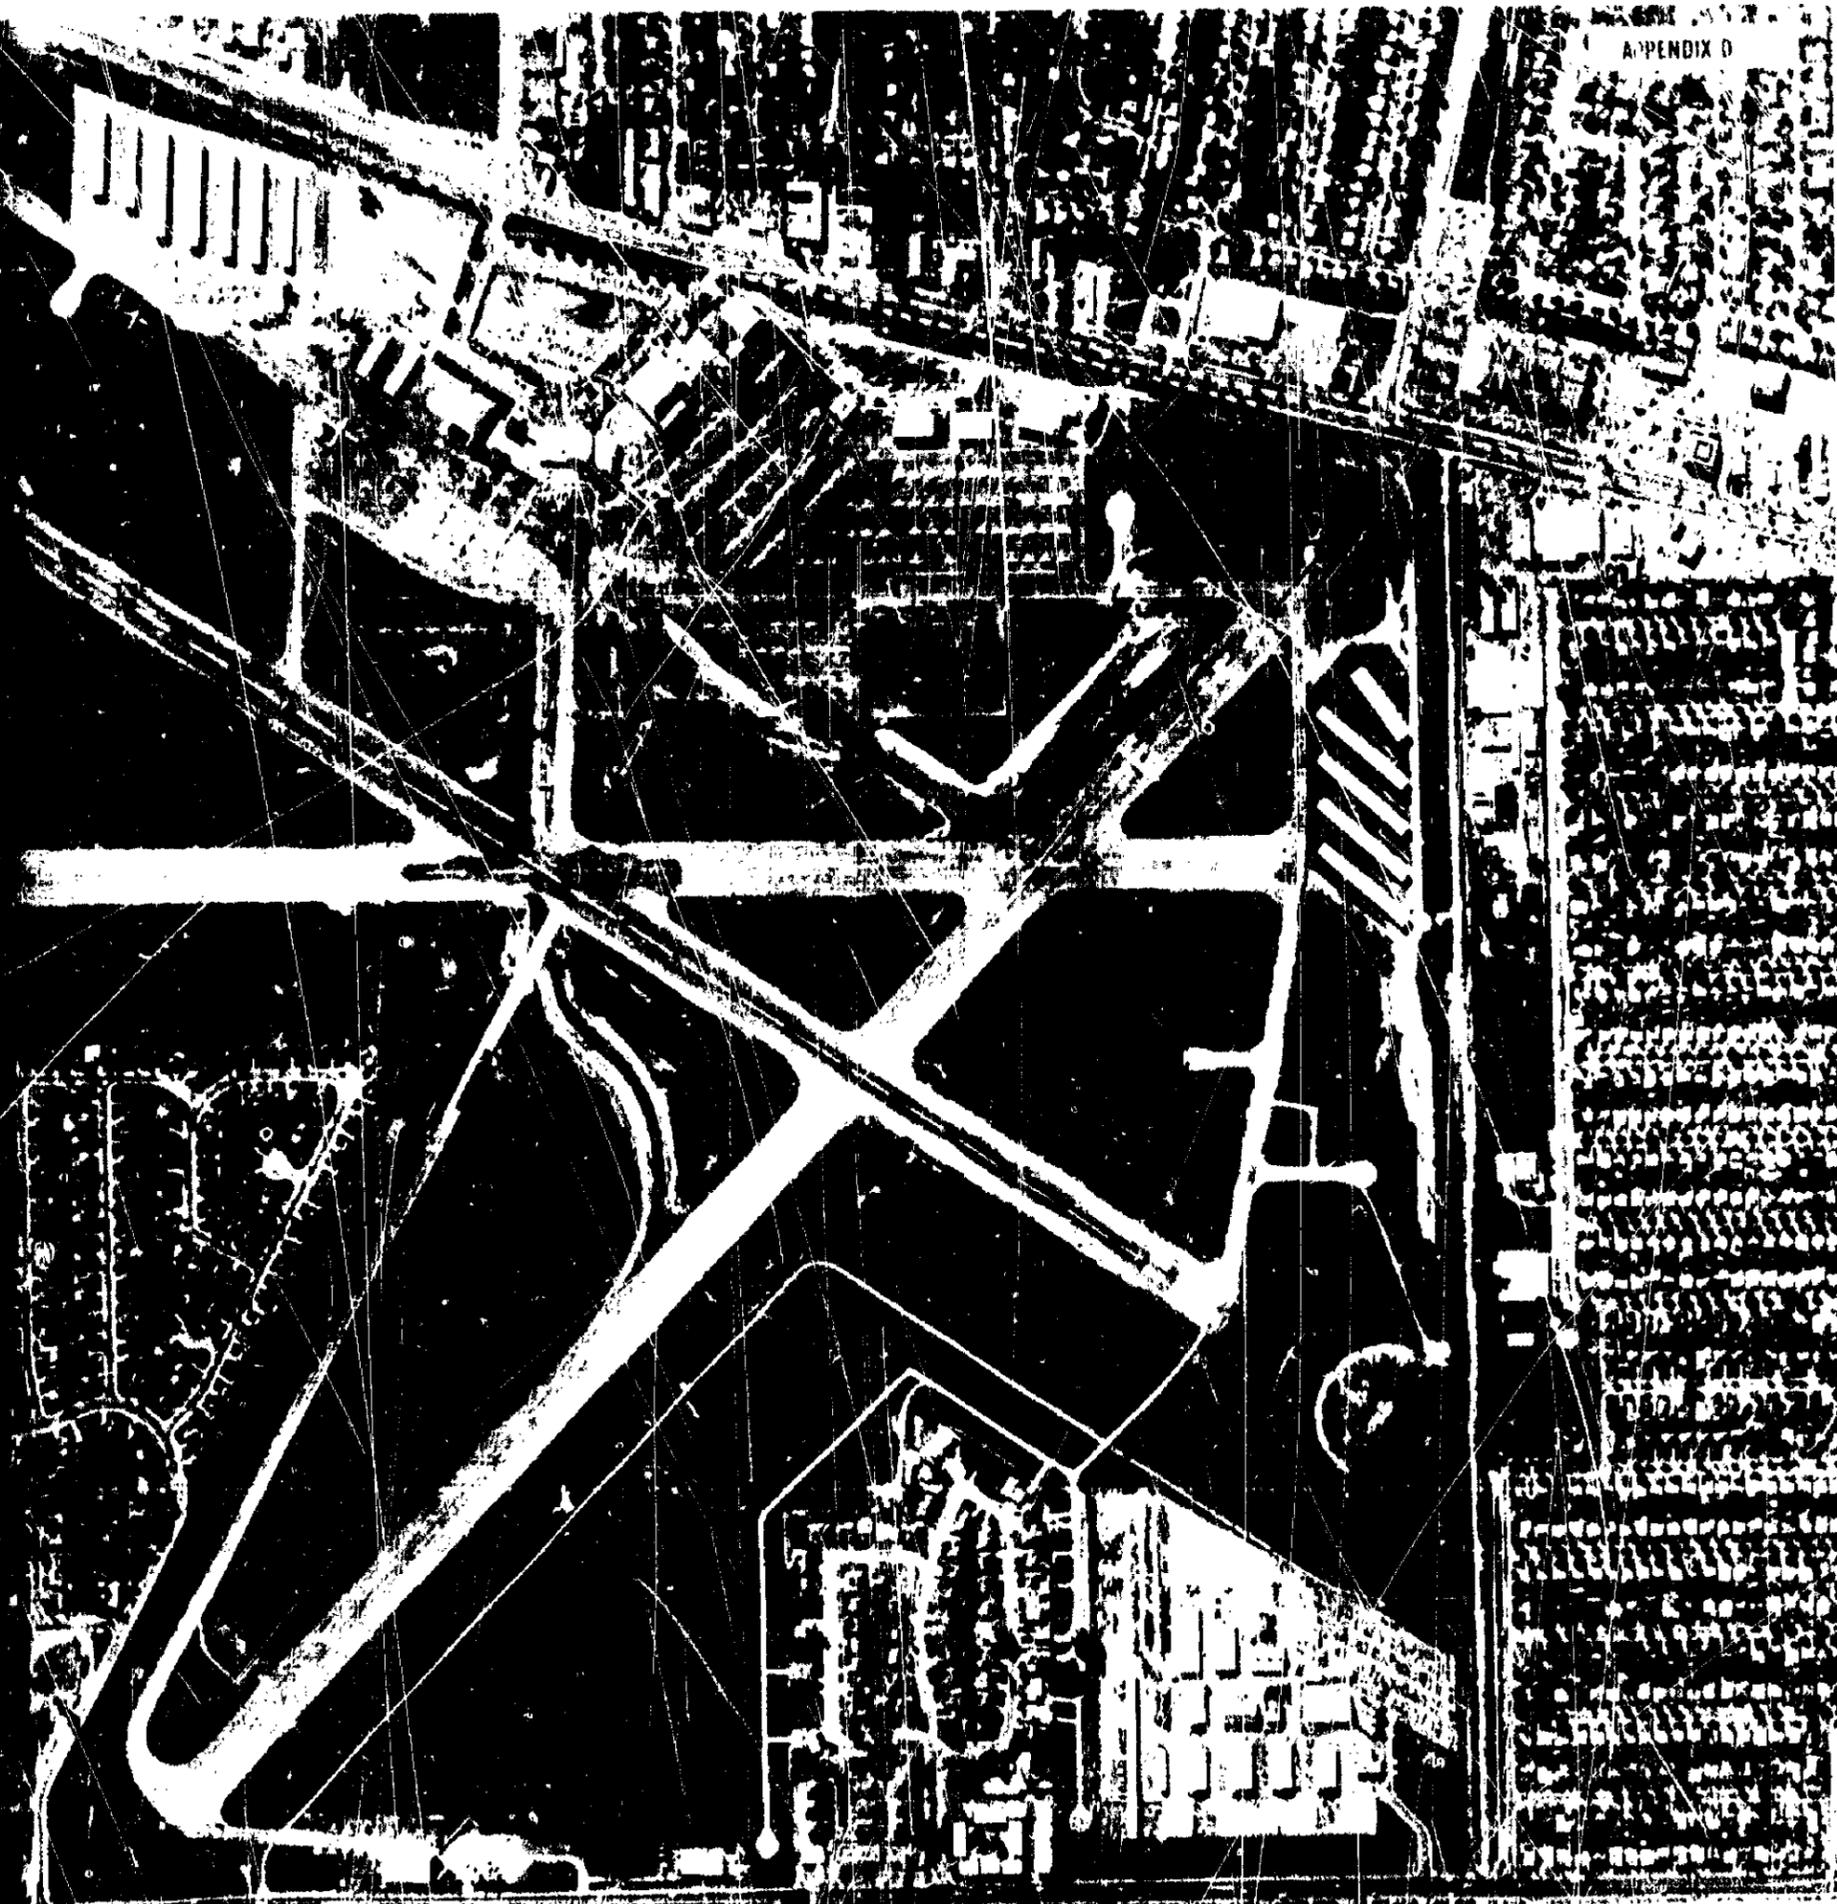
APPENDIX D

ARROW SHOWS BUILDING
STRUCK BY AIRCRAFT
