AIRCRAFT ACCIDENT REPORT

MACHINERY BUYERS CORPORATION

Learjet Model 24, N454RN

February 26, 1973

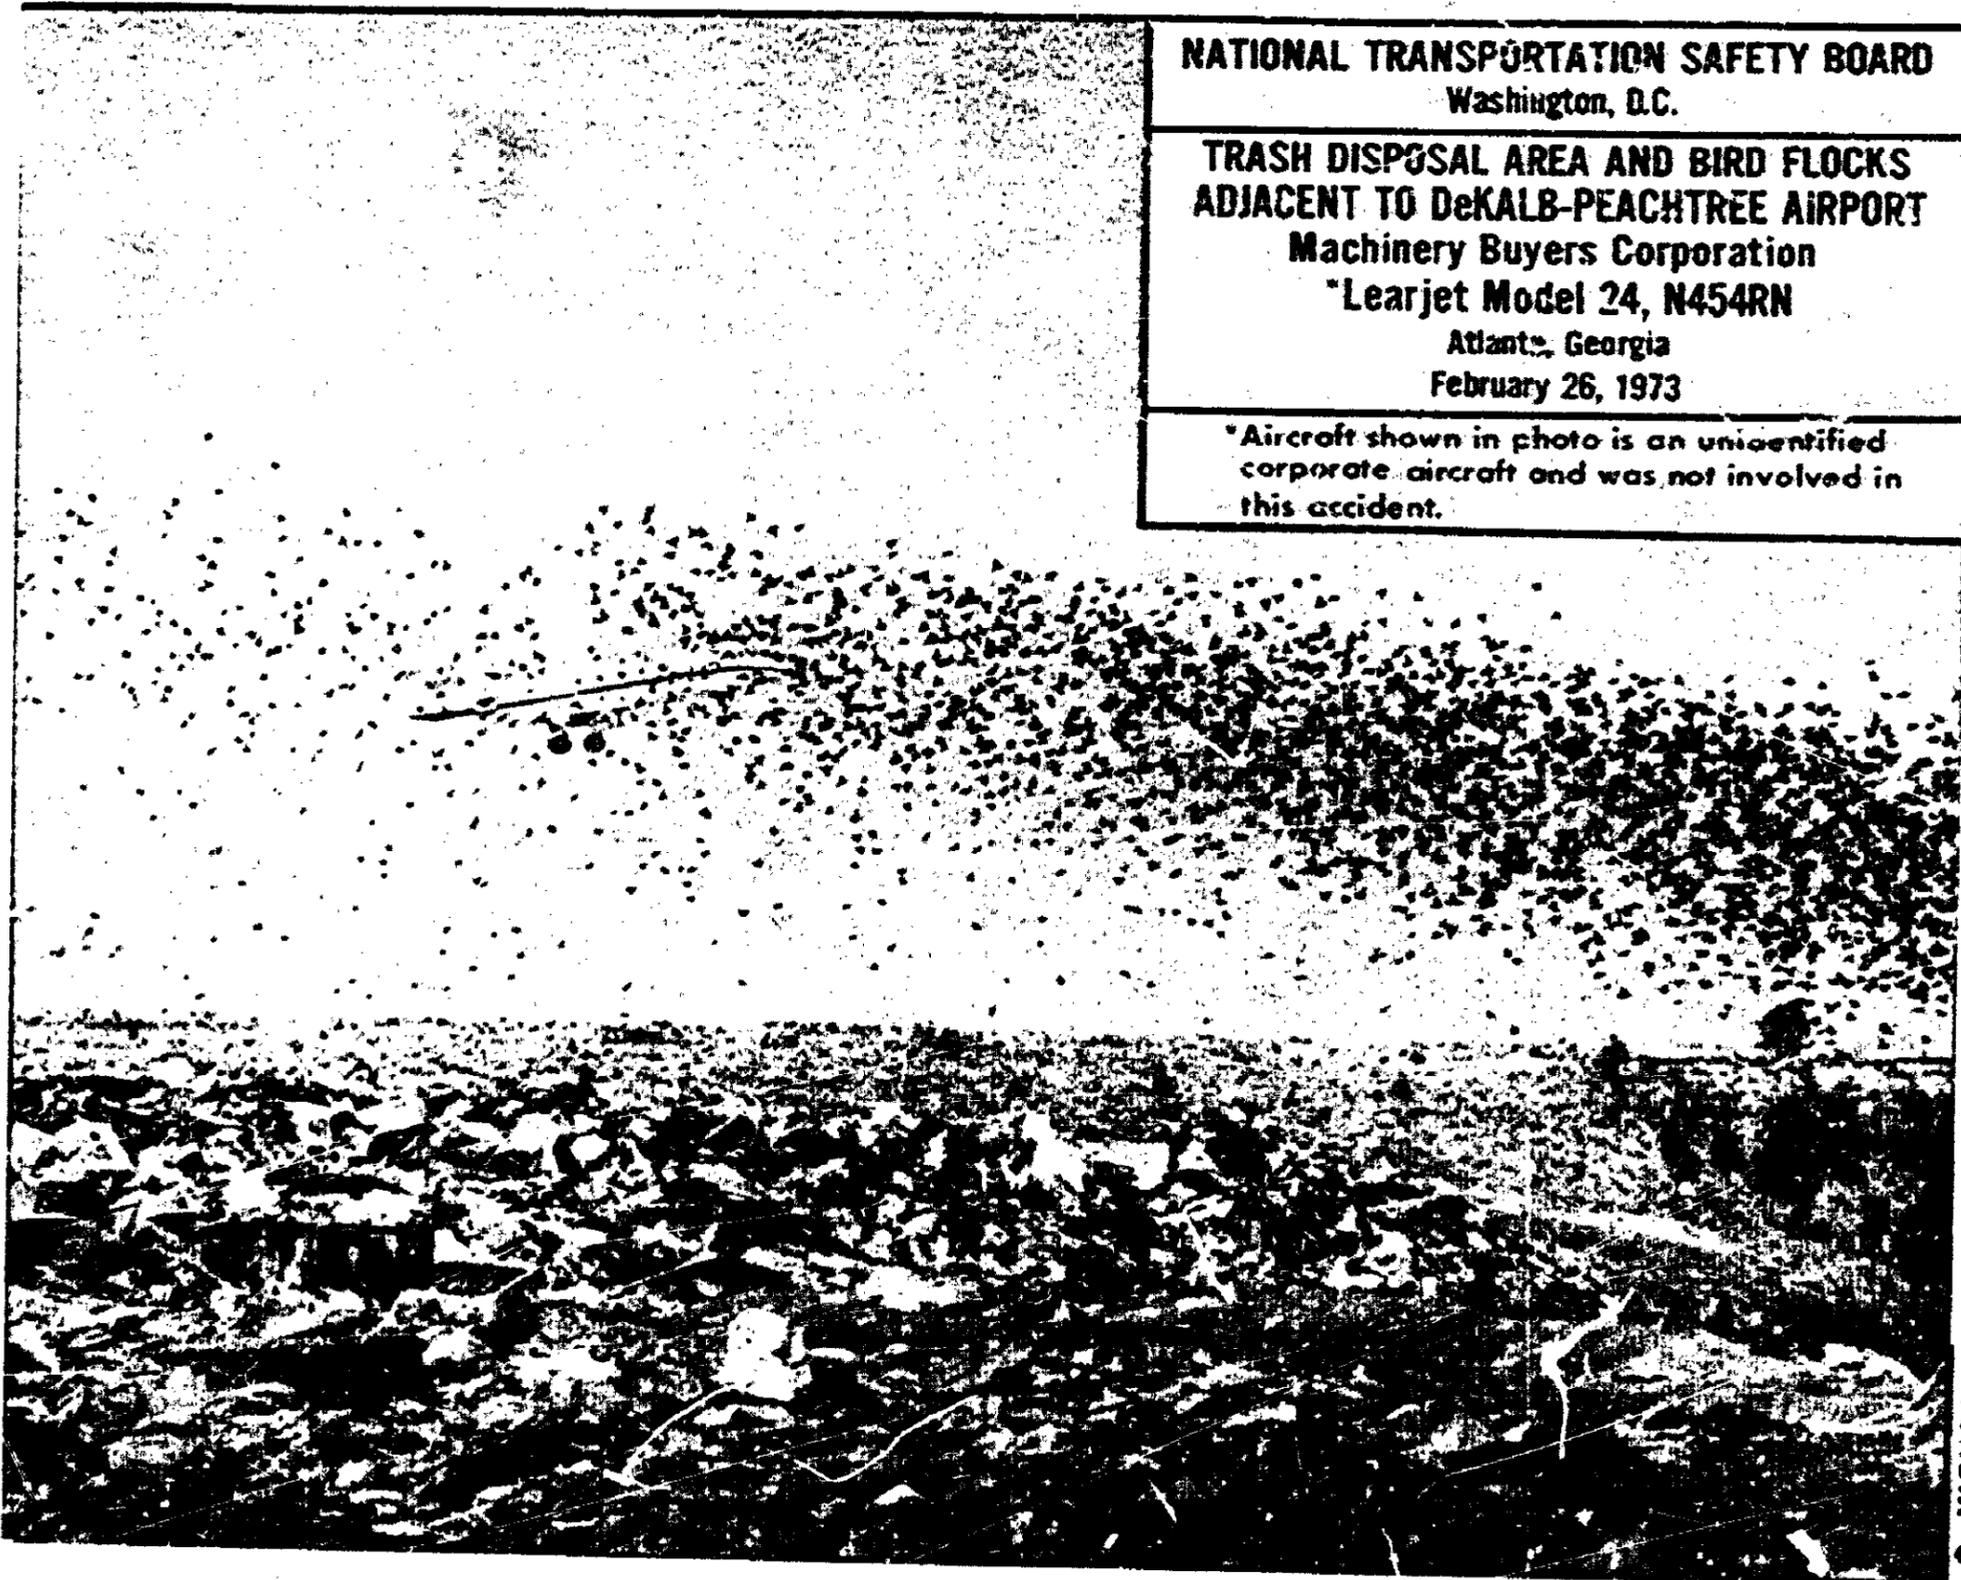
APPENDIX C

The area was used subsequently as a trash and garbage dump which attracted birds. (See Appendix C.) Under the provisions of FAA Order ASP5190.1, entitled "Compliance Requirements for Airports Developed or Improved with Federal Funds," the FAA advised the County in 1970 of the hazard to aviation presented by the dump. In the interim period, numerous communications were exchanged between the FAA and municipal authorities relative to this matter. In February 1971, the FAA was advised by the County that the dump would be closed by August 1972.

There is little doubt that the municipal dump located adjacent to the airport property attracts birds which are a serious hazard to aircraft. Local authorities did not close the dump by August 1972, as previously planned. The airport was returned to DeKalb County under Public Law 289 in 1960, and Federal funds were used for subsequent airport improvements in exchange for binding commitments designed to assure that the public interest would be served. In following-up on the compliance requirements for airports developed or improved with Federal funds, the FAA did not take adequate measures, in accordance with existing statutes, to assure that the hazard was removed from the vicinity of the airport.

**TRASH DISPOSAL AREA AND BIRD FLOCKS
ADJACENT TO DeKALB-PEACHTREE AIRPORT**
Machinery Buyers Corporation
*Learjet Model 24, N454RN
Atlanta, Georgia
February 26, 1973
