AIRCRAFT ACCIDENT REPORT

SKYWAYS INTERNATIONAL, INC.

DOUGLAS DC-7C, N296

REPORT NUMBER: NTSB-AAR-74-2

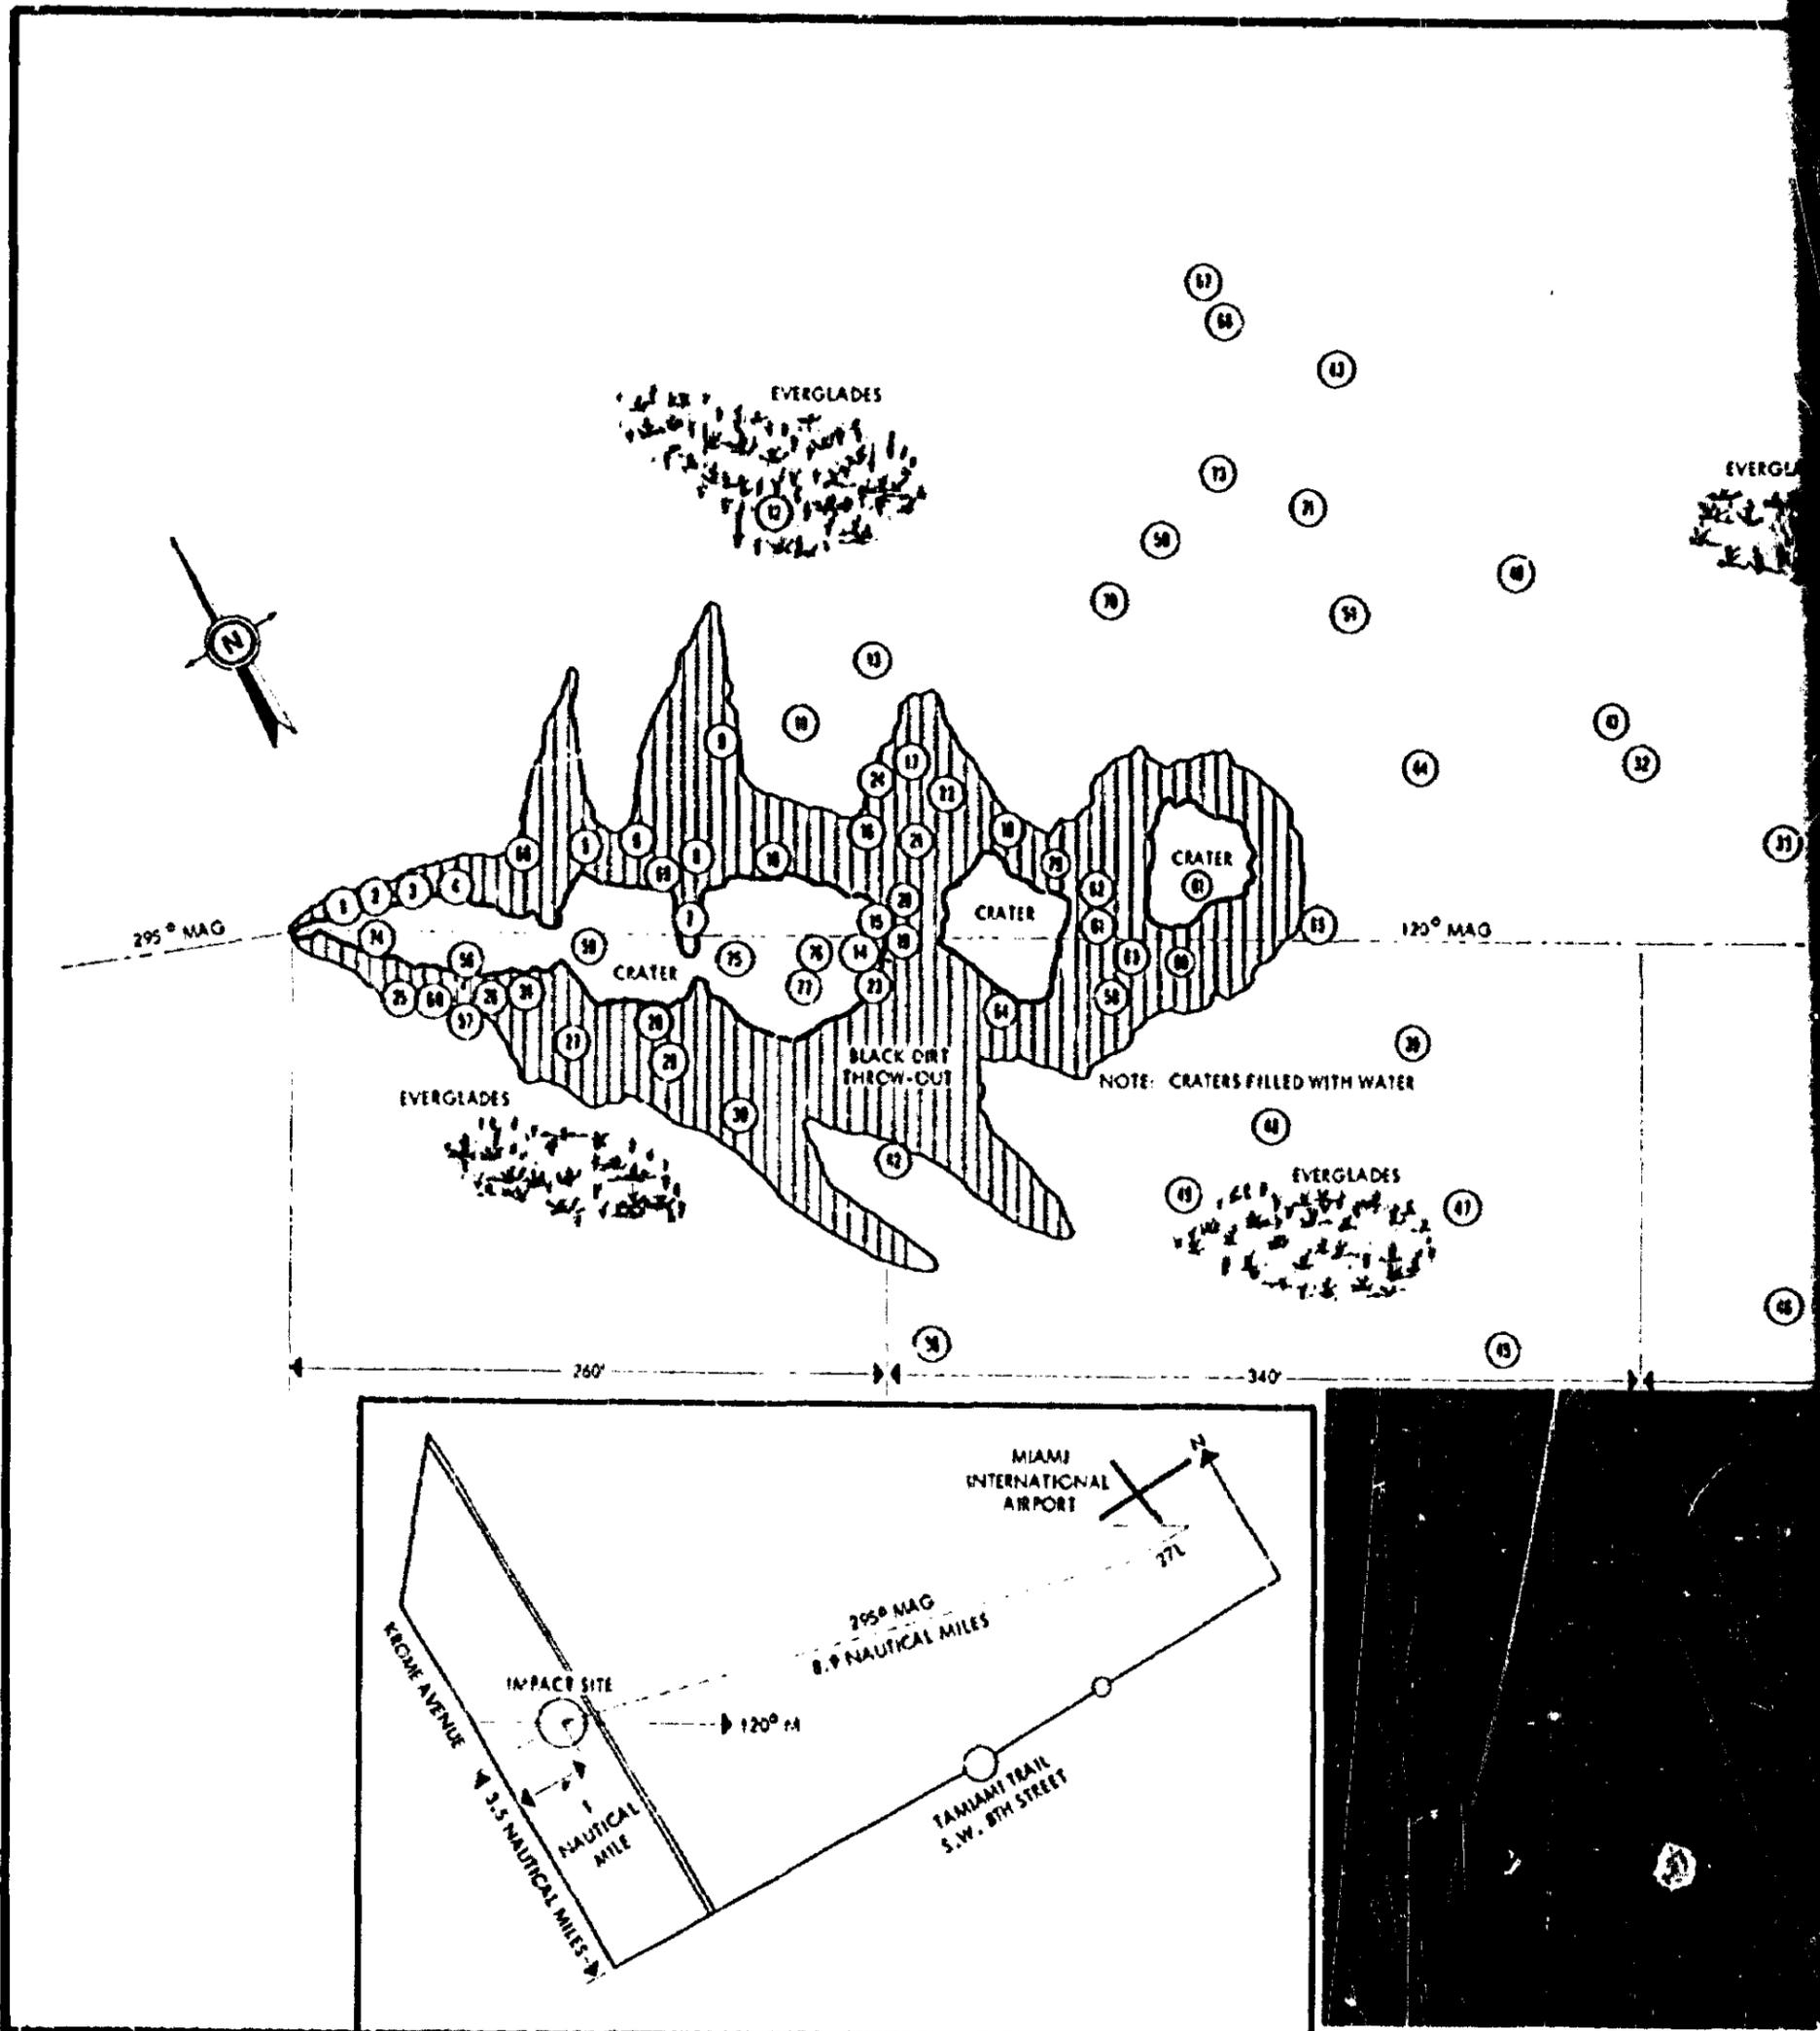
the nose were found on the surface in a fan-shaped pattern which arced left and toward 120° magnetic. (See Appendix D.) The large crater showed the approximate outline of the front profile of the left wing, two engines, and the fuselage -- all oriented on a heading of 030° magnetic. Soil was displaced in large quantities to the left and right of the craters. The saw grass in and around the area was not burnt. The aircraft's cargo was scattered throughout the area of impact. Cloth material, which was a part of the cargo, was neither scorched nor burnt. Ground fire was evident in a few isolated spots near the craters.
