1. Report No. NTSB-AAR-74-7		2. Government Accession No. PB 233 366	
4. Title and Subtitle Aircraft Accident Report - Piedmont Airlines, Boeing 737 (N751N) Greensboro, North Carolina, October 28, 1973		5. Report Date May 22, 1974

AIRCRAFT ACCIDENT REPORT

PIEDMONT AIRLINES
BOEING 737, N751N
GREENSBORO, N.C.
OCTOBER 28, 1973

NATIONAL TRANSPORTATION SAFETY BOARD
Washington, D.C. 20591
Report Number: NTSB-AAR-74-7

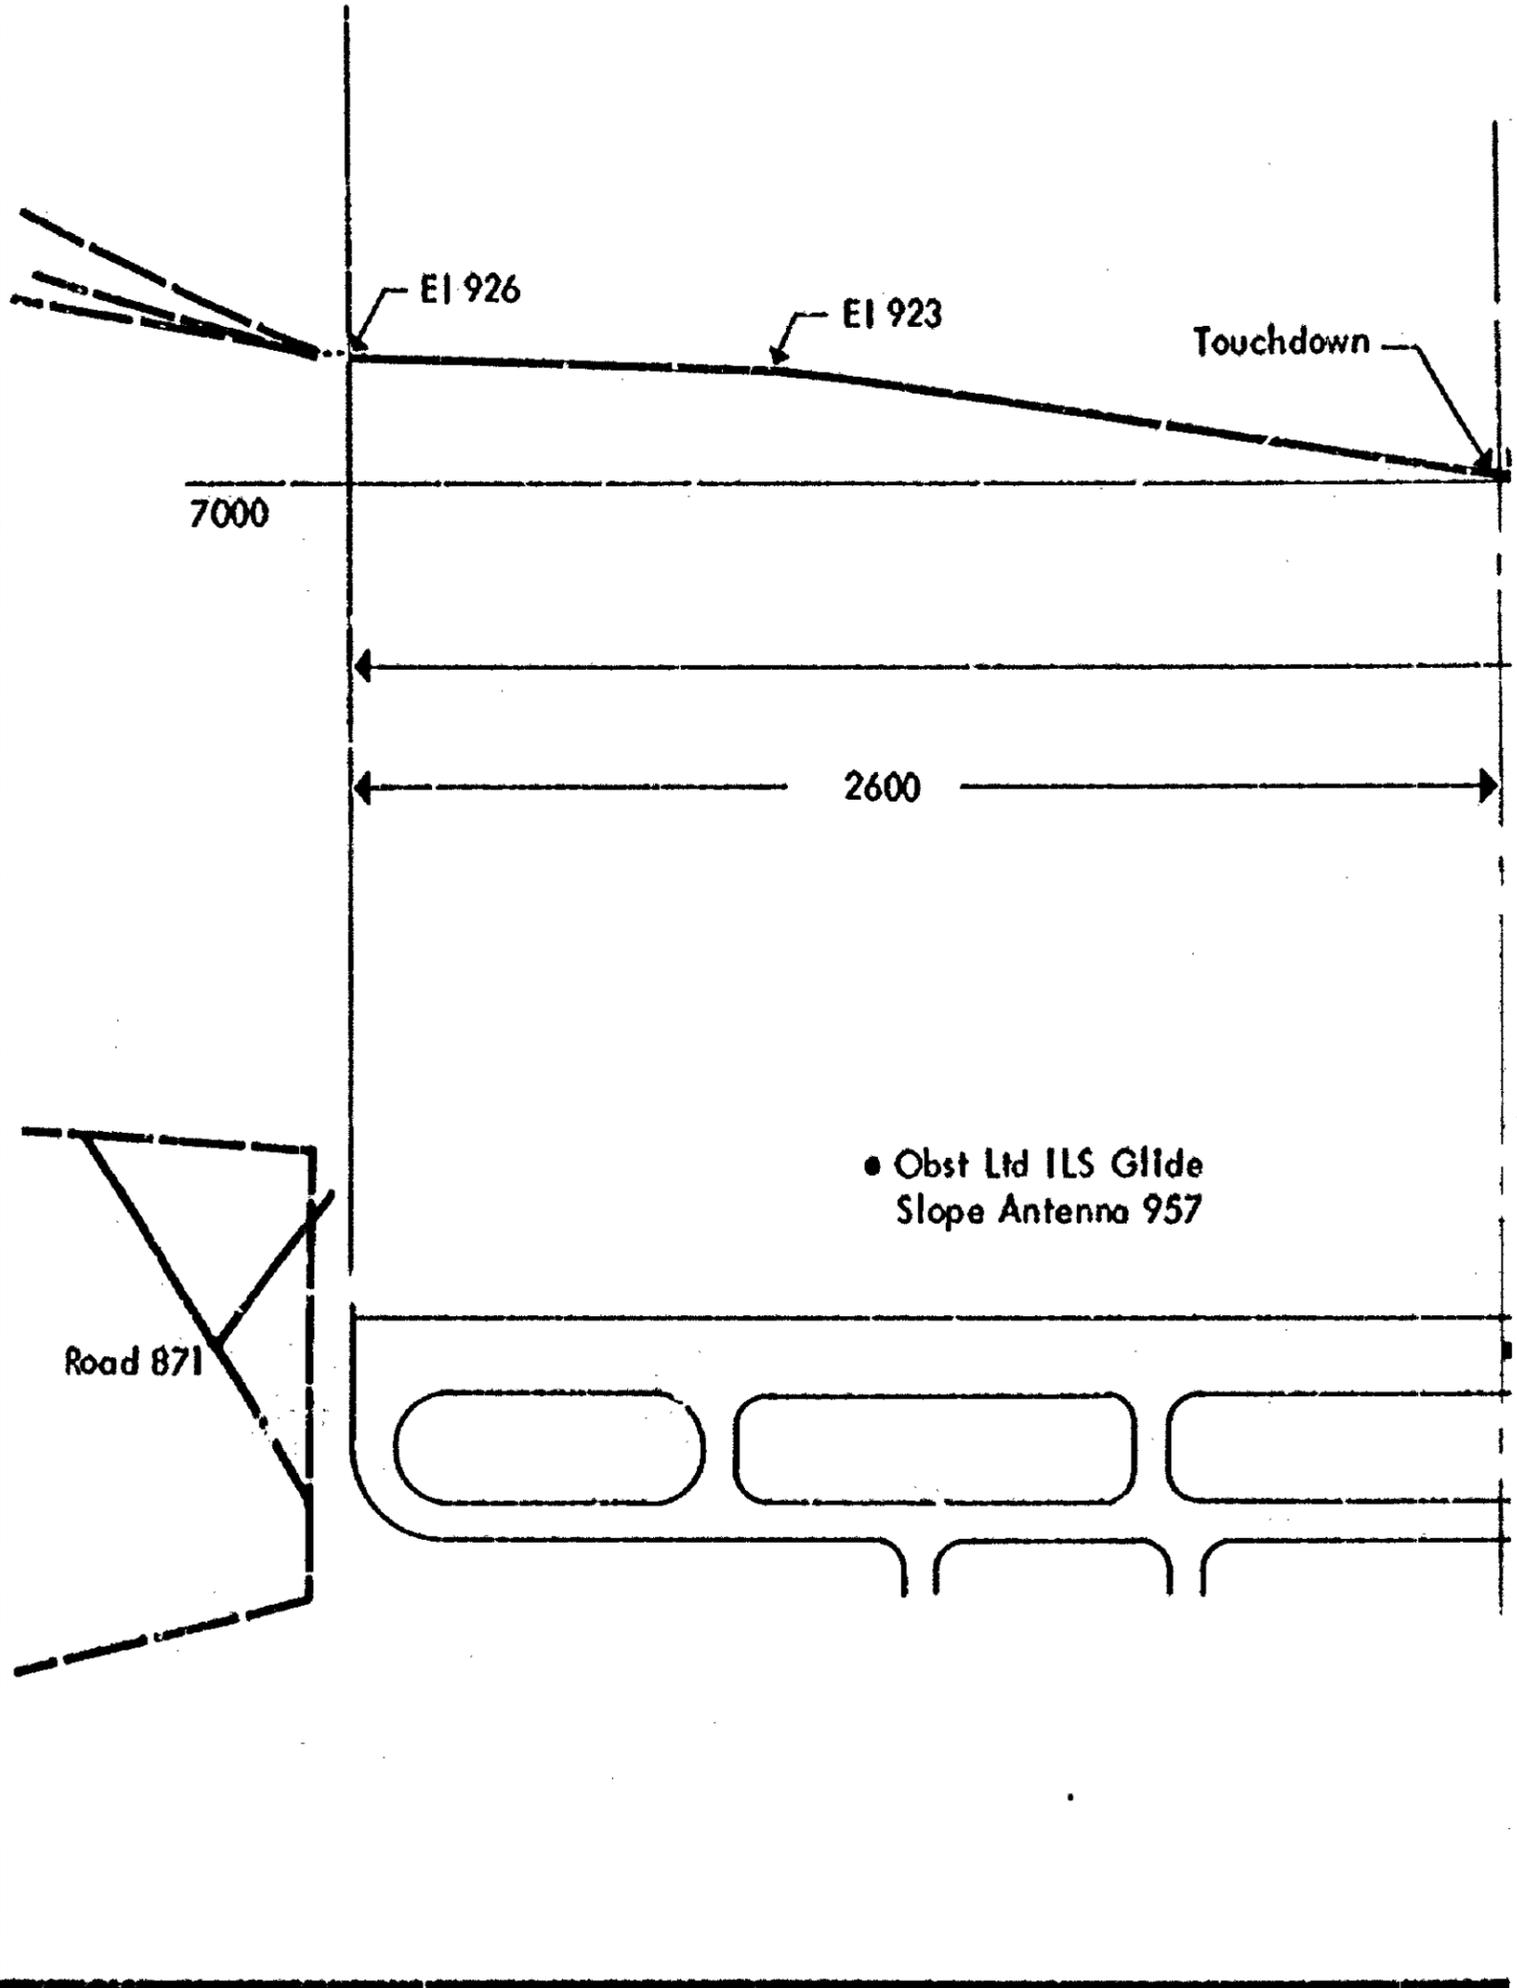
The aircraft continued about 640 feet, crossed a service road, and stopped on an incline 820 feet from the runway. (See Appendix D.)

Tire tracks began where the right main tires contacted the runway, 2,600 feet from the approach threshold and about 10 feet left of the centerline. Tracks of the nose wheel tires began 2,900 feet down the runway; tracks from the left main tires began at 3,000 feet. The left main wheels rolled to within 9 feet 10 inches of the left side of the runway, and 5,400 feet down the runway at which point the tracks turned toward the center of the runway. When the aircraft crossed the end of the runway, the tracks of the left main tires were 47 feet 6 inches from the left edge of the runway.
