1. Report No. NTSB-AAR-74-8		2. Government Accession No. PB 234 422	
4. Title and Subtitle Aircraft Accident Report - Trans World Airlines, Inc., Boeing 707-331B, N8705T Los Angeles, California, August 28, 1973		5. Report Date July 10, 1974

AIRCRAFT ACCIDENT REPORT

TRANS WORLD AIRLINES, INC.
BOEING 707-331B, N8705T
LOS ANGELES, CALIFORNIA
AUGUST 28, 1973

NATIONAL TRANSPORTATION SAFETY BOARD
Washington, D.C. 20591
REPORT NUMBER: NTSB-AAR-74-8

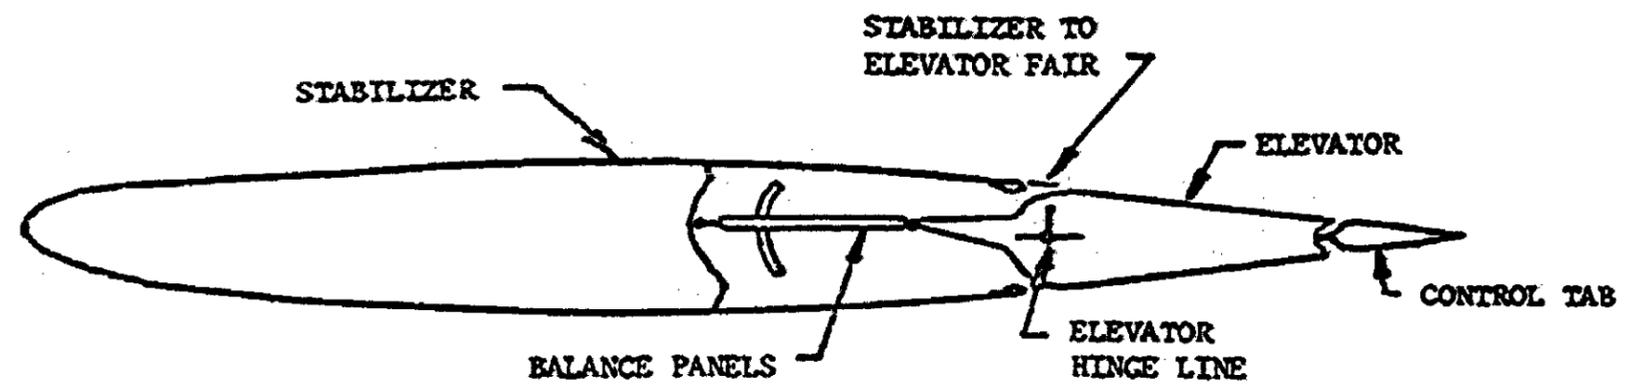
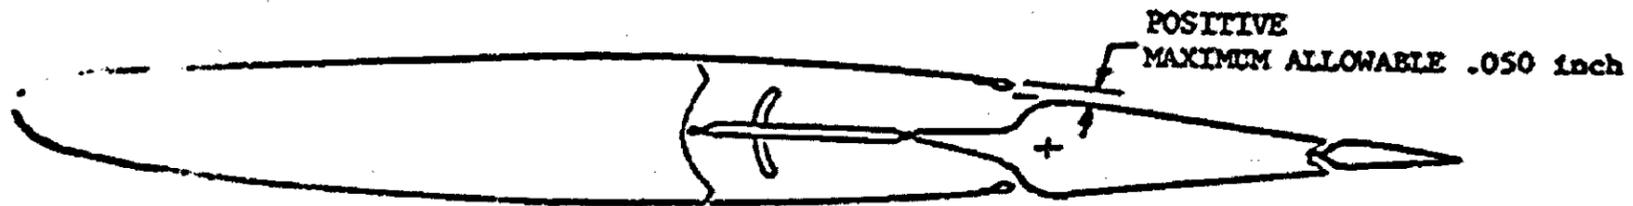
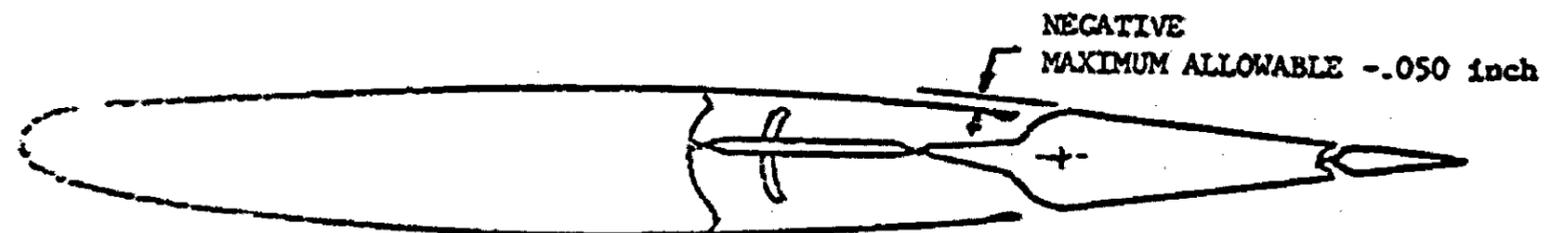
BOEING 707/720 STABILIZER-ELEVATOR CONTOUR FAIR

Boeing Company engineers theorized that the boundary layer effects caused by the upper surface skin waviness would be aggravated by the step down that was predominant at the hinge line on the left elevator.

(c) The upper nose contour of the left elevator at its hinge line was predominantly below the faired contour extension of the upper stabilizer surface. Although the alignment was within prescribed limits, the resulting step down caused further disturbance to the thickened boundary layer. The disturbed flow of air within the boundary layer affected the pressure distribution and thus the resultant lift vector acted on the elevator so that the moment about the elevator hinge caused by air loads on a deflected control surface was lower than normal.

The low control forces were caused by the effect of a thickened boundary layer on the left stabilizer which was produced by waviness on the stabilizer upper surface combined with the step down at the stabilizer-to-elevator contour fair.

The stabilizer to elevator contour fair was changed on both assemblies to produce a condition wherein the elevator nose contour was predominantly above the stabilizer contour extensions. The alteration was accomplished by removing shims between the stabilizer trailing edge beam and the elevator hinge support structure.
