1. Report No. NTSB-AAR-74-10	2. Government Accession No.	PB 235 838	
4. Title and Subtitle Aircraft Accident Report - Trans World Airlines, Inc., Boeing 707-131B, N757TW, Los Angeles, California, January 16, 1974		5. Report Date August 14, 1974	6. Performing Organization Code

# **AIRCRAFT ACCIDENT REPORT**

**TRANS WORLD AIRLINES, INC.  
BOEING 707-131B, N757TW**

**JANUARY 16, 1974**

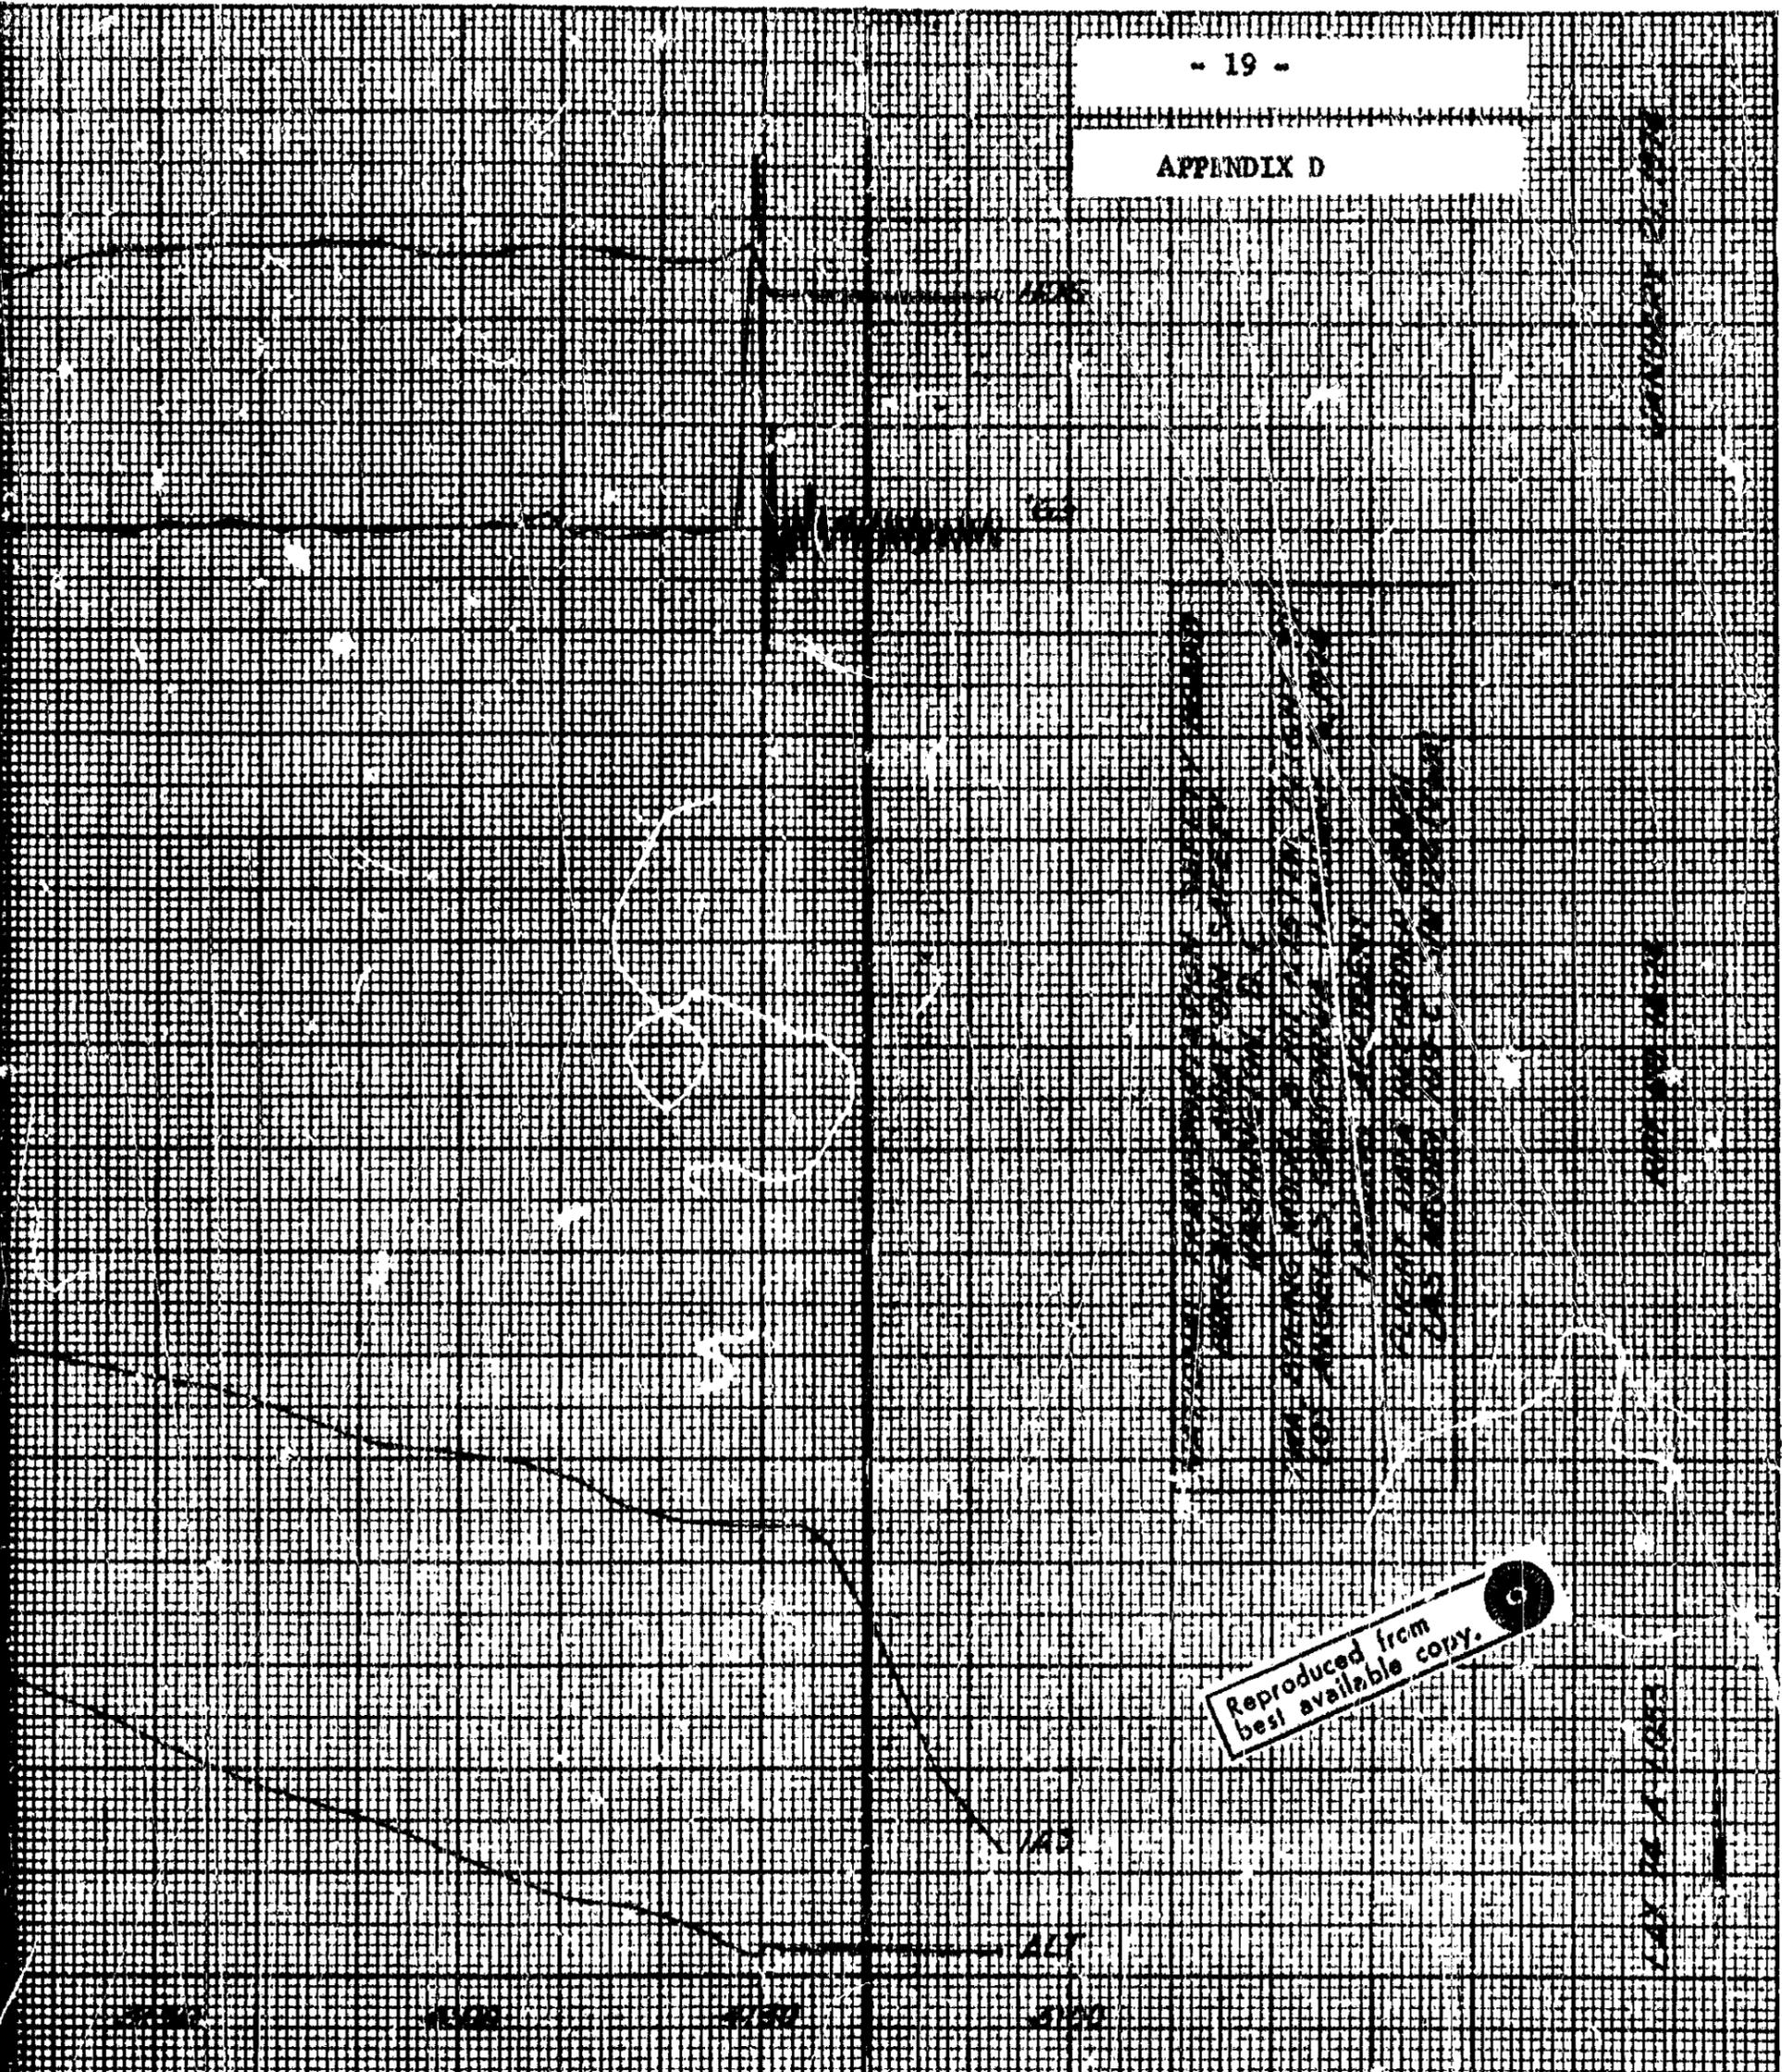
APPENDIX D

Contrary to the crew's belief that all three landing gears touched down simultaneously, the tire marks on the runway confirm that the nose wheel touched down first. The 1,400-foot per minute rate of descent in the 9 seconds before touchdown, and the vertical acceleration trace reading of +4.60g on the FDR upon touchdown, indicate an unchecked high sink rate and a resultant hard landing. The approach should have been discontinued under these conditions.
