AIRCRAFT ACCIDENT REPORT:
AIRCRAFT POOL LEASING CORPORATION,
LOCKHEED SUPER CONSTELLATION,
L-1049H, N6917C, MIAMI, FLORIDA,
DECEMBER 15, 1973

1. Report No. NTSB-AAR-74-11	2. Government Accession No.	PB 240 120	
4. Title and Subtitle Aircraft Accident Report - Aircraft Pool Leasing Corporation, Lockheed Super Constellation - L-1049H, N6917C - Miami, Florida, December 15, 1973		5. Report Date September 11, 1974	6. Performing Organization Code

AIRCRAFT ACCIDENT REPORT

AIRCRAFT POOL LEASING CORPORATION
LOCKHEED SUPER CONSTELLATION
L-1049H, N6917C
ML-MI, FLORIDA
DECEMBER 15, 1973

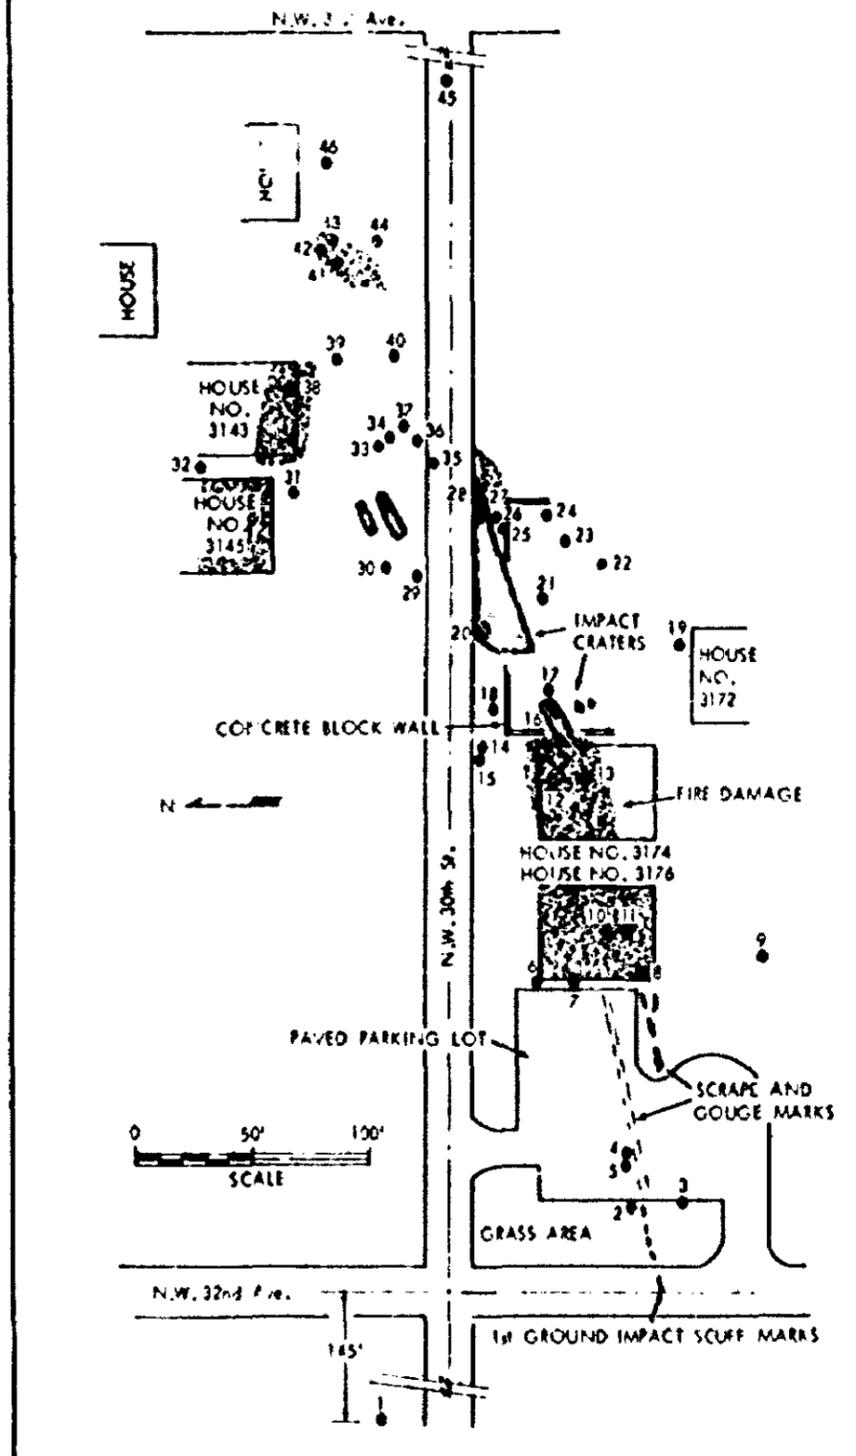
1. 7"x10" piece of Propeller Blade
2. Broken piece of red Navigational Light Lens
3. Tree with tops shredded
4. Parking wheel bumper
5. Fragments of red Navigational Light Lens

13. Left Outboard Main Landing Gear Door
14. Section of Propeller Blade - No. 2 Propeller
15. Broken Utility Pole
16. Left Inboard Main Landing Gear Door
17. No. 1 Engine and Propeller

25. Broken Utility Pole
26. Engine Nacelle Bulkhead
27. Electric Hydraulic Pump
28. Section of Cargo Floor
29. Propeller Blade
30. Broken Utility Pole
31. Section of Propeller Blade

32. No. 4 Engine
33. Broken Utility Pole
34. No. 4 Engine Propeller
35. 2 Inboard Wing Plank Sections
36. Emergency Escape Hatch
37. Broken Utility Pole
38. Remaining section of Right Wing
