1. Report No. NTSB-AAR-74-13		2. Government Accession No.	
4. Title and Subtitle Aircraft Accident Report - Delta Air Lines, Inc., Douglas DC-9-32, N33231, Chattanooga Municipal Airport, Chattanooga, Tennessee, November 27, 1973		5. Report Date November 8, 1974

**DELTA AIR LINES, INC.
McDONNELL DOUGLAS DC-9-32, N3323L
CHATTANOOGA MUNICIPAL AIRPORT
CHATTANOOGA, TENNESSEE
NOVEMBER 27, 1973**

**NATIONAL TRANSPORTATION SAFETY BOARD
Washington, D.C. 20591
REPORT NUMBER: NTSB-AAR-74-13**

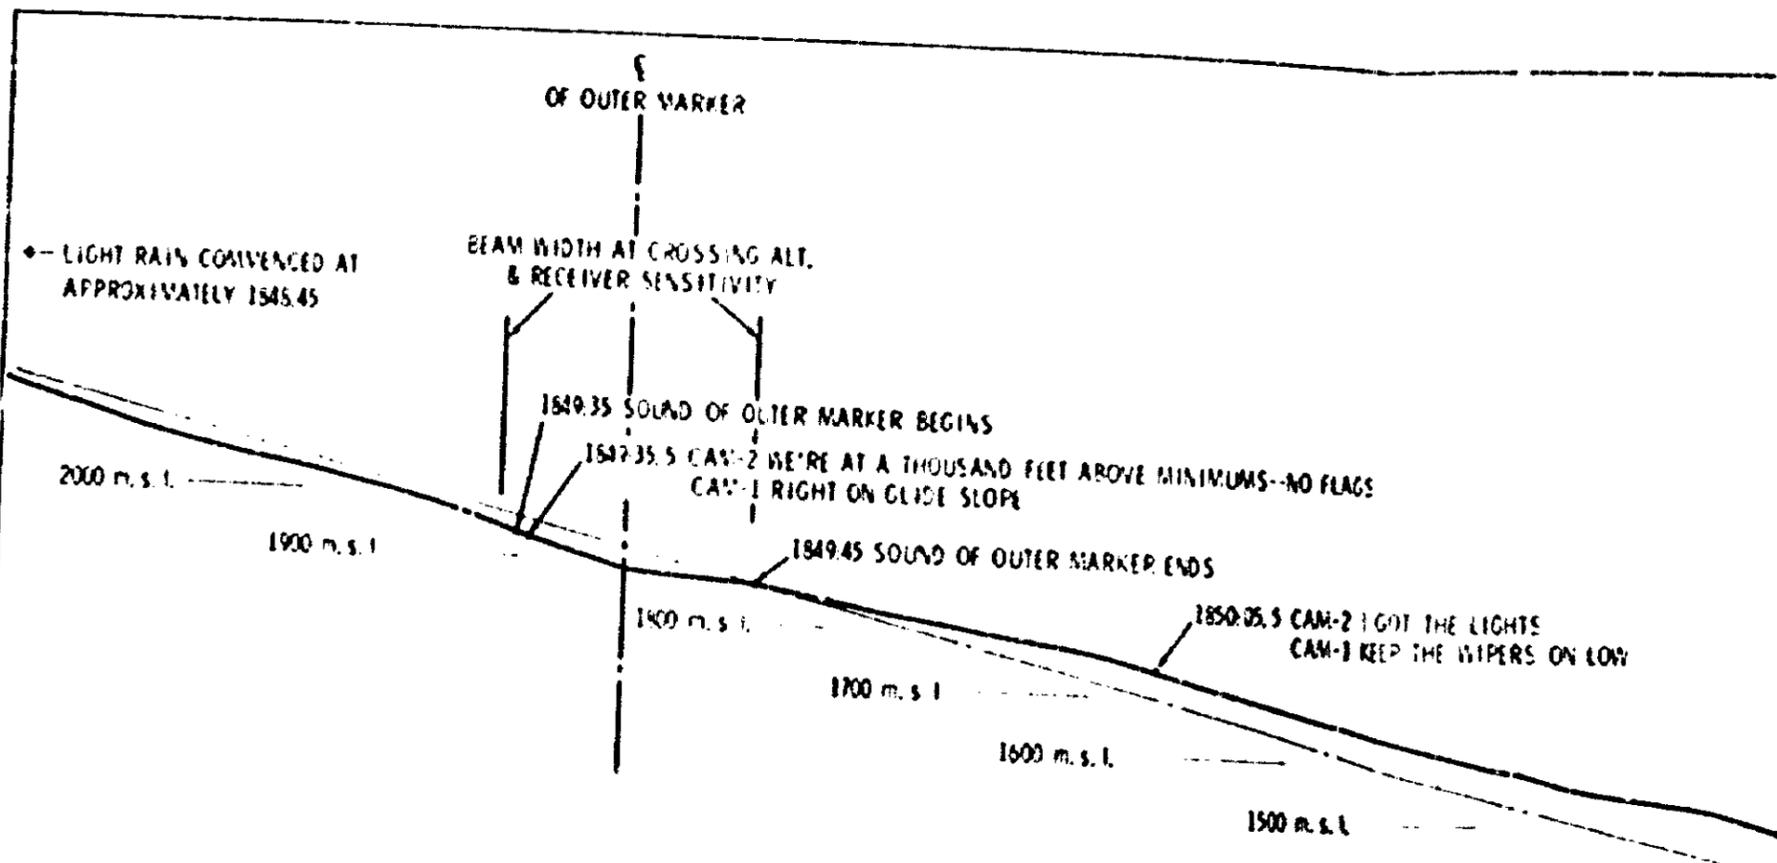
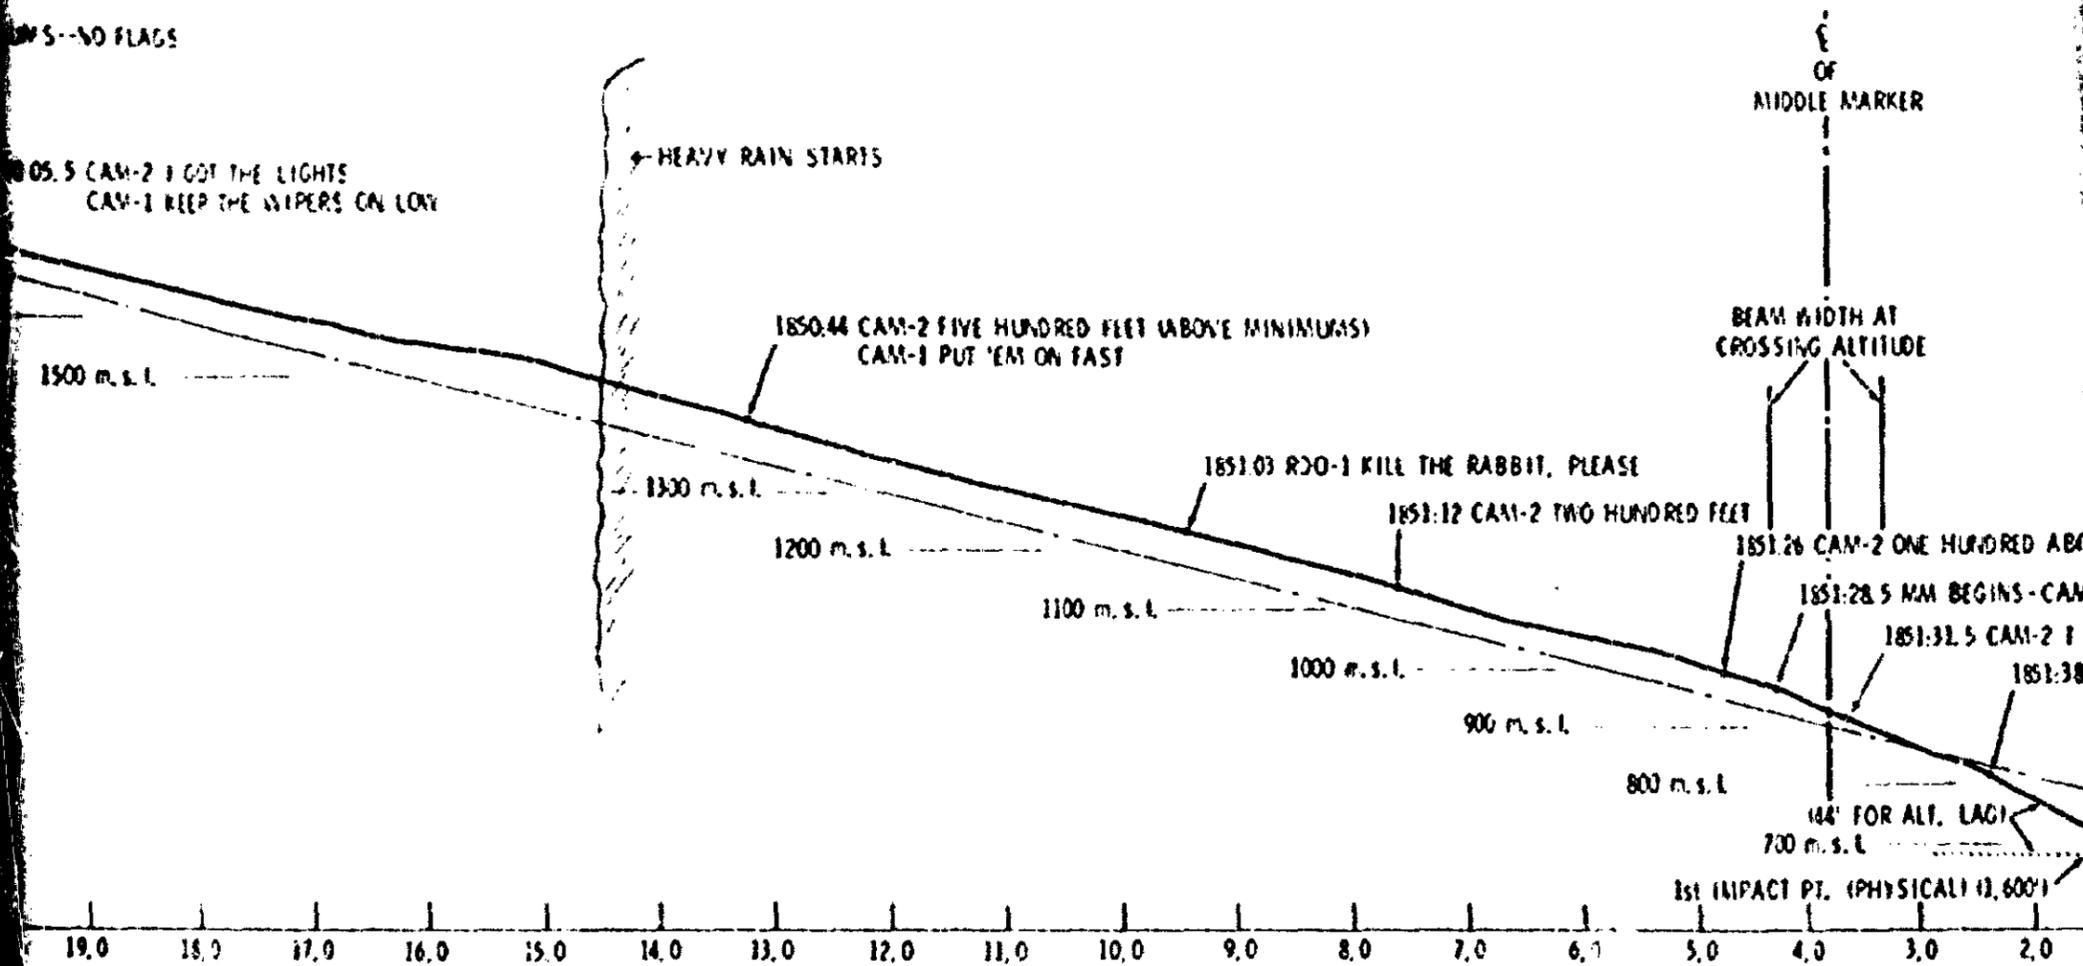
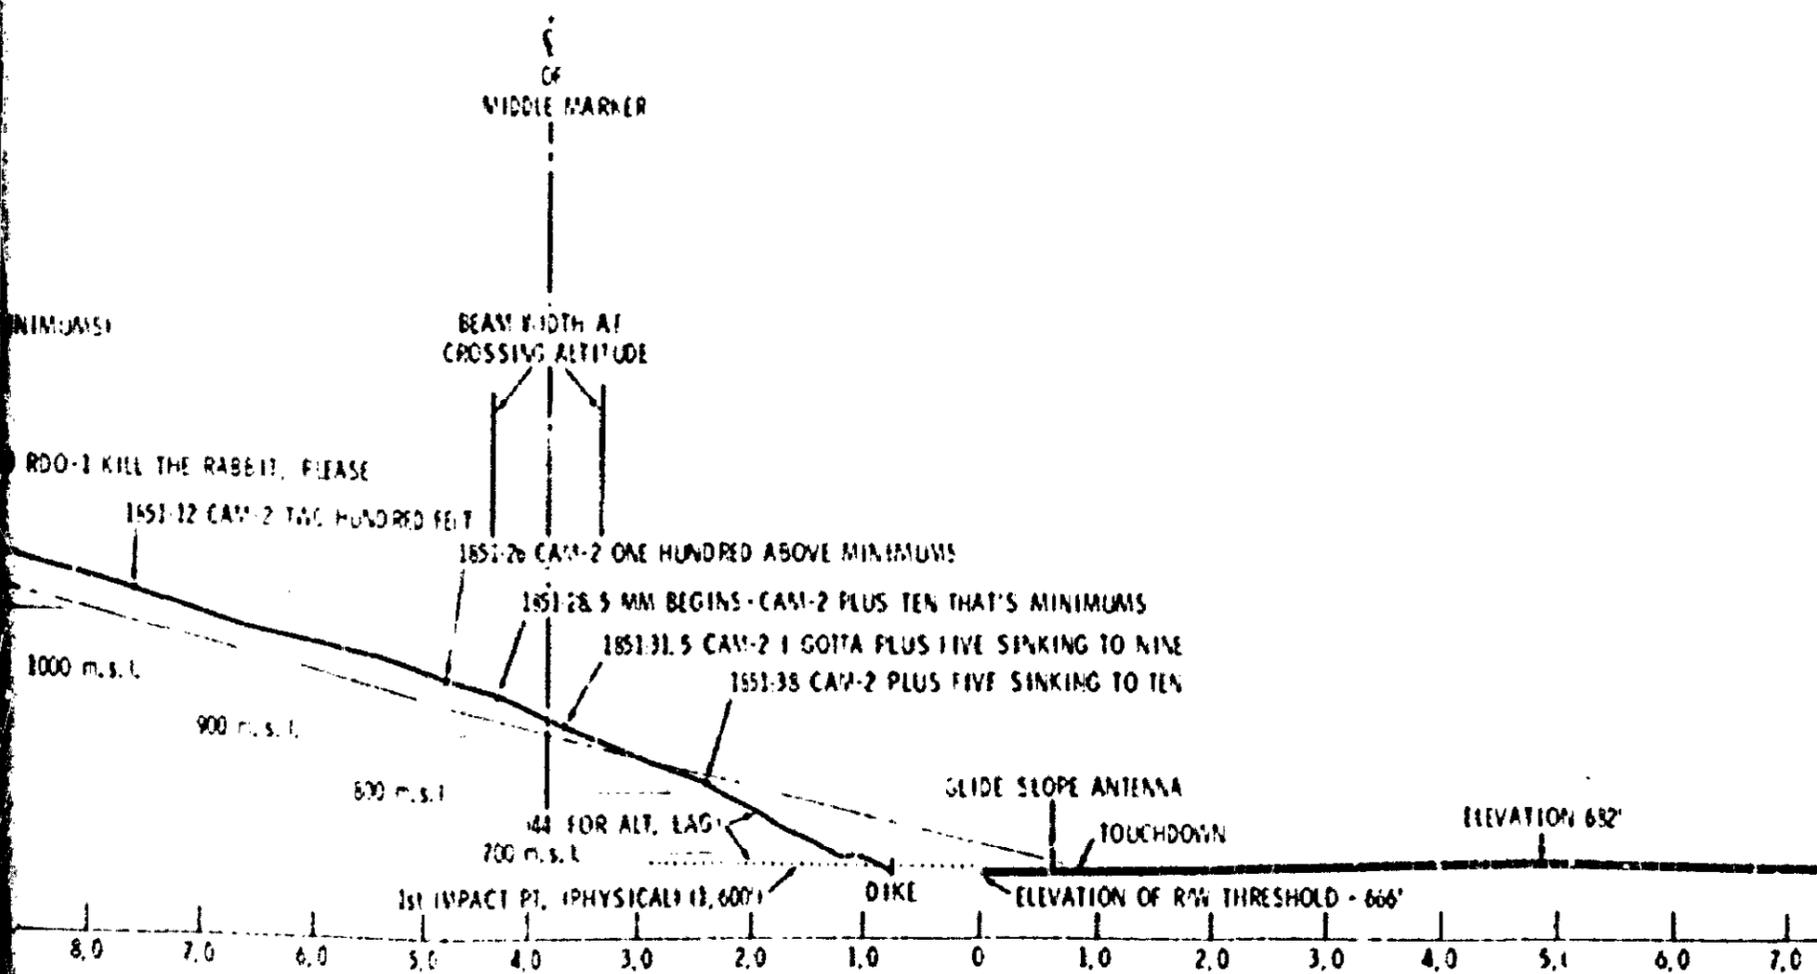
APPENDIX D

ELEVATION	WIND	
	DIRECTION (TRUE)	VELOCITY (KNOTS)
4,000 FT.	185°	41
3,000 FT.	185°	35+
2,000 FT.	185°	32.5
1,000 FT.	180°	15.5
SURFACE	167°	1 TO 4

ELEVATION (m. s. l.)	AVERAGE	
	GROUND SPEED	AIR SPEED
3,000' to 2,000'	107 kts.	140 kts.
2,000' to 1,000'	110 kts.	134 kts.
1,000' to IMPACT	117 kts.	130 kts.
