# **AIRCRAFT ACCIDENT REPORT**

**CONVAIR 340/440, N4819C**

**NEAR BISHOP, CALIFORNIA**

**REPORT NUMBER: NTSB-AAR-75-1**

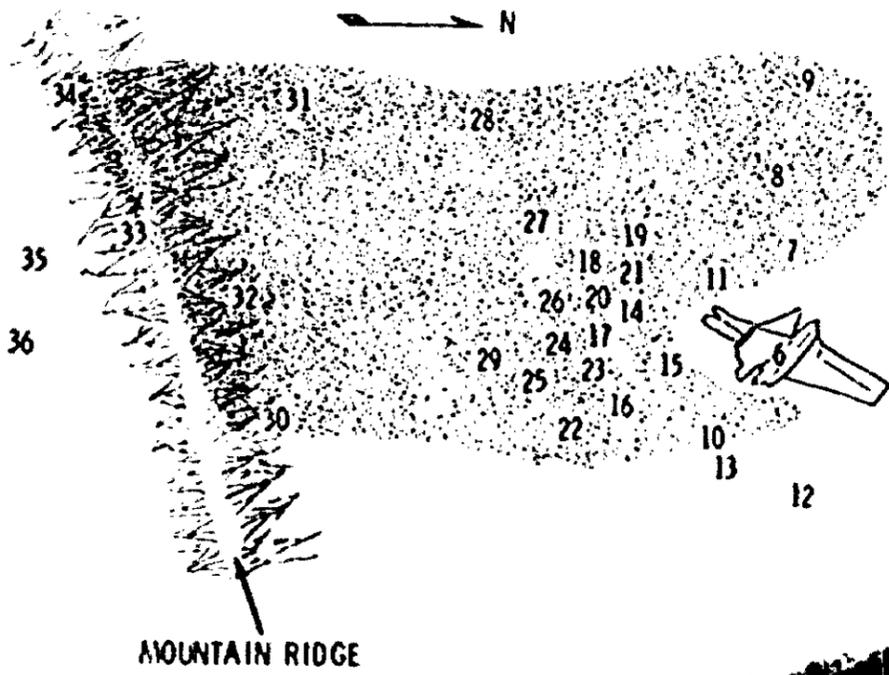
PHOTO 'A'

ROCKY TERRAIN
