| 4. Title and Subtitle Aircraft Accident Report- Air France, Boeing 707-B-328B - FDLCA, Near O'Neill, Nebraska, May 13, 1974 | | 5. Report Date January 15, 1975 | |

AIRCRAFT ACCIDENT REPORT

BOEING 707-B-328B

REPORT NUMBER: NTSB-AAR-75-4

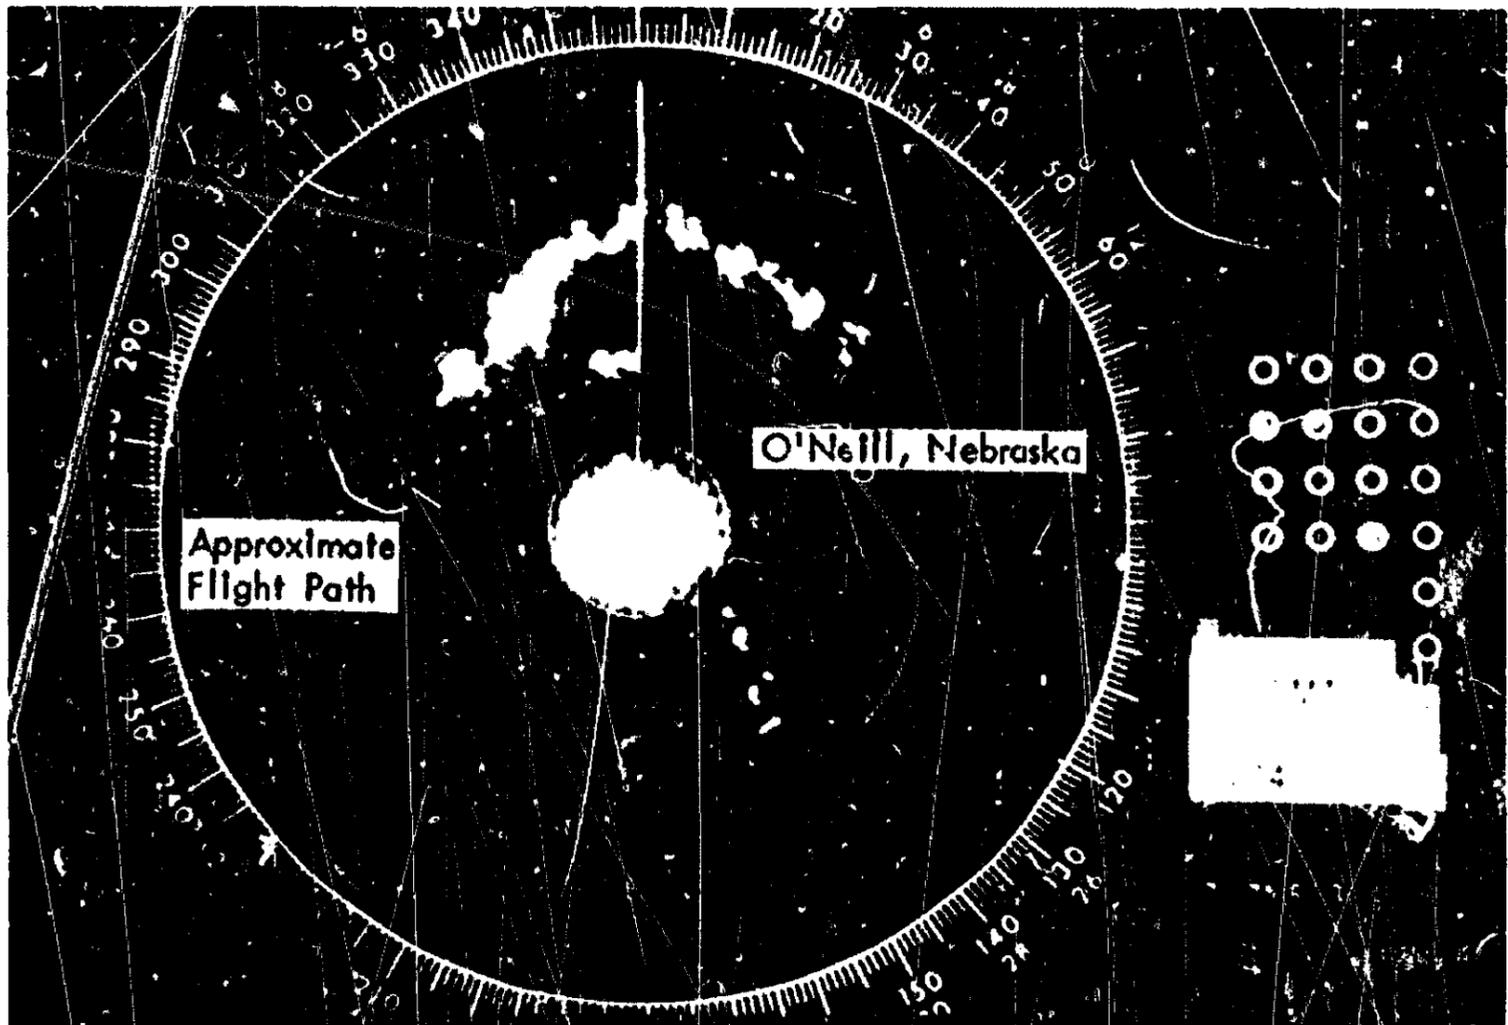
Grand Island, Nebraska, Weather Radarscope Photograph

Additionally, this observation (and the photographs) showed a thunderstorm cell, 20 miles in diameter, near O'Neill. The thunderstorm cell was characterized as: Very strong, hail indicated, top 42,000 feet, moving from 260° at 50 kn. (See Appendices D and E.)

In view of the extent and intensity of the thunderstorm activity shown by the radar weather observations and the radarscope photographs, the Safety Board believes that a properly operating and properly operated airborne weather radar would have detected such activity.

The flight data recorder disclosed that at the time of the turbulence encounter, the flight was at 33,000 feet and on a heading of 052° magnetic. Considering the magnetic variation (about 10° E) and applying a true track to the radarscope photographs, it is evident that no other echoes could have masked the one near O'Neill. On such a heading and at the aircraft's altitude, the frequent and intense lightning from the cell should have been visible for many miles. Therefore, even if the radar were inoperative, the thunderstorm activity near O'Neill should have been easily visible and could have been circumnavigated without difficulty.
