1. Report No. NTSB-AAR-75-6	2. Government Accession No.		
4. Title and Subtitle Aircraft Accident Report - New Jersey Air National Guard Convair F106, Serial Number 59-0044, Piper PA-24-250, N6876P, Midair Collision Near Saxis, Virginia, October 11, 1974.		5. Report Date January 29, 1975

AIRCRAFT ACCIDENT REPORT

REPORT NUMBER: NTSB-AAR-75-6

New Jersey Air National Guard Convair F106
Serial Number 59-0044
Piper PA 24-250, N6876P
Near Saxis, Virginia
October 11, 1974

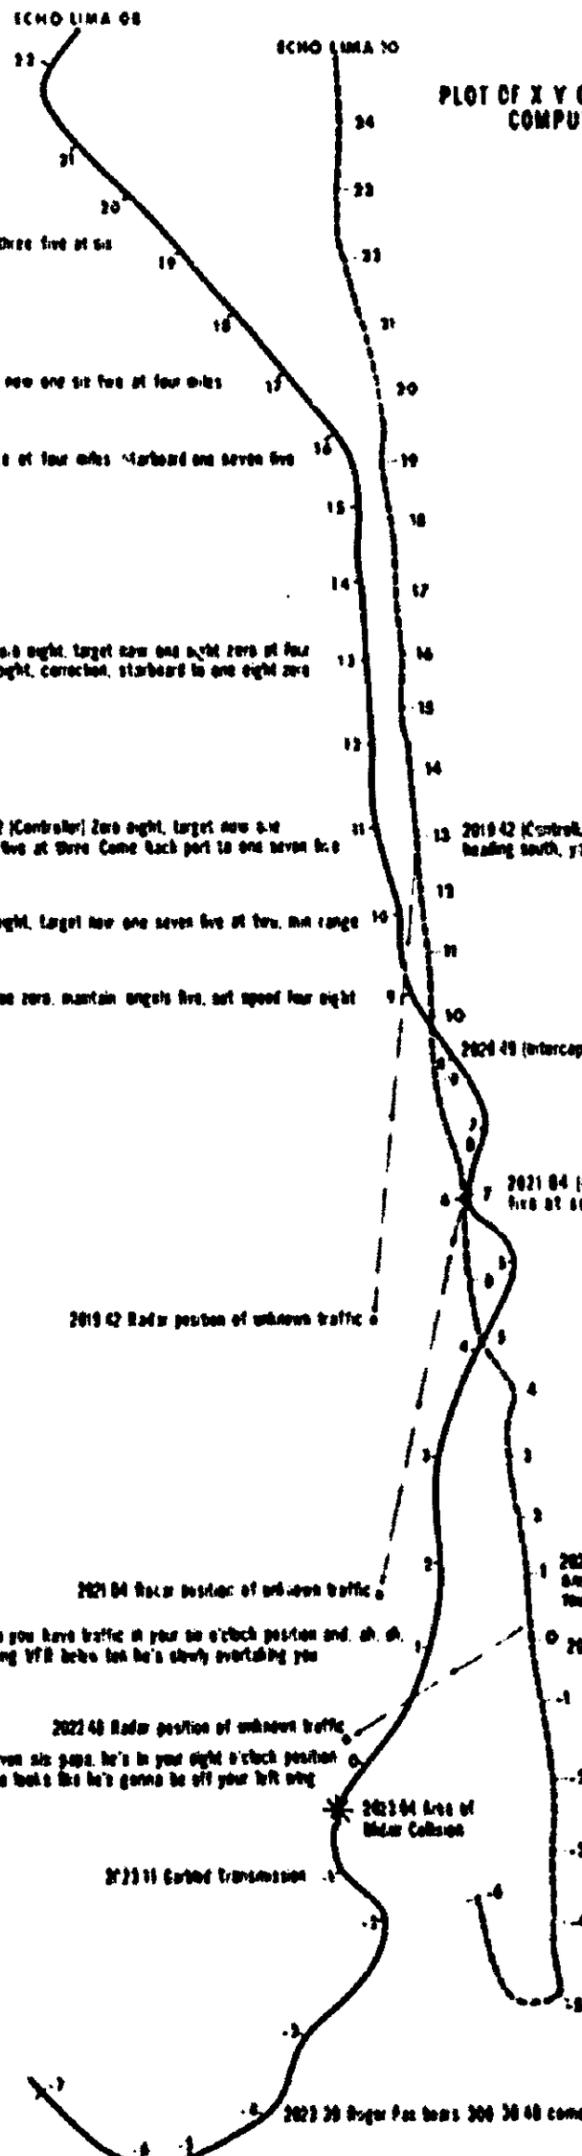
PLOT OF X Y COORDINATES FROM 20TH AIR DEFENSE COMMAND COMPUTER DATA AND RELATIVE COMMUNICATIONS

The plot of X-Y coordinates generated by the NORAD computer radar, which was tracking EL08 and EL10, correlated with the pertinent communications, tends to confirm the probability that EL08 inadvertently intercepted N6876P instead of EL10.

202304 Area of Radar Collision

NOTE: The hatch mark's superimposed along the flight tracks of the F106 aircraft represent computer frame times spaced approximately 15 seconds apart and show the relative positions of the two aircraft at the corresponding mesh numbers.
