1. Report No. NTSB-AAR-75-8	2. Government Accession No.	3. Recipient's Catalog No.	
4. Title and Subtitle Aircraft Accident Report -- International Business Machines, Inc., Grumman G-1159, N720Q, Kline, South Carolina, June 24, 1974		5. Report Date May 14, 1975

INTERNATIONAL BUSINESS MACHINES, INC.,
GRUMMAN G-1159, N720Q,
KLINE, SOUTH CAROLINA
JUNE 24, 1974

NATIONAL TRANSPORTATION SAFETY BOARD
Washington, D. C. 20594
REPORT NUMBER: NTSB-AAR-75-8

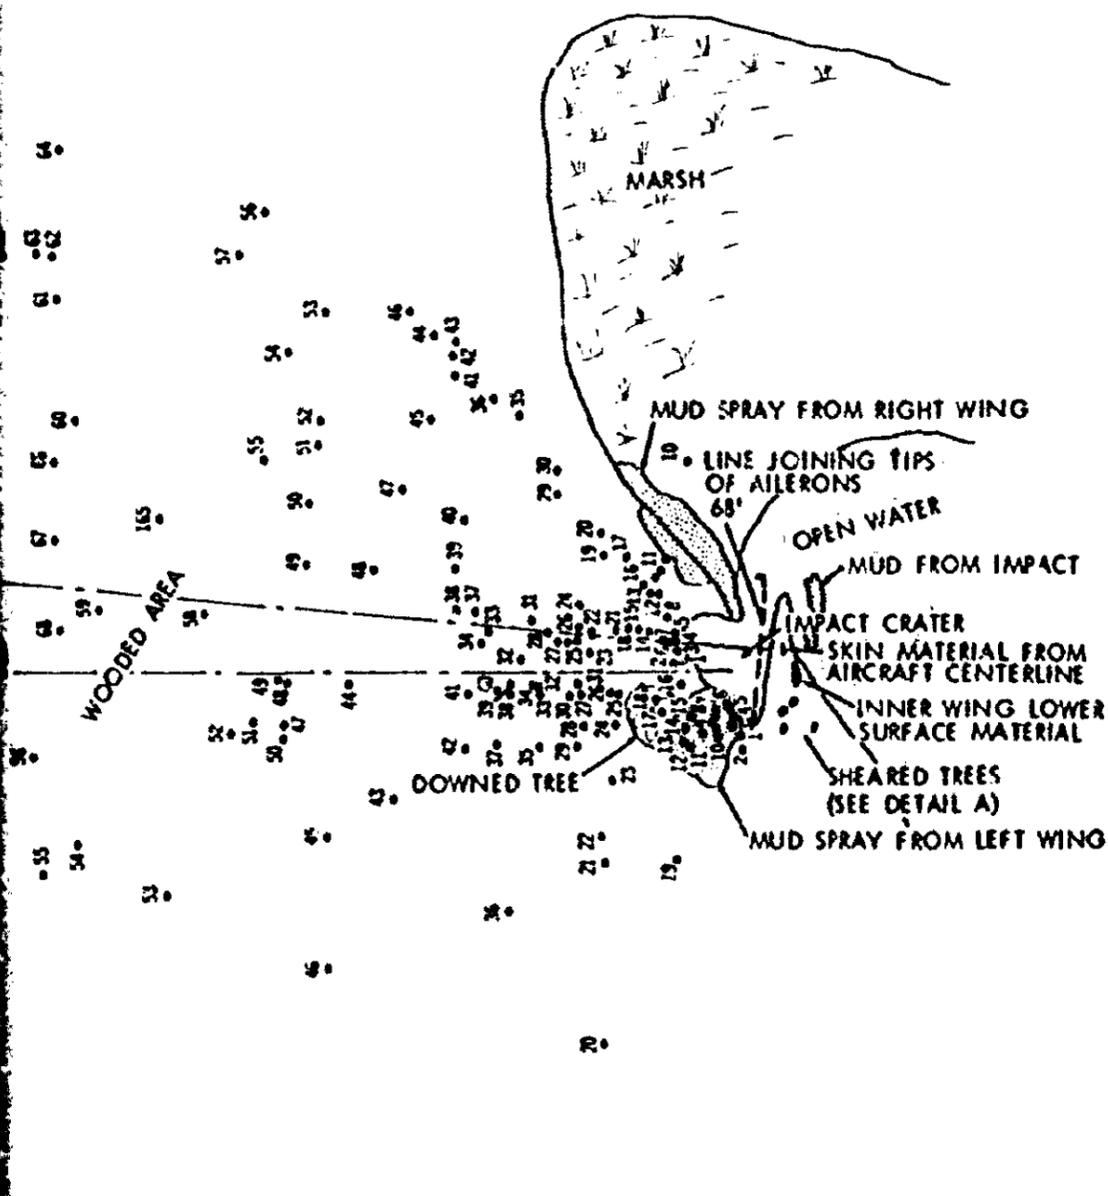
PLAN VIEW OF WRECKAGE DISTRIBUTION

The aircraft crashed in an uninhabited area. At impact, the aircraft's attitude was about 45° nosedown and 30° right wing down. The impact crater was 73 feet wide, 55 feet long, and 10 feet deep. The aircraft fragmented, and there was no assemblage to the aircraft structure. Southwest of the impact crater, wreckage was scattered over an area 1,200 feet long and 800 feet wide. (See Appendix D.) The readings and settings of the various cockpit instruments, levers, and control devices could not be determined. All major airframe components were identified. The fractures observed were typical of those caused by overload failure. There was no evidence of in-flight separation of any structural component. There was no evidence of in-flight fire, explosion, or bird strike.
