AIRCRAFT ACCIDENT REPORT

USAF CONVAIR VT-29D (CV-340) AND

CESSNA 150H, N50430

REPORT NUMBER: HTSB-AAR-75-10

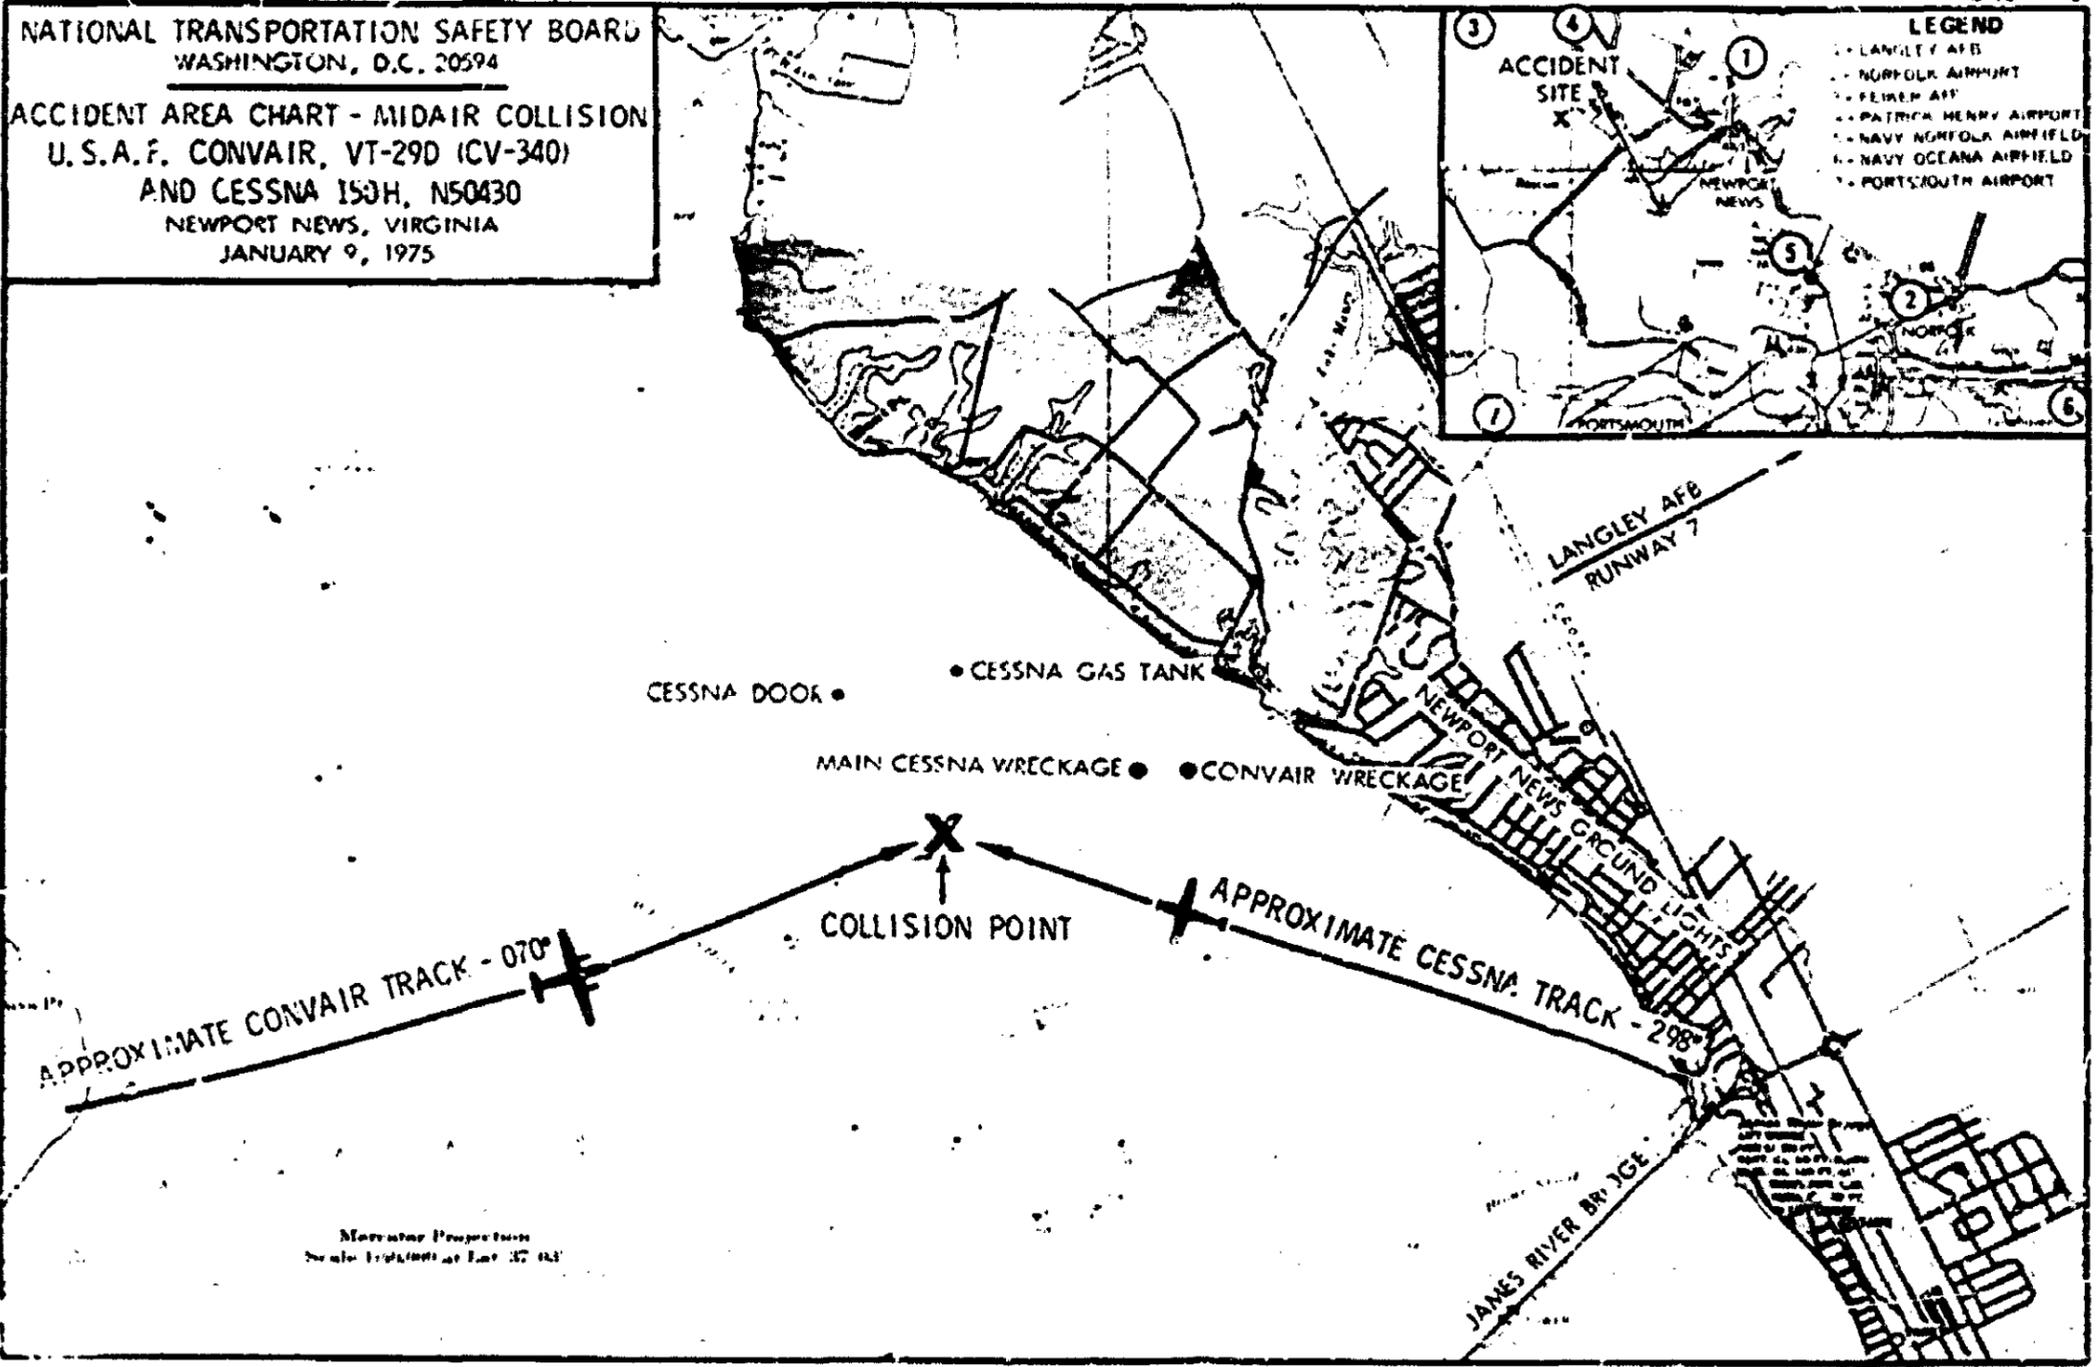
APPENDIX D

The probable flightpaths of both aircraft as established by radar tracks are shown in Appendix D.

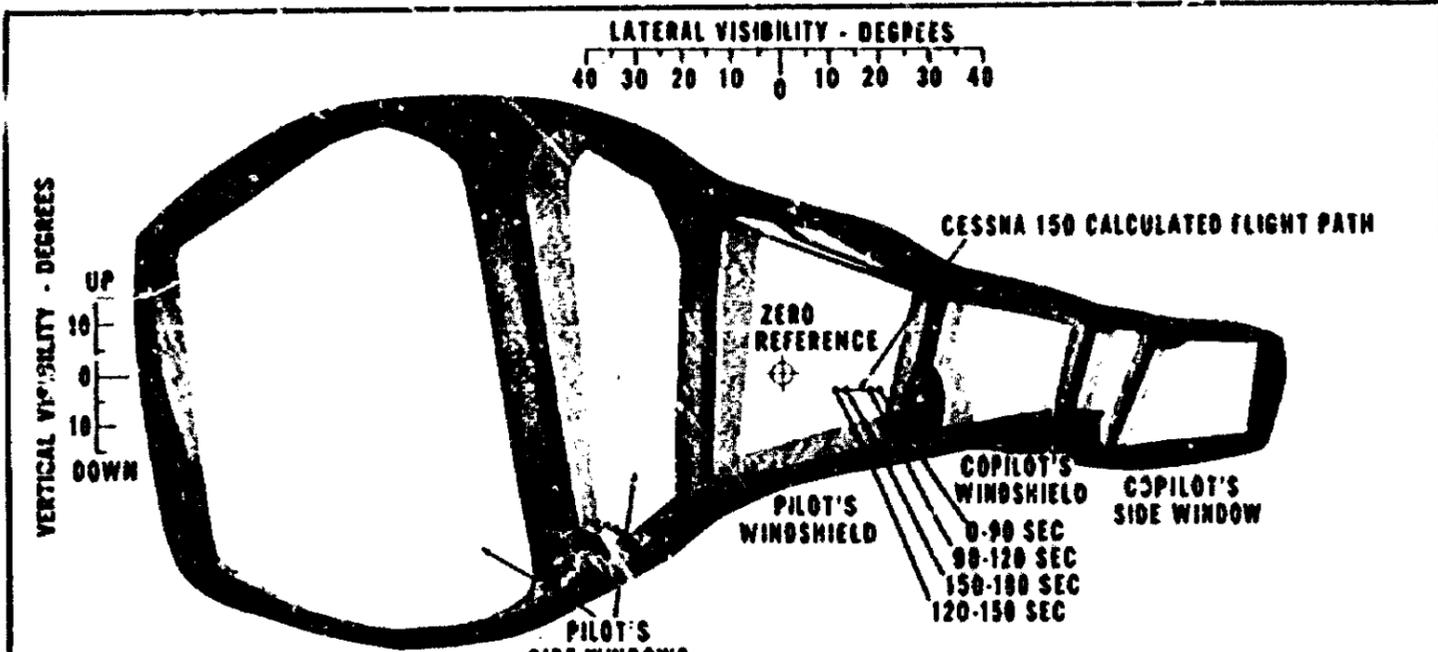
T-29 LEFT SEAT VISIBILITY FROM PILOT'S DESIGN EYE REFERENCE POINT

A visibility study was conducted to determine the field of vision from each cockpit. ^{5/} Cockpit visibility diagrams (Appendixes E and F) show the position of each aircraft in the field of vision of the occupants of the different cockpit seats. Any movement from the fixed eye position from where the photographs were taken would affect the location of the other aircraft in the viewer's field of vision.

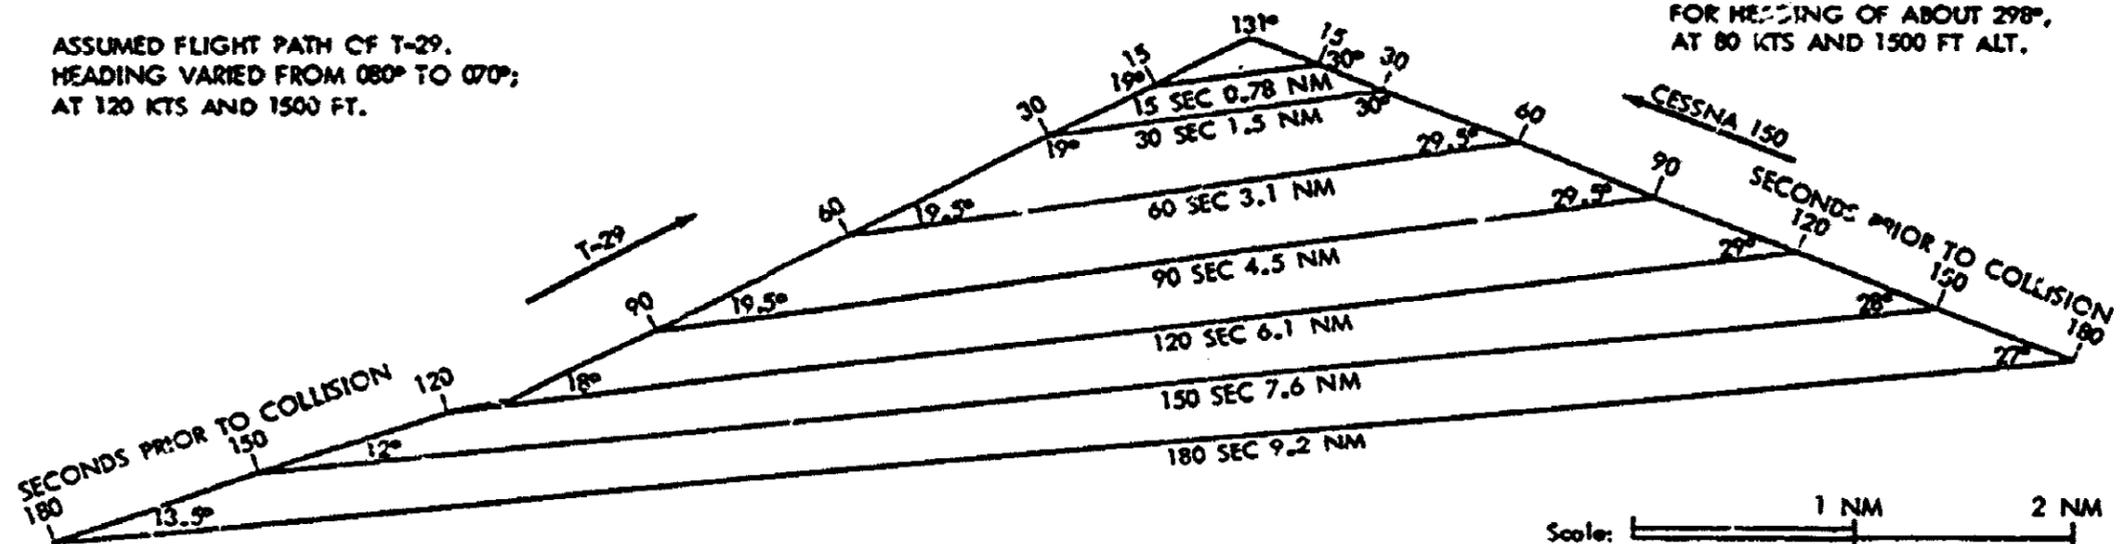
**RECONSTRUCTION OF PROBABLE FLIGHT PATHS IN FLIGHT COLLISION
USAF T-29 AND CESSNA 150
NEWPORT NEWS, VIRGINIA
JANUARY 9, 1975**

At 1835:25, when the final controller informed the Convair crew that the traffic appeared slightly higher than the Convair on the precision radar, the time to collision was about 26 seconds and the closure distance was about 1.3 nmi. At this time the visual sight angle from the Convair to the Cessna was about 19°, and from the Cessna to the Convair about 30°. (See Appendix G for the reconstructed collision angle and visual sight lines from each aircraft.)

ASSUMED FLIGHT PATH OF T-29.
HEADING VARIED FROM 080° TO 070°;
AT 120 KTS AND 1500 FT.

ASSUMED FLIGHT PATH OF C-150
FOR HEADING OF ABOUT 298°,
AT 80 KTS AND 1500 FT ALT.
