# **AIRCRAFT ACCIDENT REPORT**

**DOUGLAS DC-3C, N6**

**DuBOIS, PENNSYLVANIA**

**MARCH 27, 1975**

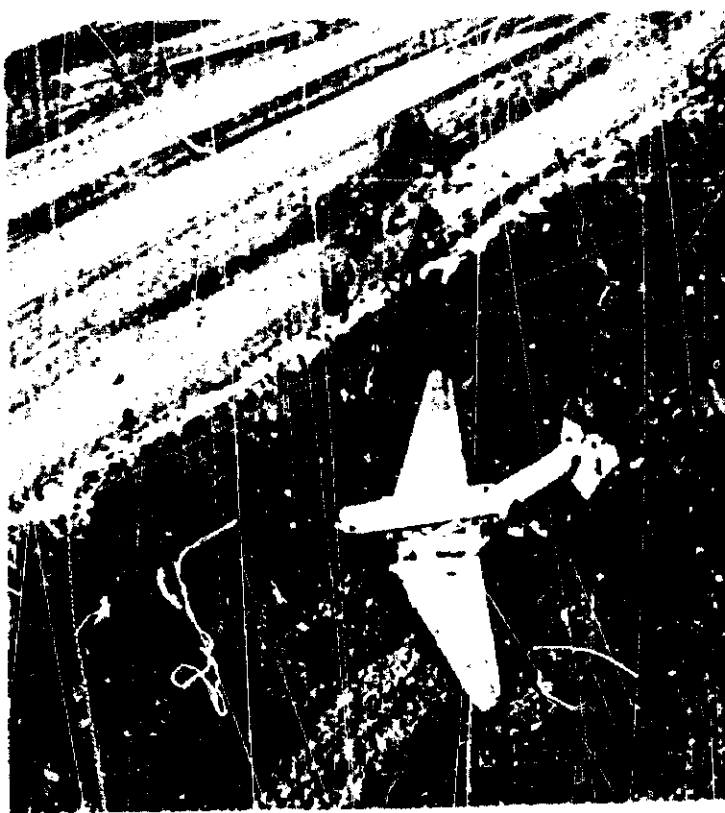
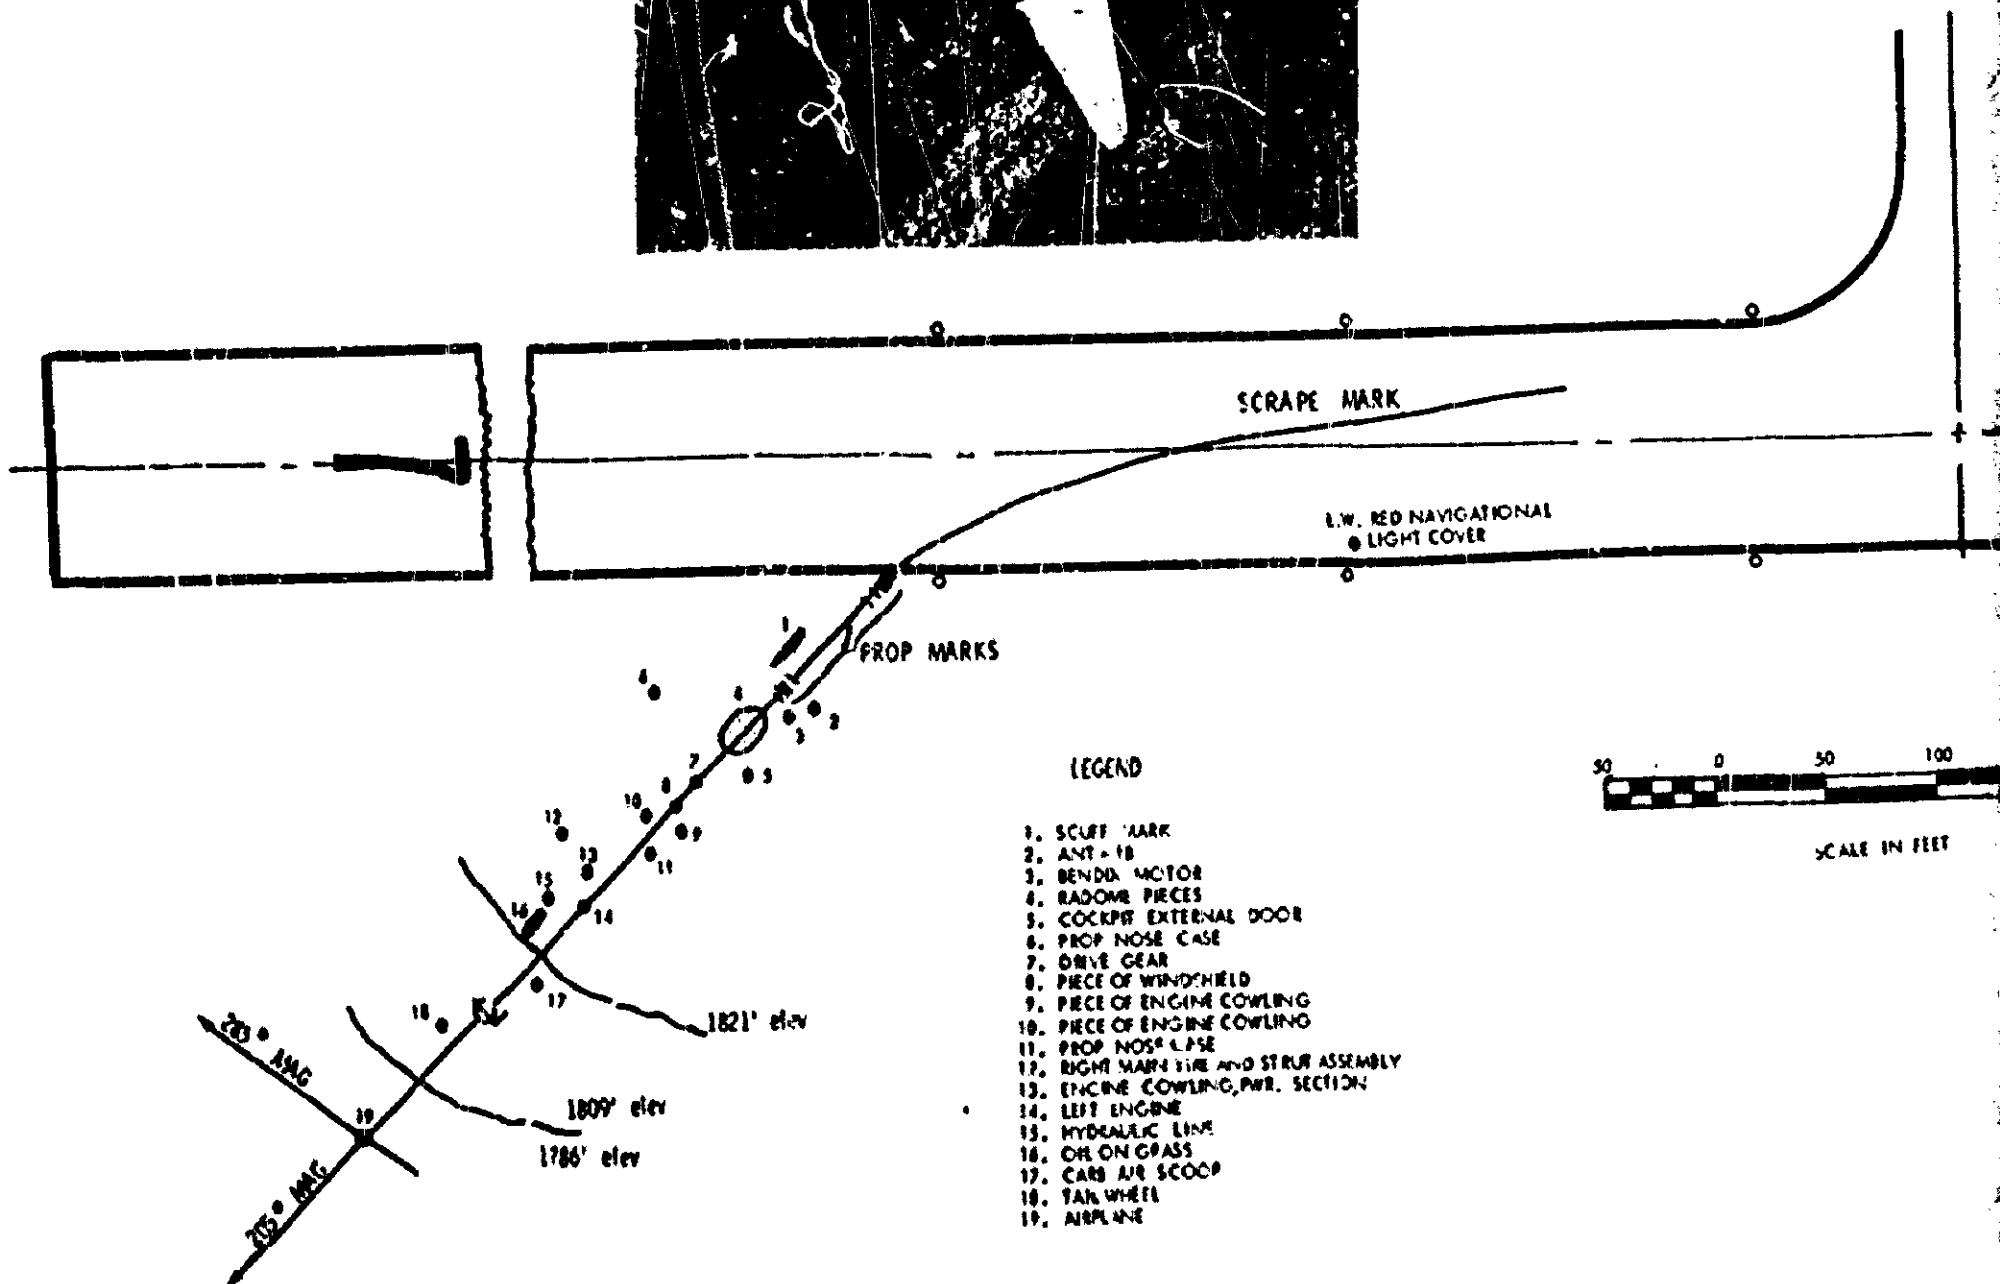
Three rubber scuff marks and a continuous scrape mark were found on runway 25. (See Appendix D.) The first rubber scuff mark, which began 12 ft. left of centerline and 1,010 ft. from the threshold, continued for 275

ft. The second rubber scuff mark, which began 6 ft. right of centerline and 1,025 ft. from the threshold, continued for 174 ft. (The spread of the main landing gear of a DC-3 is 18.5 ft.) A third rubber scuff mark, which began 10 ft. right of centerline and 1,225 ft. from the threshold, was visible for 42 ft., and after a gap of approximately 70 ft., reappeared for another 40 ft. All three scuff marks curved toward the right side of the runway.

The scrape mark, which began 23 ft. right of centerline and 1,690 ft. from the threshold, was continuous in a curve to a point on the left edge of the runway, 1,995 ft. from the threshold. At the beginning of the scrape mark, orange colored paint similar to that on the aircraft's wingtips was found embedded in the runway surface. Farther along the scrape mark, metal particles were found on the runway surface.
