AIRCRAFT ACCIDENT REPORT

TRANS WORLD AIRLINES, INC.

BOEING 727-231, N54328

REPORT NUMBER: NTSB-AAR-75-16

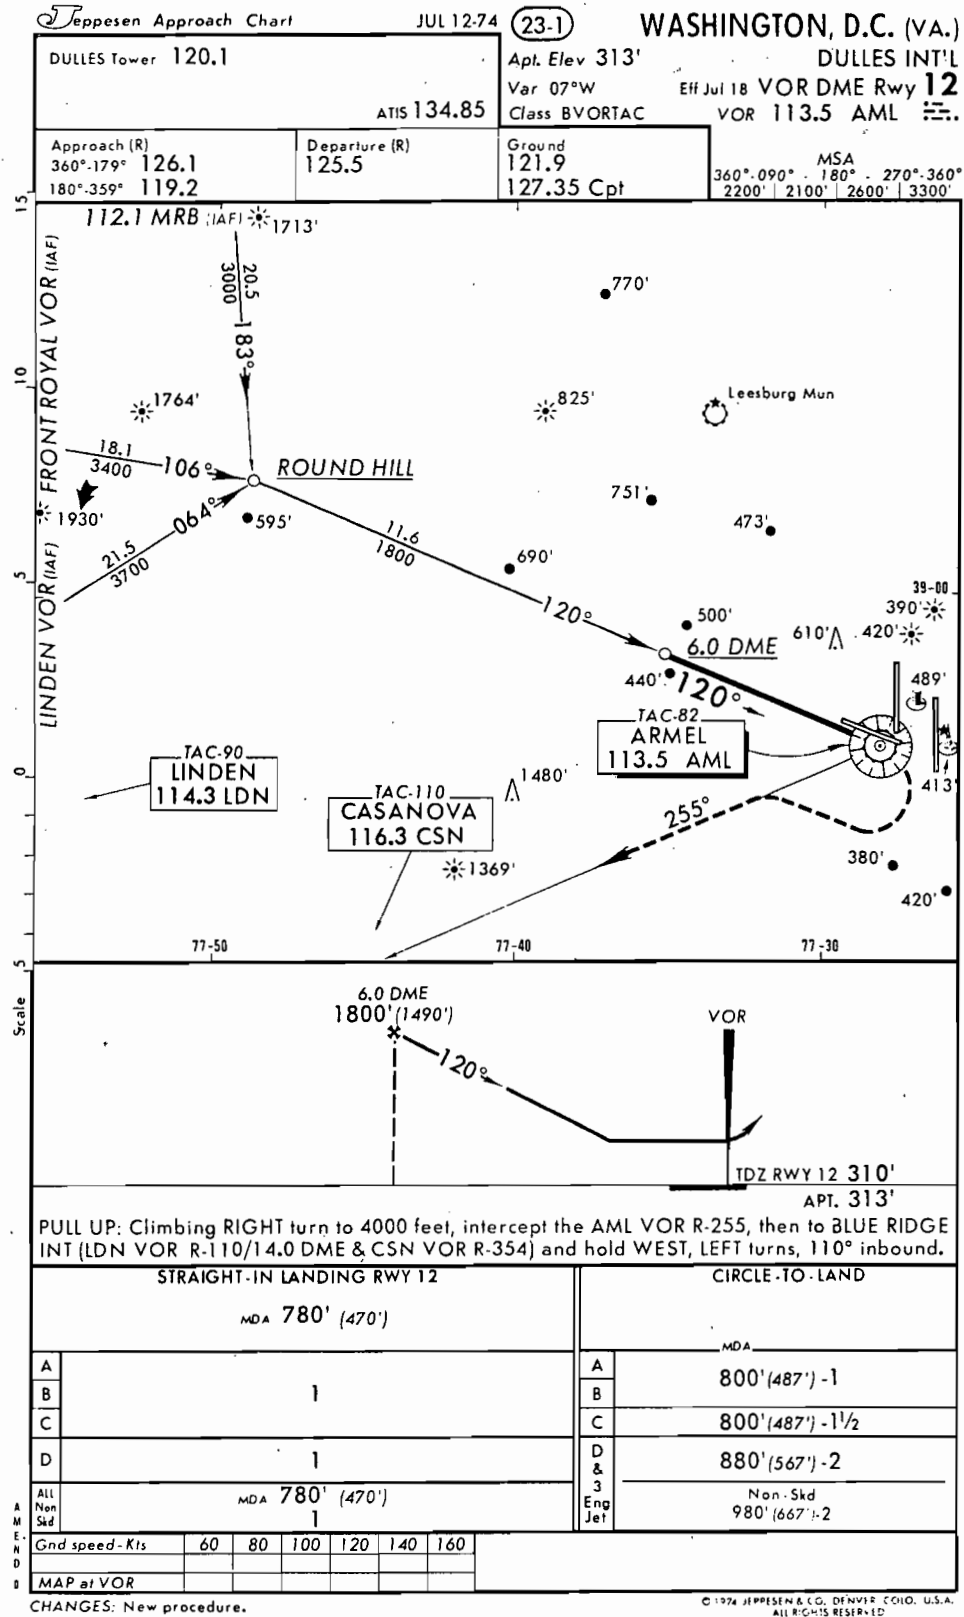
APPENDIX D

(3) Inadequate depiction of altitude restrictions on the profile view of the approach chart for the VOR/DME approach to runway 12 at Dulles International Airport.

The information available to the pilot, including the approach chart, should have alerted the crew that an unrestricted descent would be unsafe. It does appear to the Board that there was a deficiency in the chart. This particular approach chart depicted the profile view from the final approach fix to the airport. It did not depict the intermediate fix, Round Hill, with its associated minimum altitudes. This information was available from the plan view of the chart, but it appears that the crew gave their primary attention to the profile. If this was the

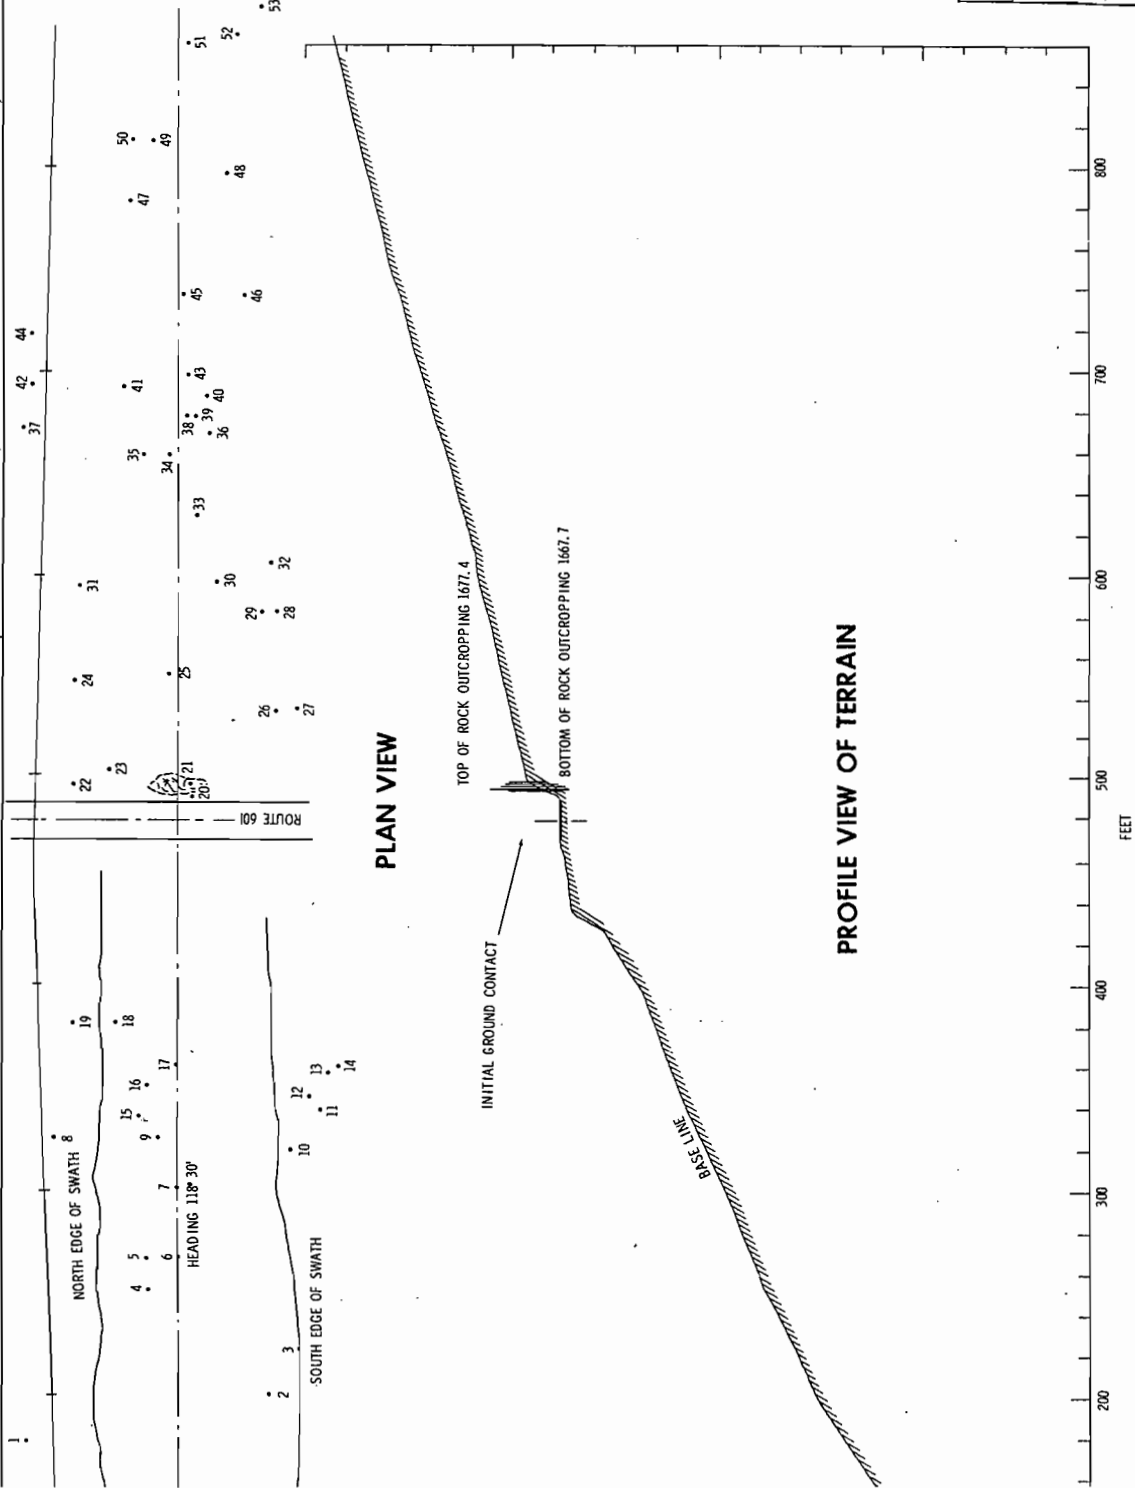
WRECKAGE DISTRIBUTION CHART
TRANS WORLD AIRLINE INC.
BOEING 727-231, N54328
BERRYVILLE, VIRGINIA
DECEMBER 1, 1974

The wing flaps, wing leading edge devices, and the landing gears were retracted. The condition of the flight control system could not be determined because of impact and fire damage. No evidence was found of preimpact structural failure or control system malfunction.

All three engines separated from the aircraft and were damaged.
